Subject: Arkansas Nuclear One - Units 1 and 2
Docket Nos. 50-313 and 50-368
License Nos. DPR-51 and NPF-6
Additional Information In Response To Generic Letter 95-03
(TAC Nos. M92220 and M92221)

Arkansas Nuclear One - Unit 1 Response to Generic Letter 95-03 Request for Additional Information

Arkansas Nuclear One - Unit 2 Response to Generic Letter 95-03 Request for Additional Information

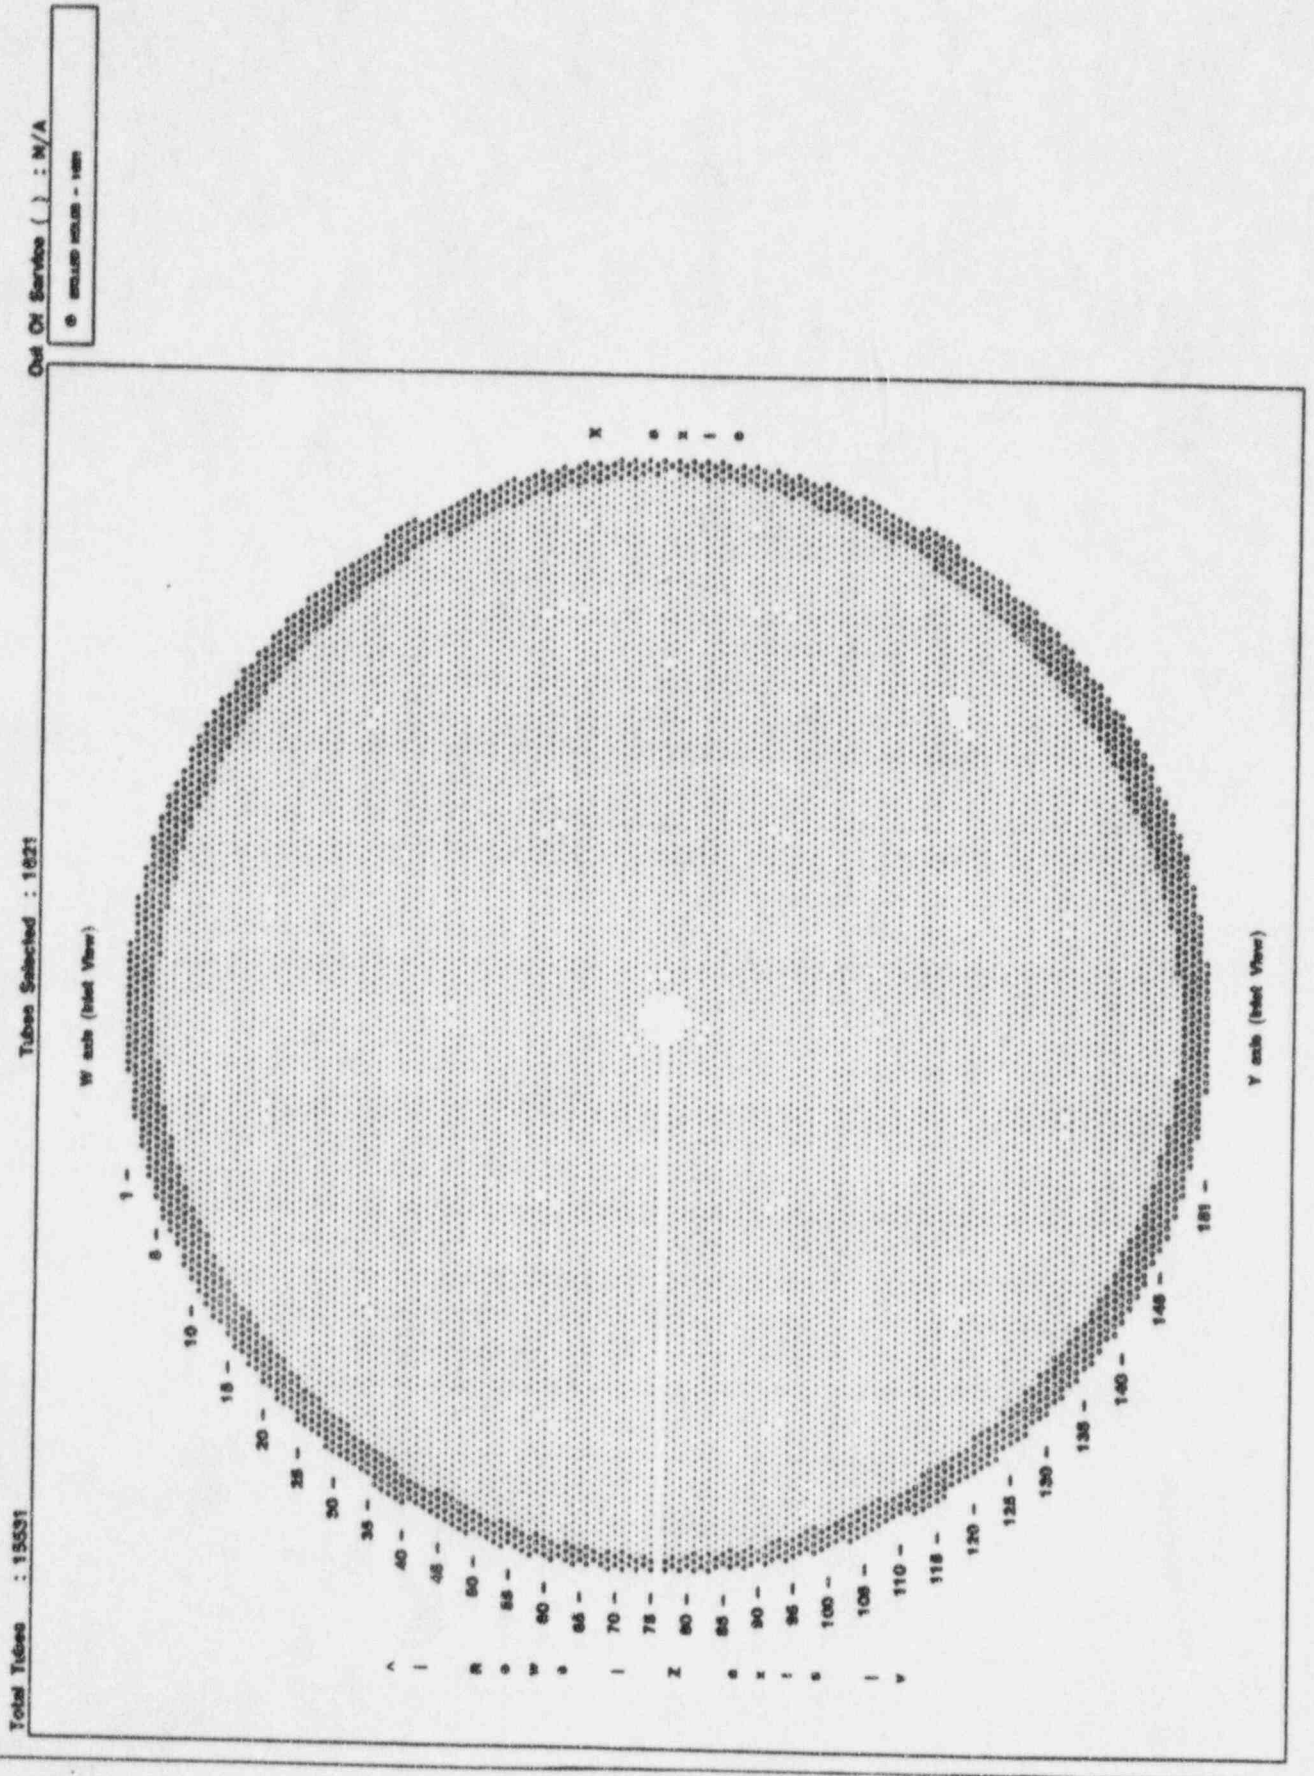
FIGURE 1
DRILLED HOLES IN THE 15TH TSP

The 15th TSPs within the ANO-1 steam generators contain both broached and drilled holes. The outer tube locations in the 15th TSP are drilled to a 0.637" minimum/0.646" maximum diameter. 1623 locations are drilled per steam generator as identified in Figure 1. All remaining tube locations within the 15th TSP and all other TSPs are of the broached hole design.

Dings have been detected at both the 15th TSP drilled holes and broached holes. Based upon previous inspection data there does not appear to be a significant preference for the occurrence of dings in the drilled hole locations over the broached hole locations. Growth of observed dings in the OTSGs has been insignificant.
