U.S. NUCLEAR REGULATORY COMMISSION

Report No. 50-456/84-09(DPRP); 50-457/84-09(DPRP)

Facility Name: Braidwood Nuclear Power Station, Units 1 and 2

Inspection Conducted: May 1 through June 4, 1984

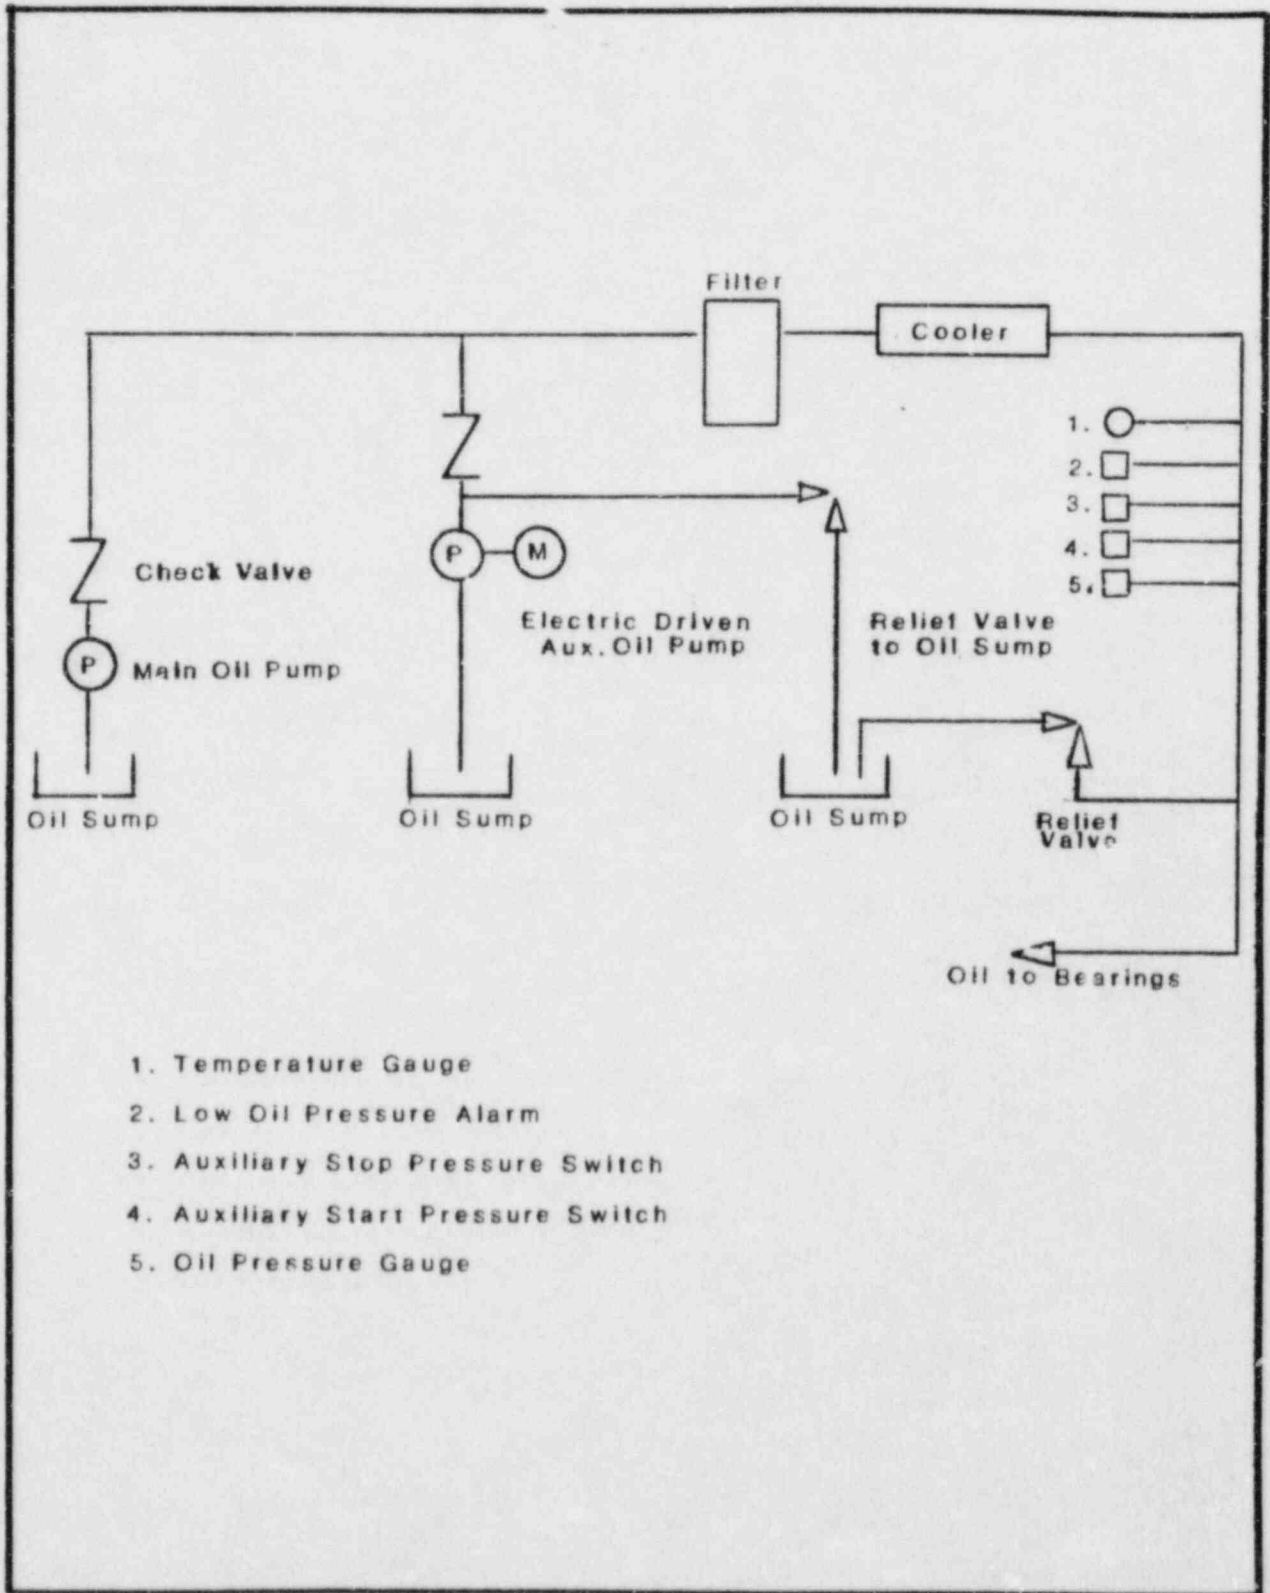
A second area of concern is the designed lubricating oil system for the auxiliary feedwater pumps (electric motor and diesel driven) and the lubricating oil system for the speed increaser (1765 RPM up to 3570 RPM) for the diesel driven auxiliary pumps (see Attachment 1). In both systems all pressure and temperature sensing devices are located after the oil cooler and do not indicate to an operator the condition of the oil filter on the discharge of the positive displacement oil pumps. No over pressure protection is installed for the main, (direct driven) oil pump and no oil filter by-pass is provided to maintain minimum oil flow to the pump bearings should the filter become plugged.

With only the present oil pressure switches or indicating gauge an operator cannot determine the condition of the pump output pressure, the ΔP across the oil filter, and ΔP or ΔT across the oil cooler. These readings are vital signs which are necessary to understand the operating conditions of each component and potential problem areas.

The "as-built" condition of the auxiliary feedwater pump lubricating oil systems are considered to be an unresolved item (456/84-09-12; 457/84-09-12) pending further information from the licensee.
