METALLURGICAL EVALUATION  
OF  
DIESEL GENERATOR TURBOCHARGER  
GUIDE VANE HOLD DOWN BOLTS  
AT  
GRAND GULF NUCLEAR STATION - UNIT 1

PREPARED FOR: NUCLEAR PLANT ENGINEERING  
MISSISSIPPI POWER & LIGHT COMPANY  
PORT GIBSON, MISSISSIPPI 39150

PREPARED BY: J. S. BRIHMADESAM  
NUCLEAR ENGINEERING DEPARTMENT  
MIDDLE SOUTH SERVICE, INC.  
NEW ORLEANS, LOUISIANA 70112

JULY, 1984

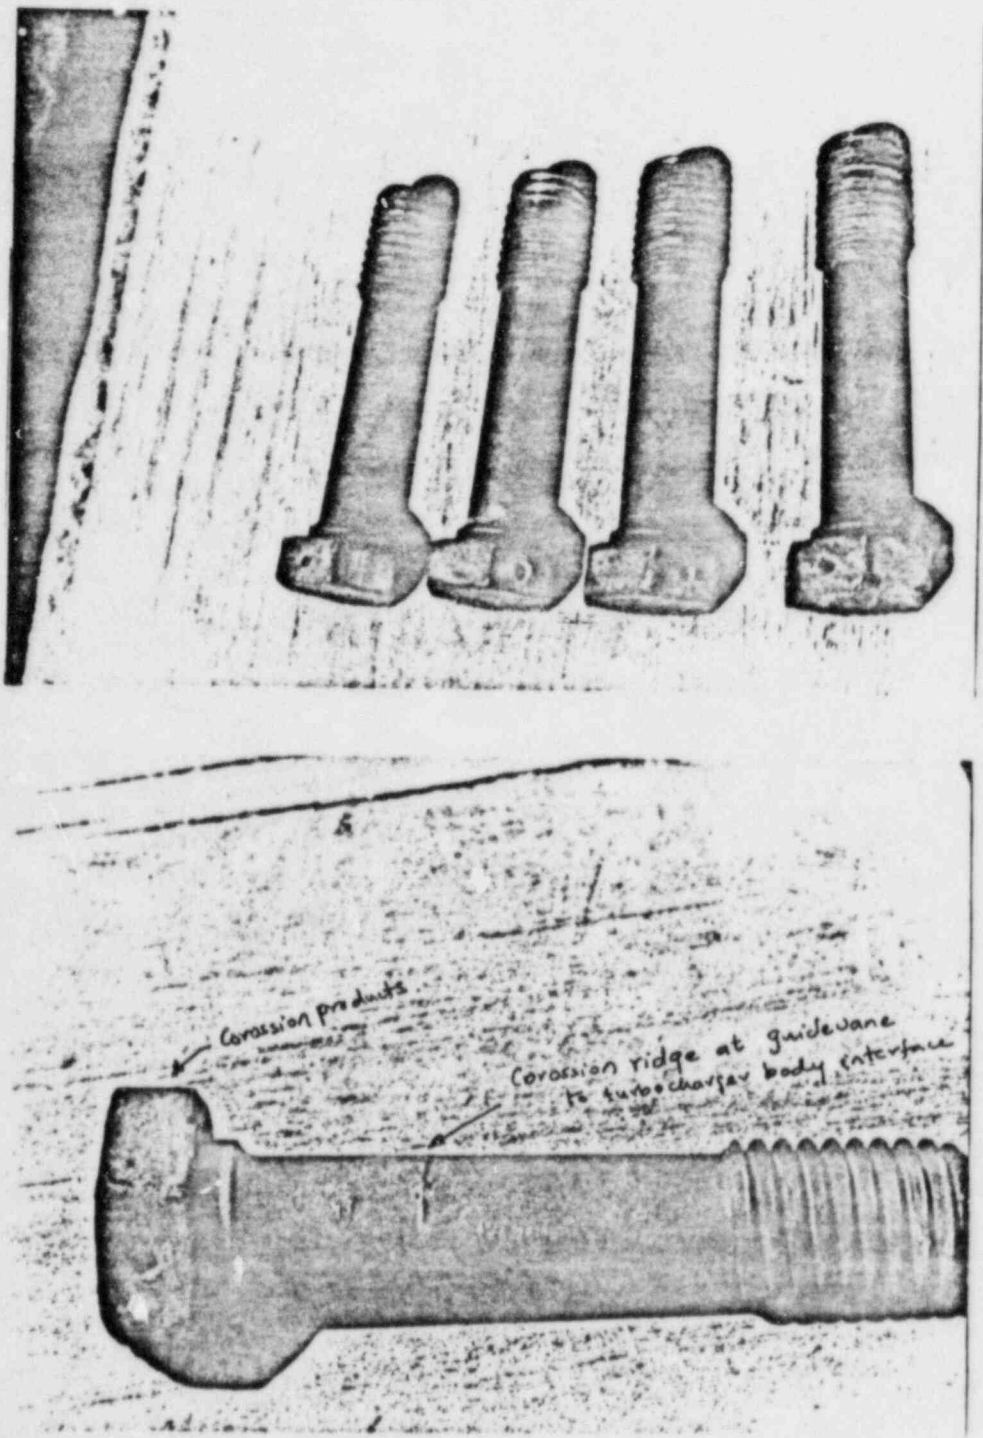
Figure 1 As-received Turbocharger Bolts From Division I

exhaust gases. On some bolts there was a whitish salt-like deposit at the head to shank radius. Some bolts also had a small ridge of reddish brown oxide at the interface between nozzle ring and turbocharger body. These observed features are shown in Figure 1. The fracture surface of the broken bolt showed a smooth half moon surface and a grainy morphology elsewhere. A macrograph of the fracture surface is shown in Figure 2. Lower power microscopic evaluation of the bolts did not reveal the presence of cracks in any of the other bolts and the fracture surface of the broken bolt showed evidence of secondary cracking in the grainy region.

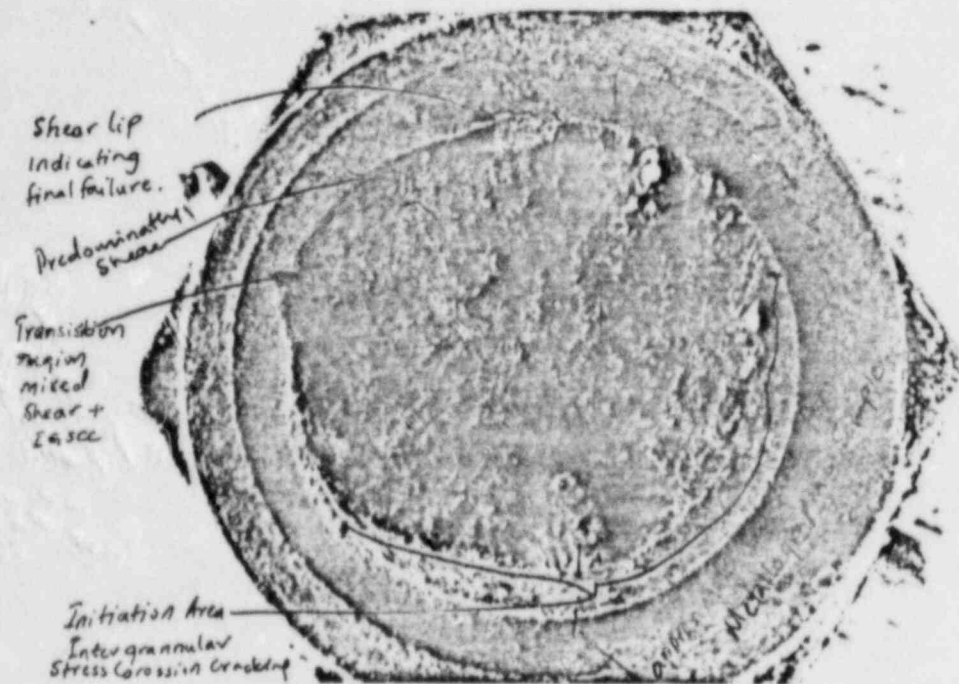
Figure 2 As-received Fracture Surface of Broken Bolt From Division I

Figure 29 and Figure 24 it is clear that this region is better revealed after cleaning. Based on the fractographic observations it is evident that the crack initiated and propagated by IGSCC over a majority of the fracture area, converted to a mixed mode (IGSCC plus shear) when overload conditions were approached, to an overload ductile tearing mode and finally to a shear lip failure. This progression is approximately mapped in Figure 2.

Shows where specimen for metallography was obtained. The areas of fracture initiation and propagation were marked based on fractographic evaluation presented in Section 4.0.

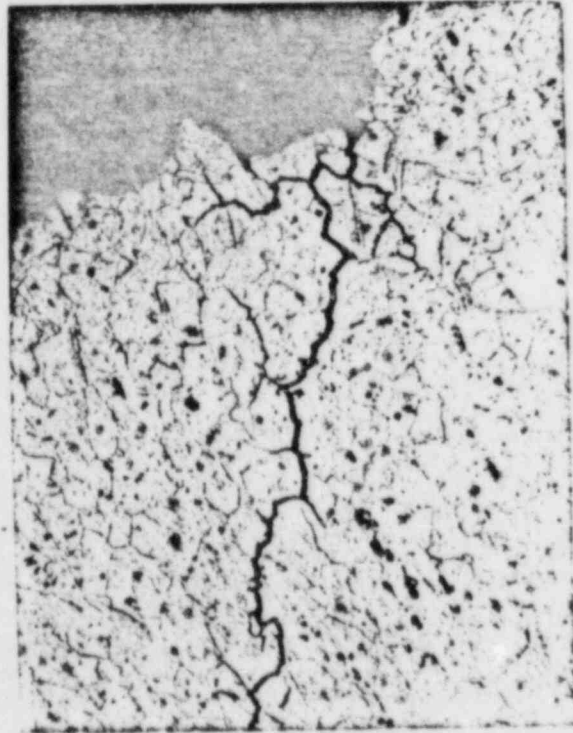
Figure 3 Intergranular Crack at Fracture Surface

A cross-section, as shown in Figure 2, was obtained, polished and etched. The crack profile is shown in Figure 3. The crack is intergranular and appears to be filled with corrosion products. In order to determine the morphology and identify the corrosion products, this cross-section was further analyzed using a Scanning Electron Microscope (SEM). SEM metallographs are presented in Figures 4 through 8. Figure 4 is taken at the fracture surface showing the individual grains, secondary cracking and a profile of secondary cracks on the polished face. Figure 5 shows the existence of the branched intergranular cracks which connect to other cracks that

Crack follows grain boundaries showing a typical IGSCC appearance. Inclusion like islands in the matrix are Intermetallic Compound precipitates.

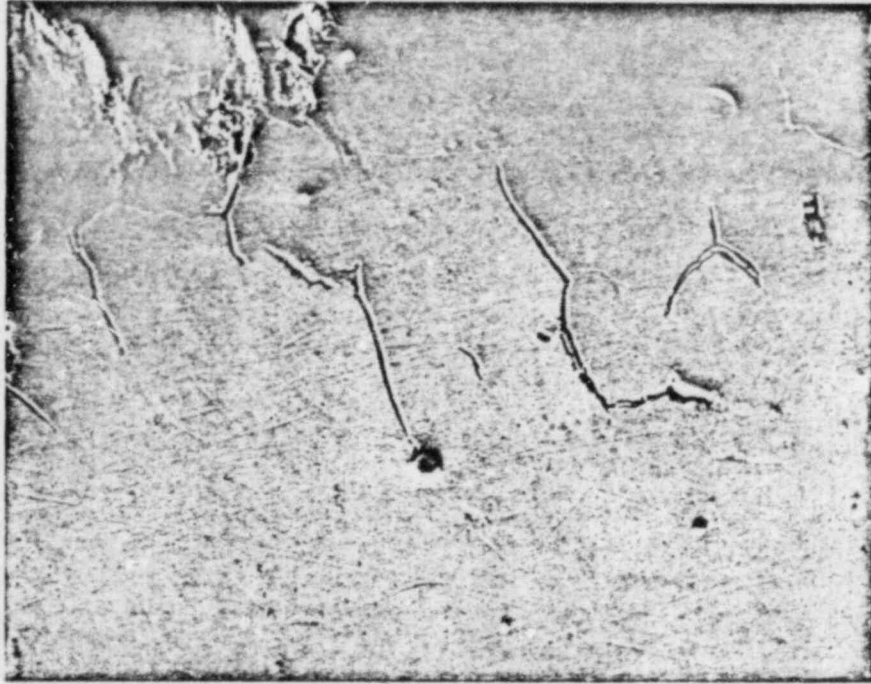
Figure 5 SEM Metallograph at Fracture Surface Intergranular Cracking  
Appearance similar to Figure 4.

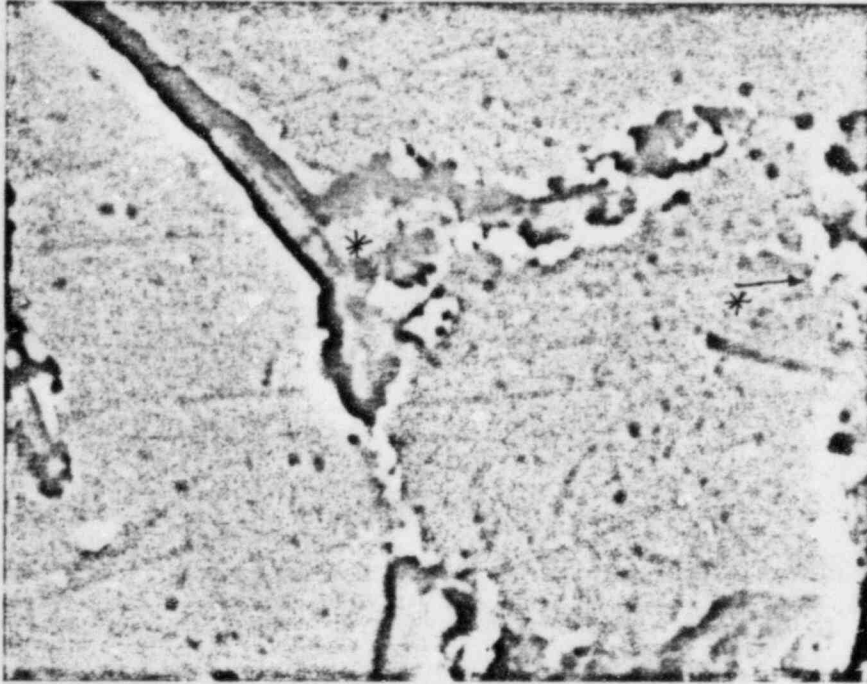
Figure 6 SEM Metallograph

emanate from the fracture surface. Intermetallic precipitates, primarily titanium and molybdenum, are also evident. At a higher magnification, Figure 6, the corrosion product within the grain boundaries is clearly visible. The corrosion product was identified to be predominantly iron with no evidence of sulphur. Thus, the product being iron oxide. This aspect is further discussed in Section 5, Chemical Analysis. Figure 7 shows the attack at the grain boundary and the remanant of a precipitate. The precipitate was found to be mostly titanium. Figure 8 shows a grain boundary corrosion product deposit with evidence of a whitish phase along the grain boundary. This whitish phase was found to be a nickel rich phase. The chemical identification of the corrosion products and phases identified here are presented in Section 5.

Corrosion Product (Iron Oxide) in Grain Boundaries (Division I)

Corrosion product within grain boundary crack clearly visible.  
Also visible is a white phase segregation along grain boundary.

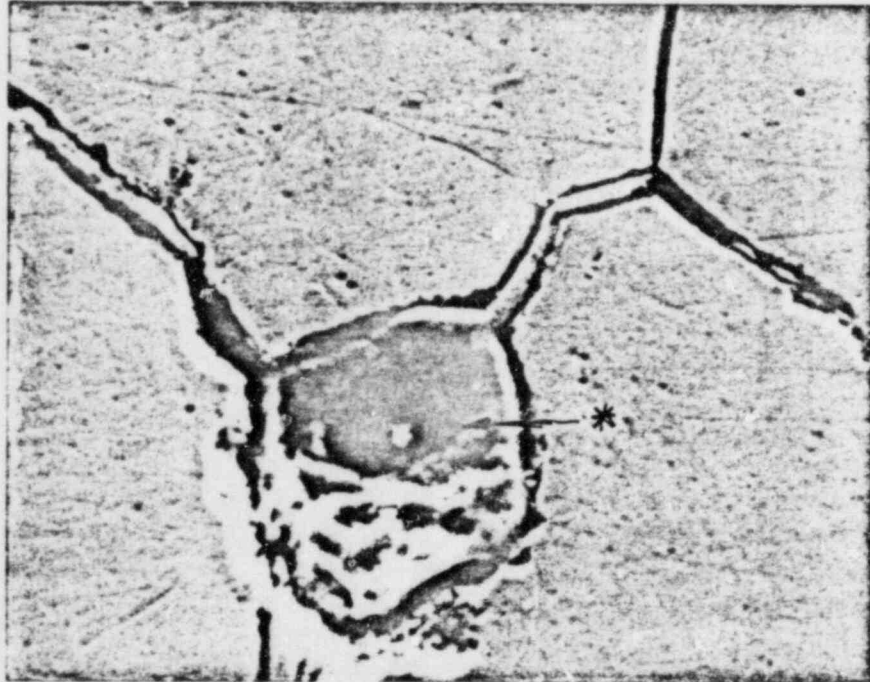
Figure 7 SEM Metallograph of Inclusion

Inclusion was found to be an intermetallic compound precipitate formed during aging treatment. Precipitate was a Titanium-Molybdenum Intermetallic Compound.

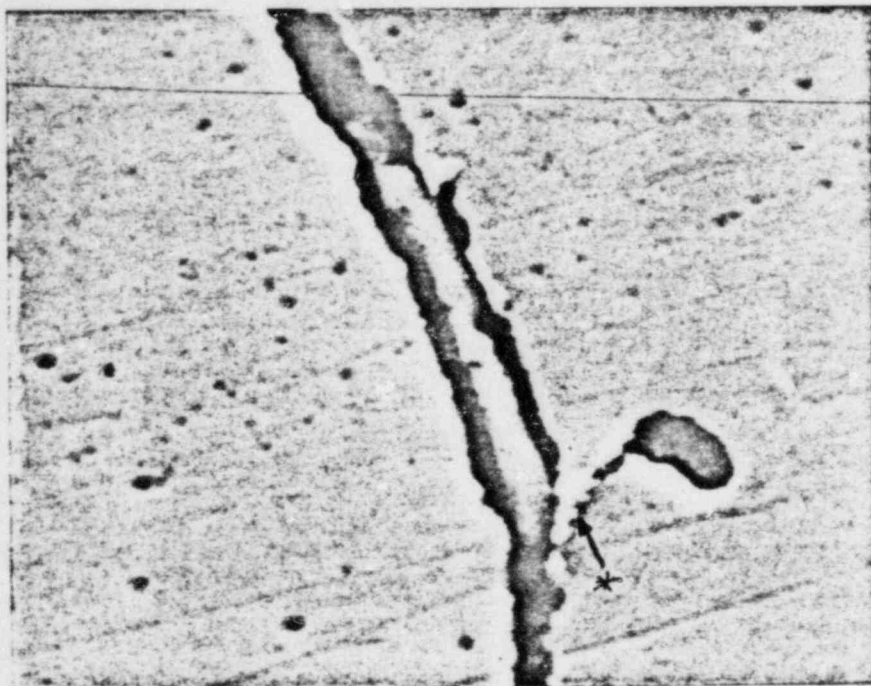
Figure 8 SEM Metallograph of Intergranular Corrosion Product  
Nickel rich phase along grain boundary.

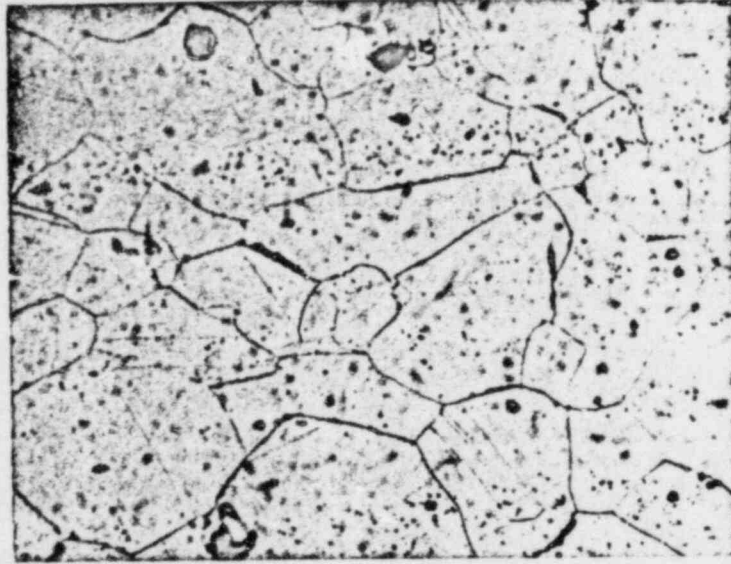
Figure 9 Photomicrograph of Broken Turbocharger Bolt (Division I)

Note large grains and intermetallic precipitates. There is some evidence of grain boundary precipitation.

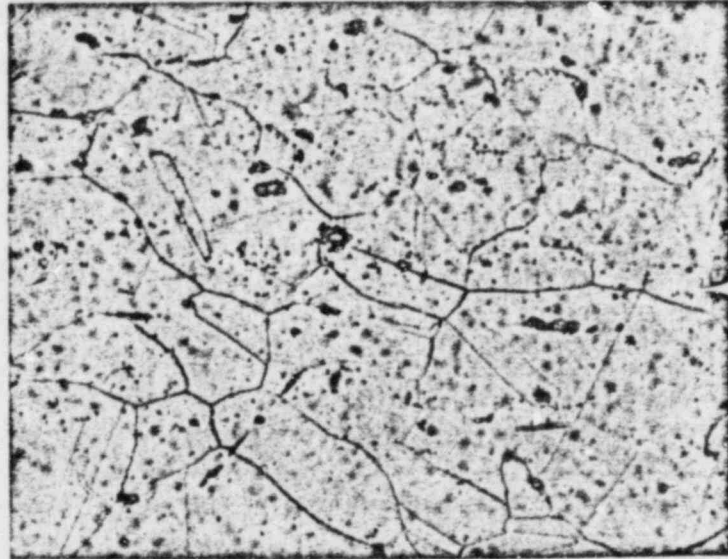
Figure 10 Photomicrograph of Unbroken Turbocharger Bolt (Division I)  
Large grains, intermetallic precipitates and grain  
boundary precipitates.

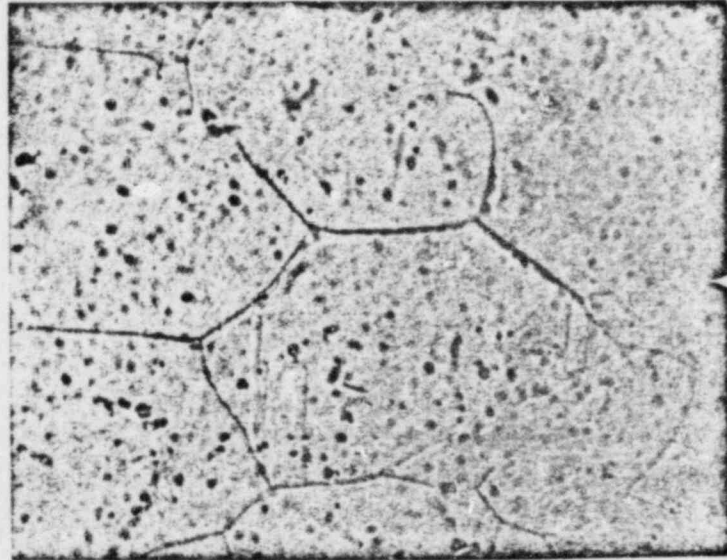
Figure 11 Photomicrograph of Broken Turbocharger Bolt (Division I)  
Note grain boundary precipitation, indicating sensitization  
of bolt material.

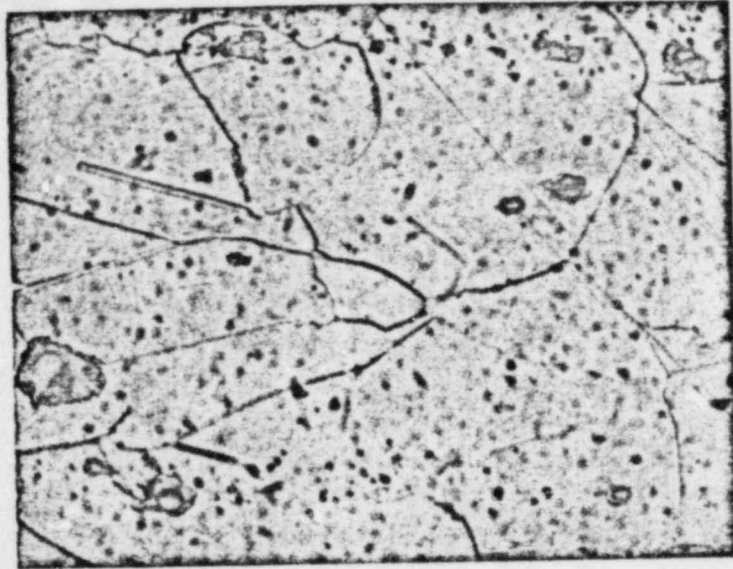
Figure 12 Photomicrograph of Unbroken Turbocharger Bolt (Division I)  
Note grain boundary precipitation. Indicates sensitization  
of bolt material.

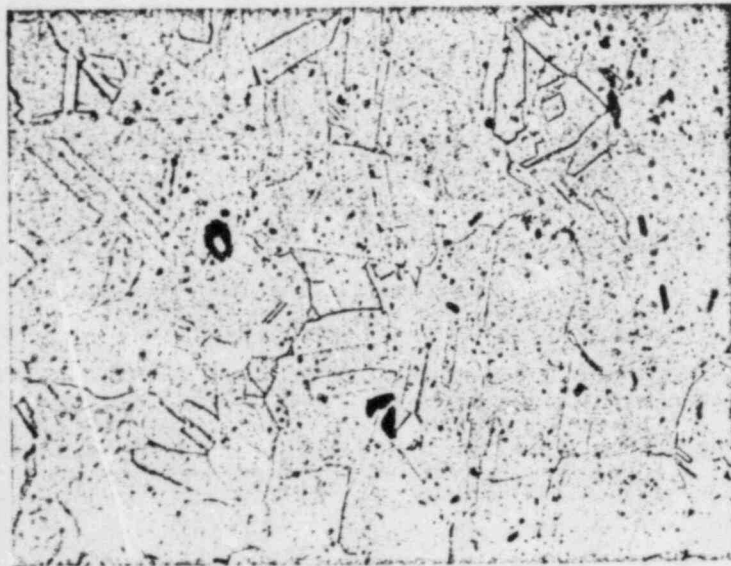
Figure 13 Photomicrograph of New Unused A-286 Bolt  
Small grains. No evidence of grain boundary precipitation.

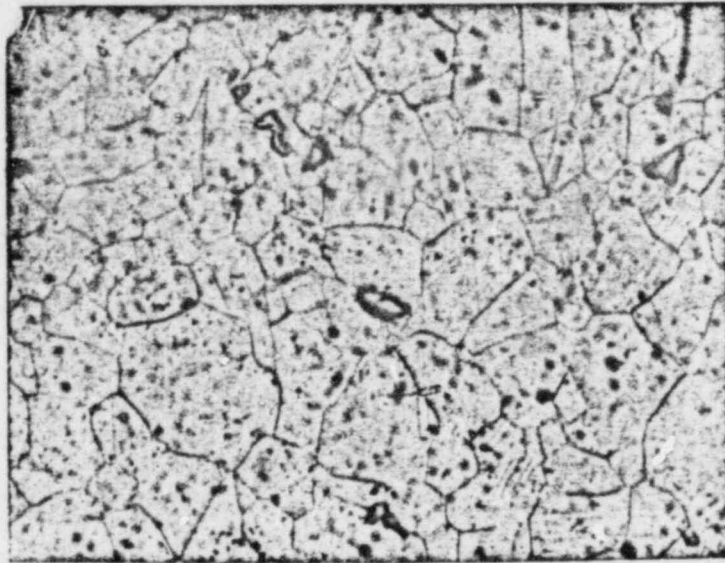
Figure 14 Photomicrograph of Turbocharger Bolt From Division II  
L-1 Bolt

Note smaller grain size than the Division I bolts. Micro-structure shows some evidence of stepping, indicating absence of sensitization.

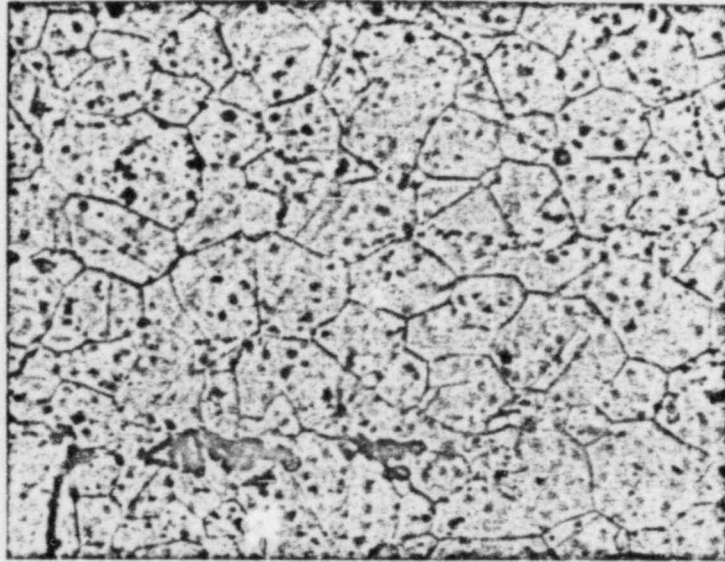
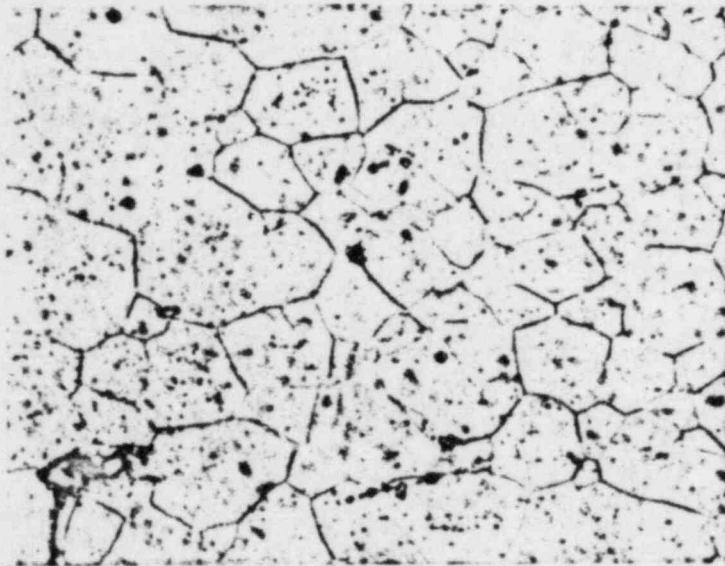
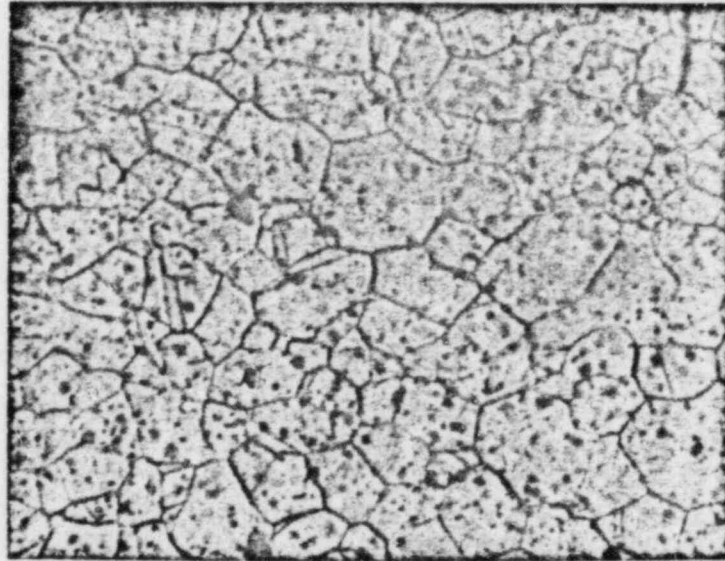
Figure 15 Photomicrograph of Turbocharger Bolt From Division II  
L-3 Bolt  
(Same as figure 14)

Figure 16 Photomicrograph of Turbocharger Bolt From Division II  
R-2 Bolt  
(Same as figure 14)

Figure 17 Photomicrograph of Turbocharger Bolt From Division II  
R-6 Bolt  
(Same as figure 14)

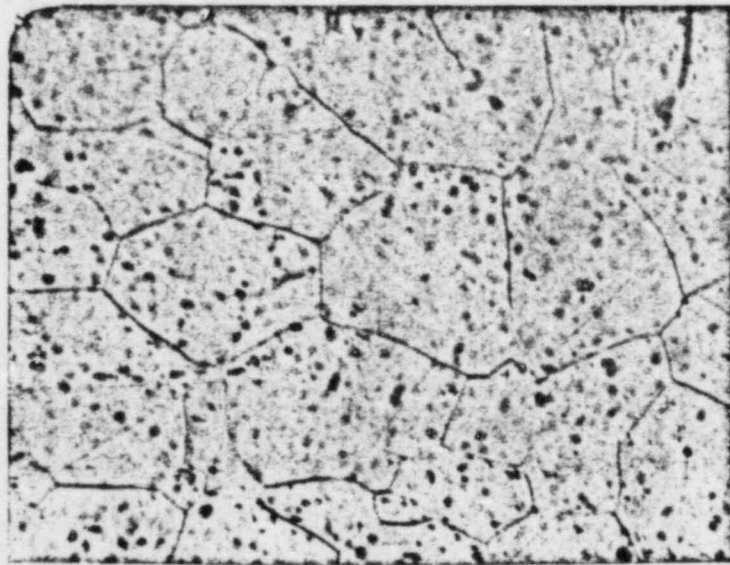
Figure 18 Photomicrograph of Turbocharger Bolt From Division II  
L-3 Bolt

Note absence of grain boundary precipitation. Material was not sensitized.

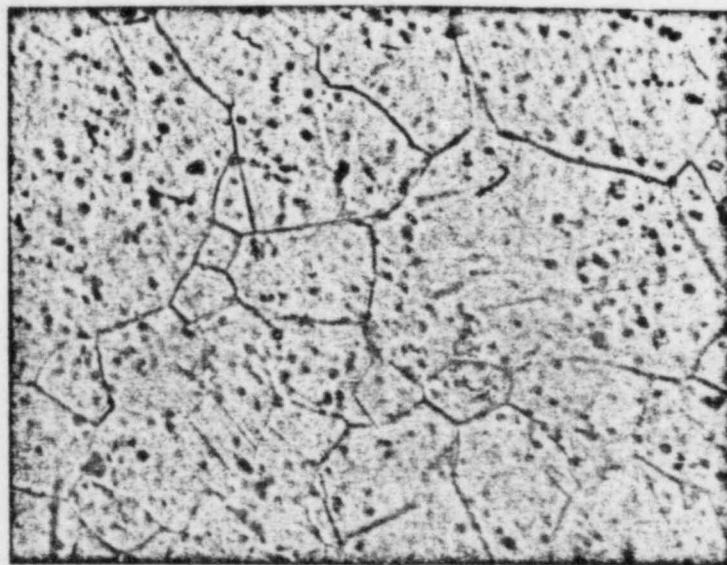
Figure 19 Photomicrograph of Turbocharger Bolt From Division II

Very slight evidence grain boundary precipitation. Material is not sensitized.

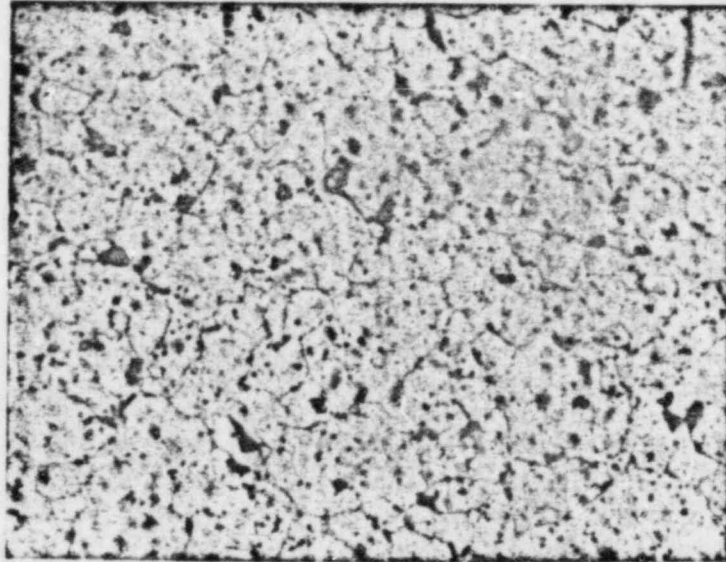
Figure 20 is a micrograph of the washer and it shows a typical microstructure of A-286 material.

Figure 20 Photomicrograph of Washer From Division II Turbocharger Bolt  
Typical A-286 microstructure.

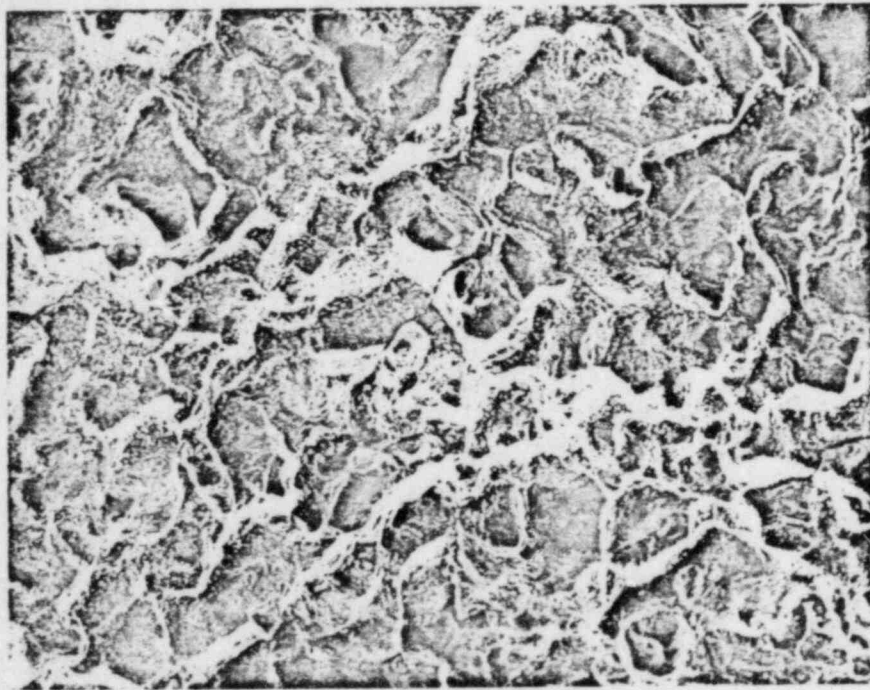
Figure 21 SEM Fractograph - Division I Broken Bolt Head  
Individual grains and secondary cracks are visible.  
Surface covered with an oxide layer.

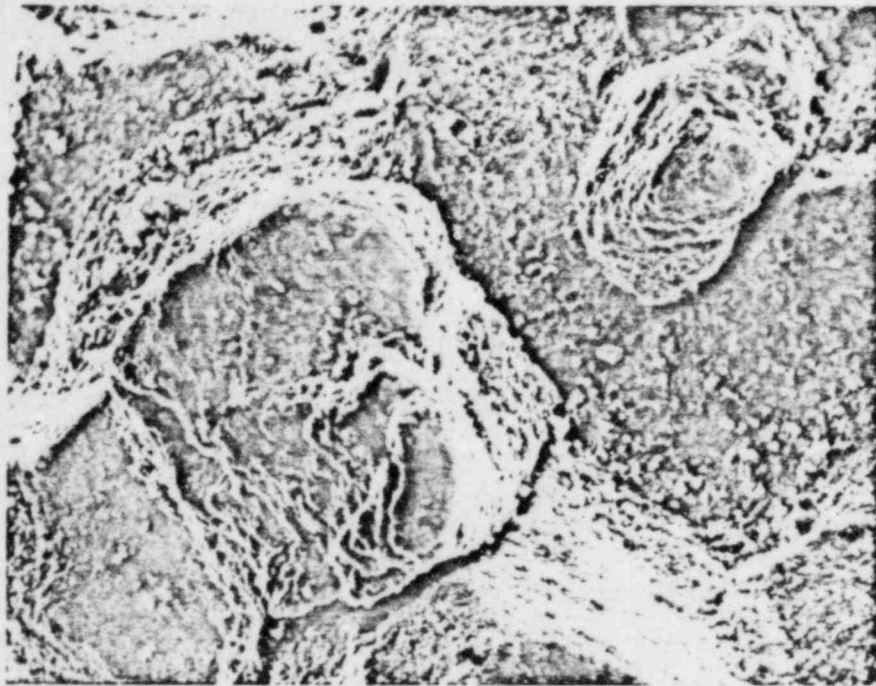
Figure 22 SEM Fractograph - Division I Broken Bolt Head

At higher magnification secondary crack, austenite grains and oxide layer are clearly visible.

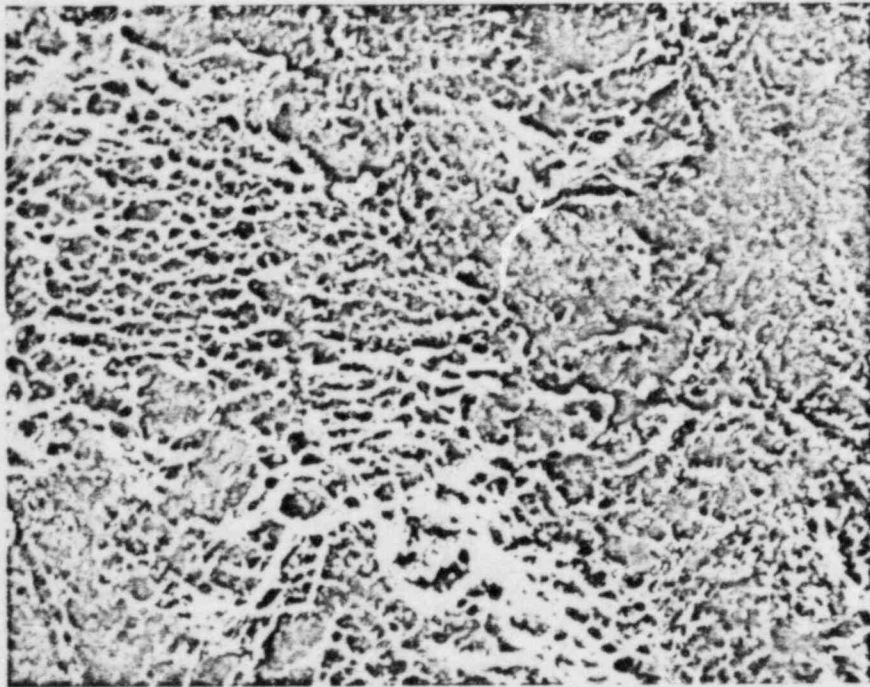
Figure 23 SEM Fractograph - Division I Broken Bolt Head

Taken near the smooth appearing region in Figure 2.  
Appearance of ductile tearing due to mechanical overload is  
blurred by oxide film.

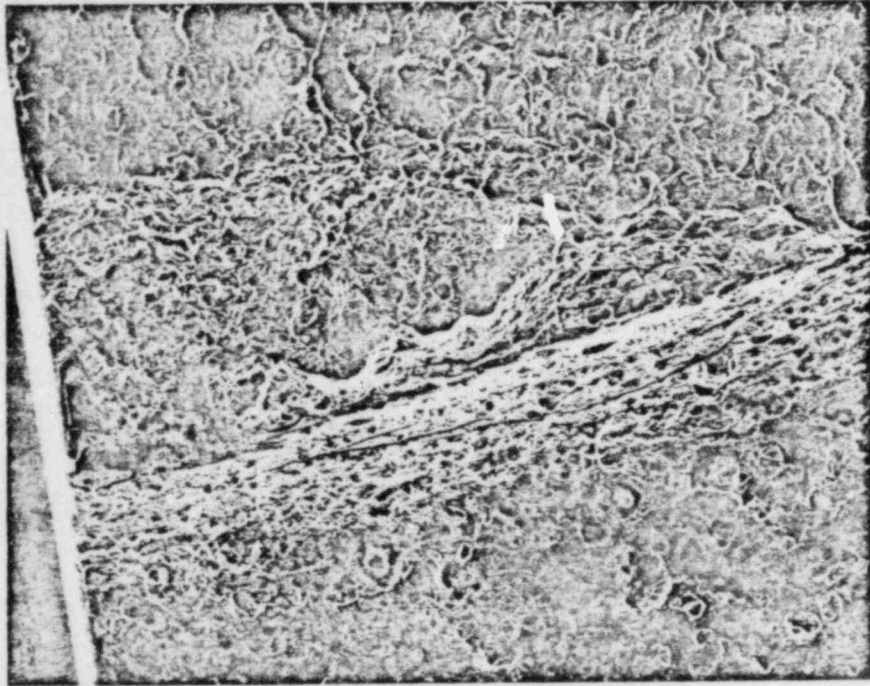
Figure 24 SEM Fractograph - Division I Broken Bolt Head  
Area near shear lip. Appearance of shear blurred  
by oxide film.

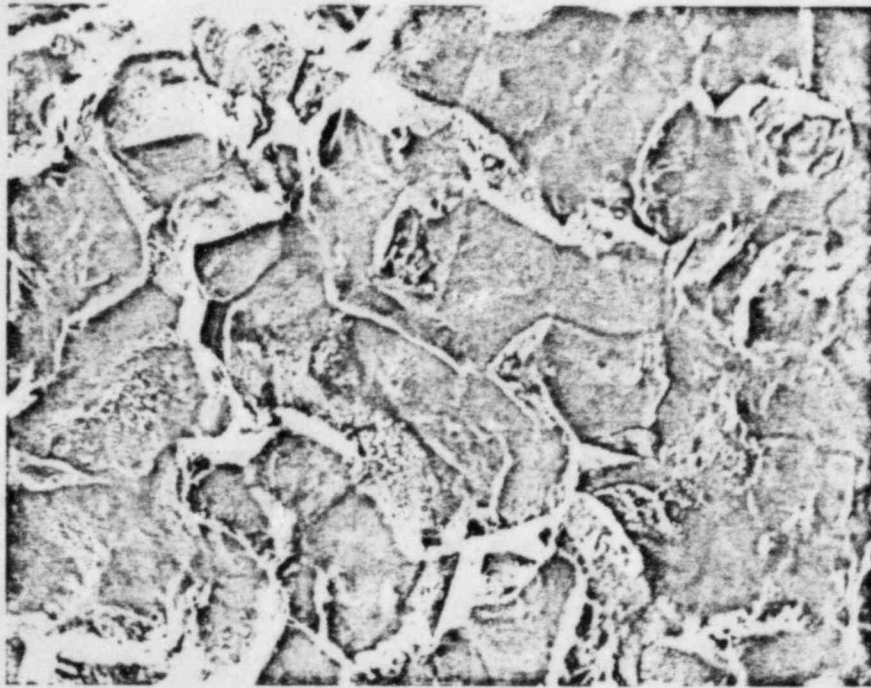
Figure 25 SEM Fractograph - Division I Broken Bolt Head  
(After cleaning)  
Fractograph taken near initiation point. Clear evidence that IGSCC initiated cracking.

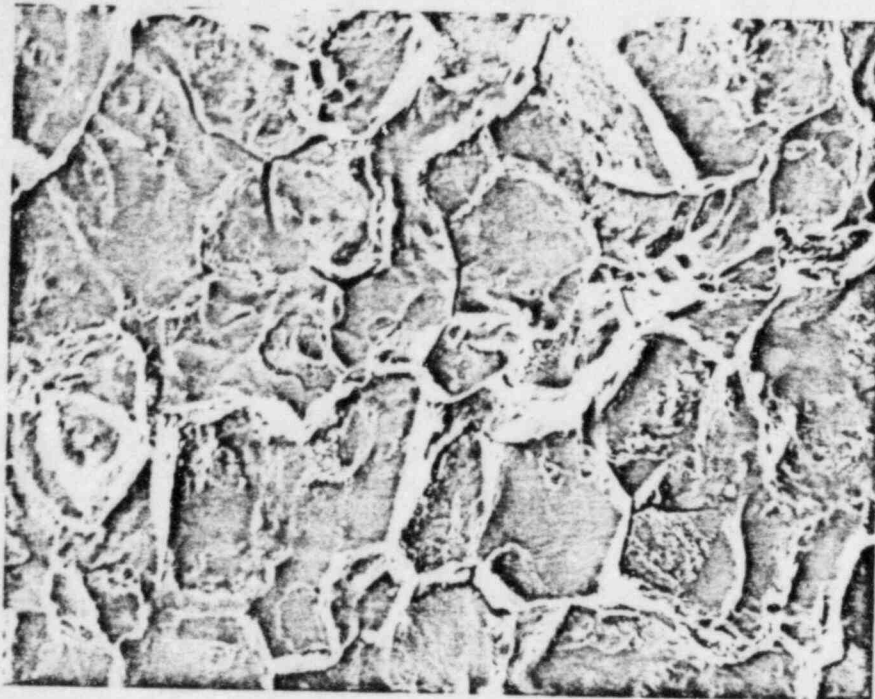
Figure 26 SEM Fractograph - Division I Broken Bolt Head  
(After cleaning)

Fractograph taken in the mid-region of grainy surface. Evidence of IGSCC is clear.

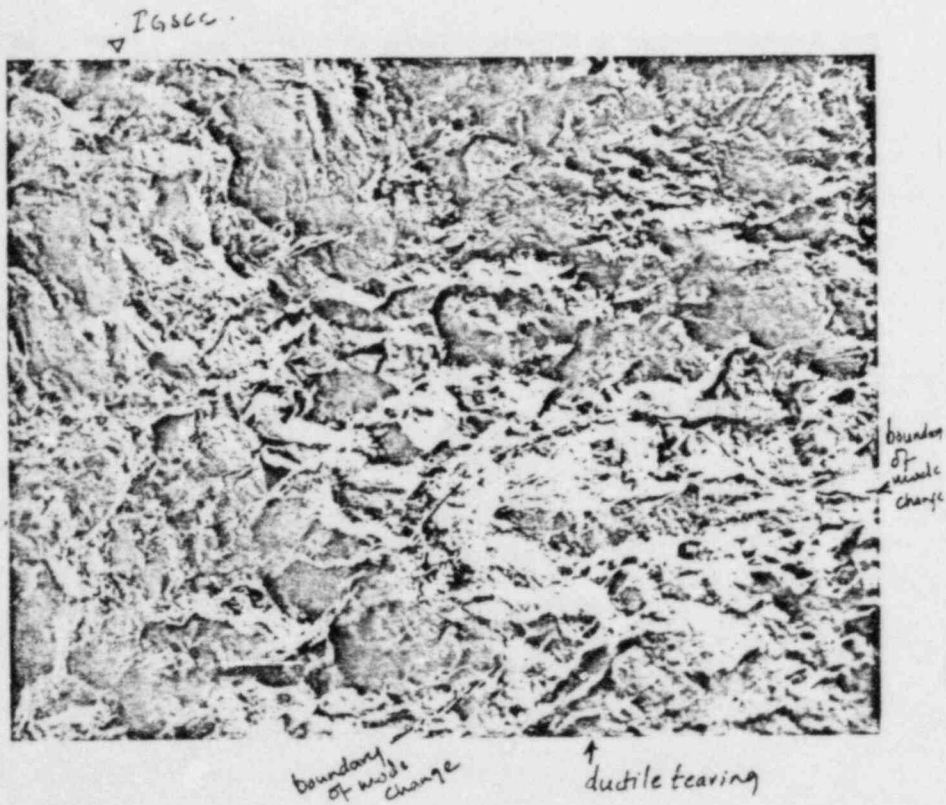
Figure 27 SEM Fractograph - Division I Broken Bolt Head  
(After cleaning)

Fractograph taken at transition region between grainy surface and smooth surface. Evidence of IGSCC (grains and secondary cracks) at upper half and ductile tearing at lower right.

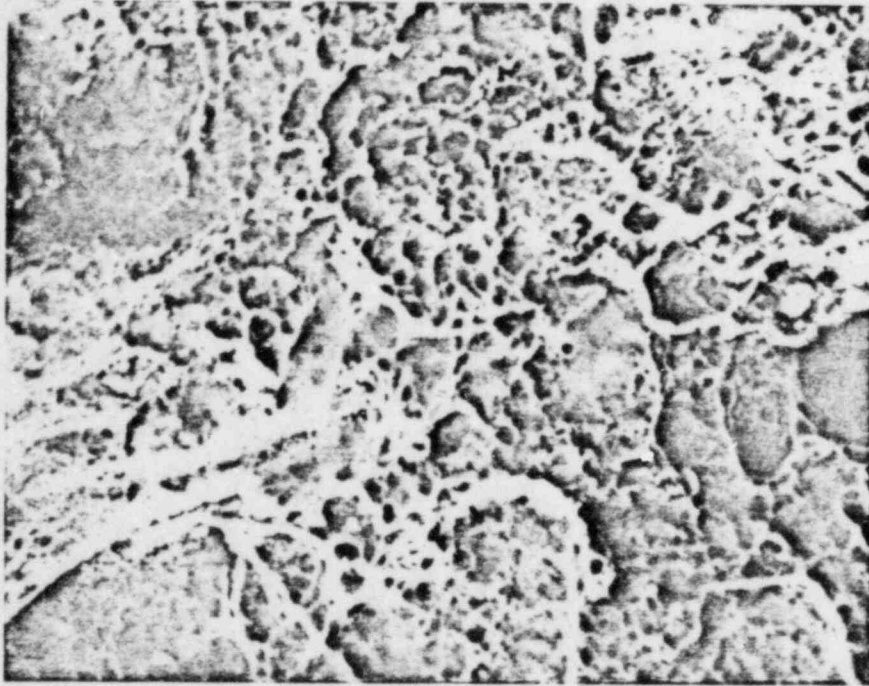
Figure 28 SEM Fractograph - Division I Broken Bolt Head  
(After cleaning)

Taken in the smooth region in Figure 2. Dimpled morphology typical of ductile tearing due to mechanical overload.  
(Preload supported by a small ligament area)

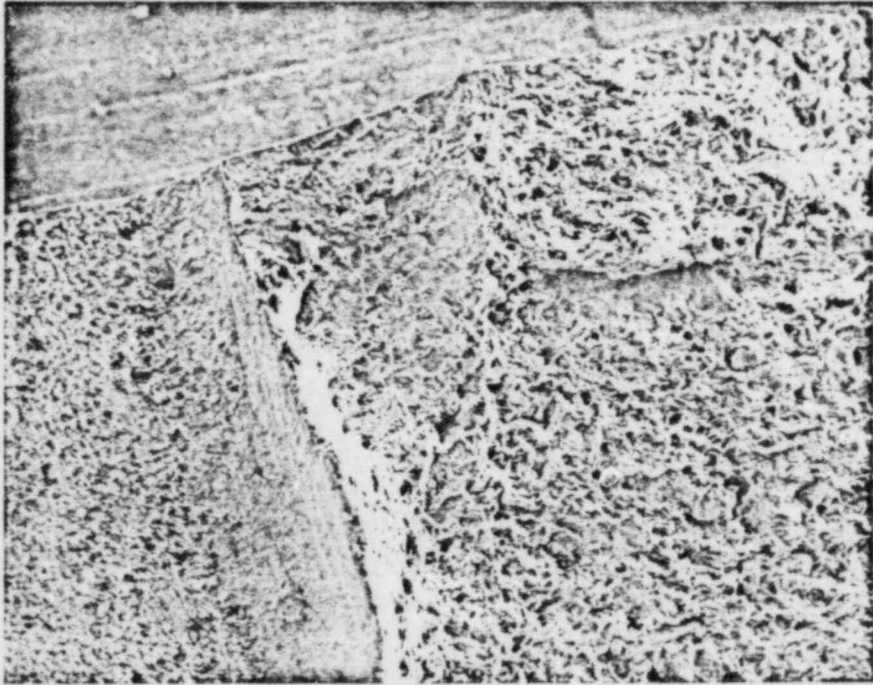
Figure 29 SEM Fractograph - Division I Broken Bolt Head  
(After cleaning)

Shear lip formation is evident. Indicates the last step of fracture.
