METALLURGICAL EVALUATION  
OF  
DIESEL GENERATOR CYLINDER HEAD  
VALVE SEAT CRACKS  
AT  
GRAND GULF NUCLEAR STATION - UNIT 1

PREPARED FOR: NUCLEAR PLANT ENGINEERING  
MISSISSIPPI POWER & LIGHT COMPANY  
PORT GIBSON, MISSISSIPPI 39150

PREPARED BY: J. S. BRIHMADESAM  
NUCLEAR ENGINEERING DEPARTMENT  
MIDDLE SOUTH SERVICE, INC.  
NEW ORLEANS, LOUISIANA 70112

JUNE, 1984

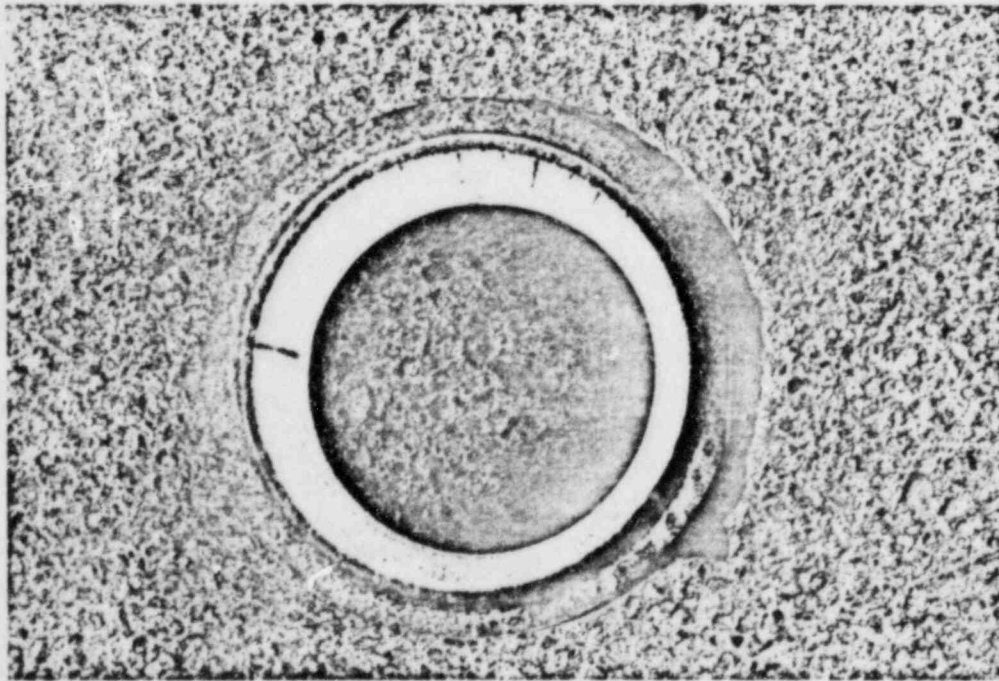
FIGURE 1: Liquid Penetrant Indications on Valve Seat

The specimen was examined using LP. The indications revealed are shown in Figure 1. A close up of the suspected leaker is shown in Figure 2 and Figure 3 shows multiple radial cracks on the seating surface.

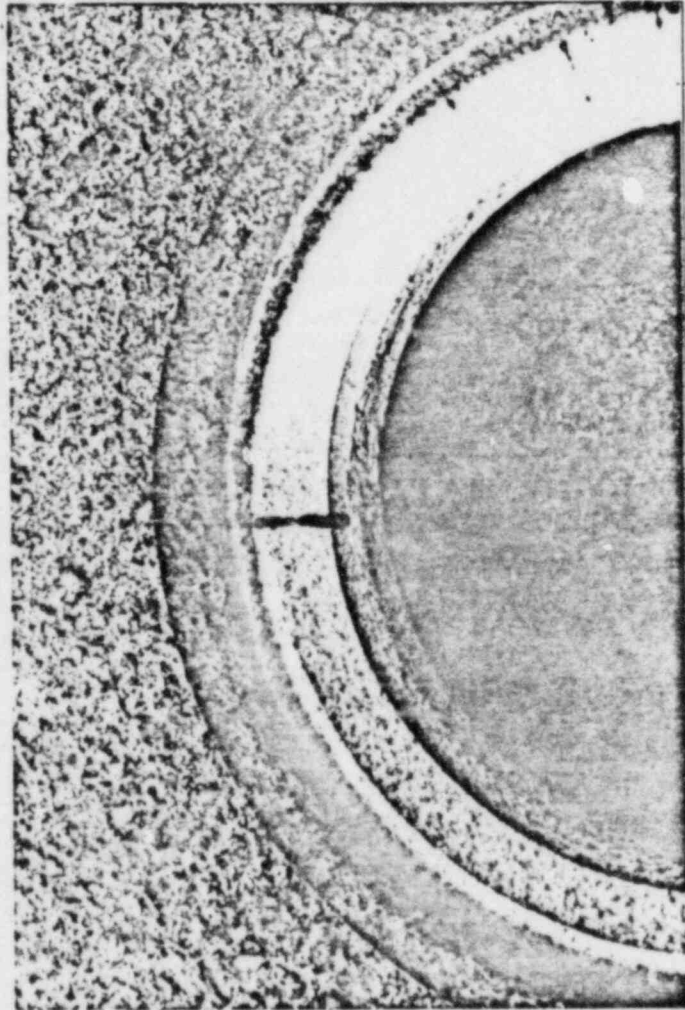
FIGURE 2: Liquid Penetrant Indication of Suspected Leaker

The LP indications shows that the larger crack was about 90° away from the multiple cracks. A visual examination of the back side of the ring specimen, which was machined out of the cylinder head, showed a casting defect to be located behind the single large crack. Thus, it was decided to perform the following investigations:

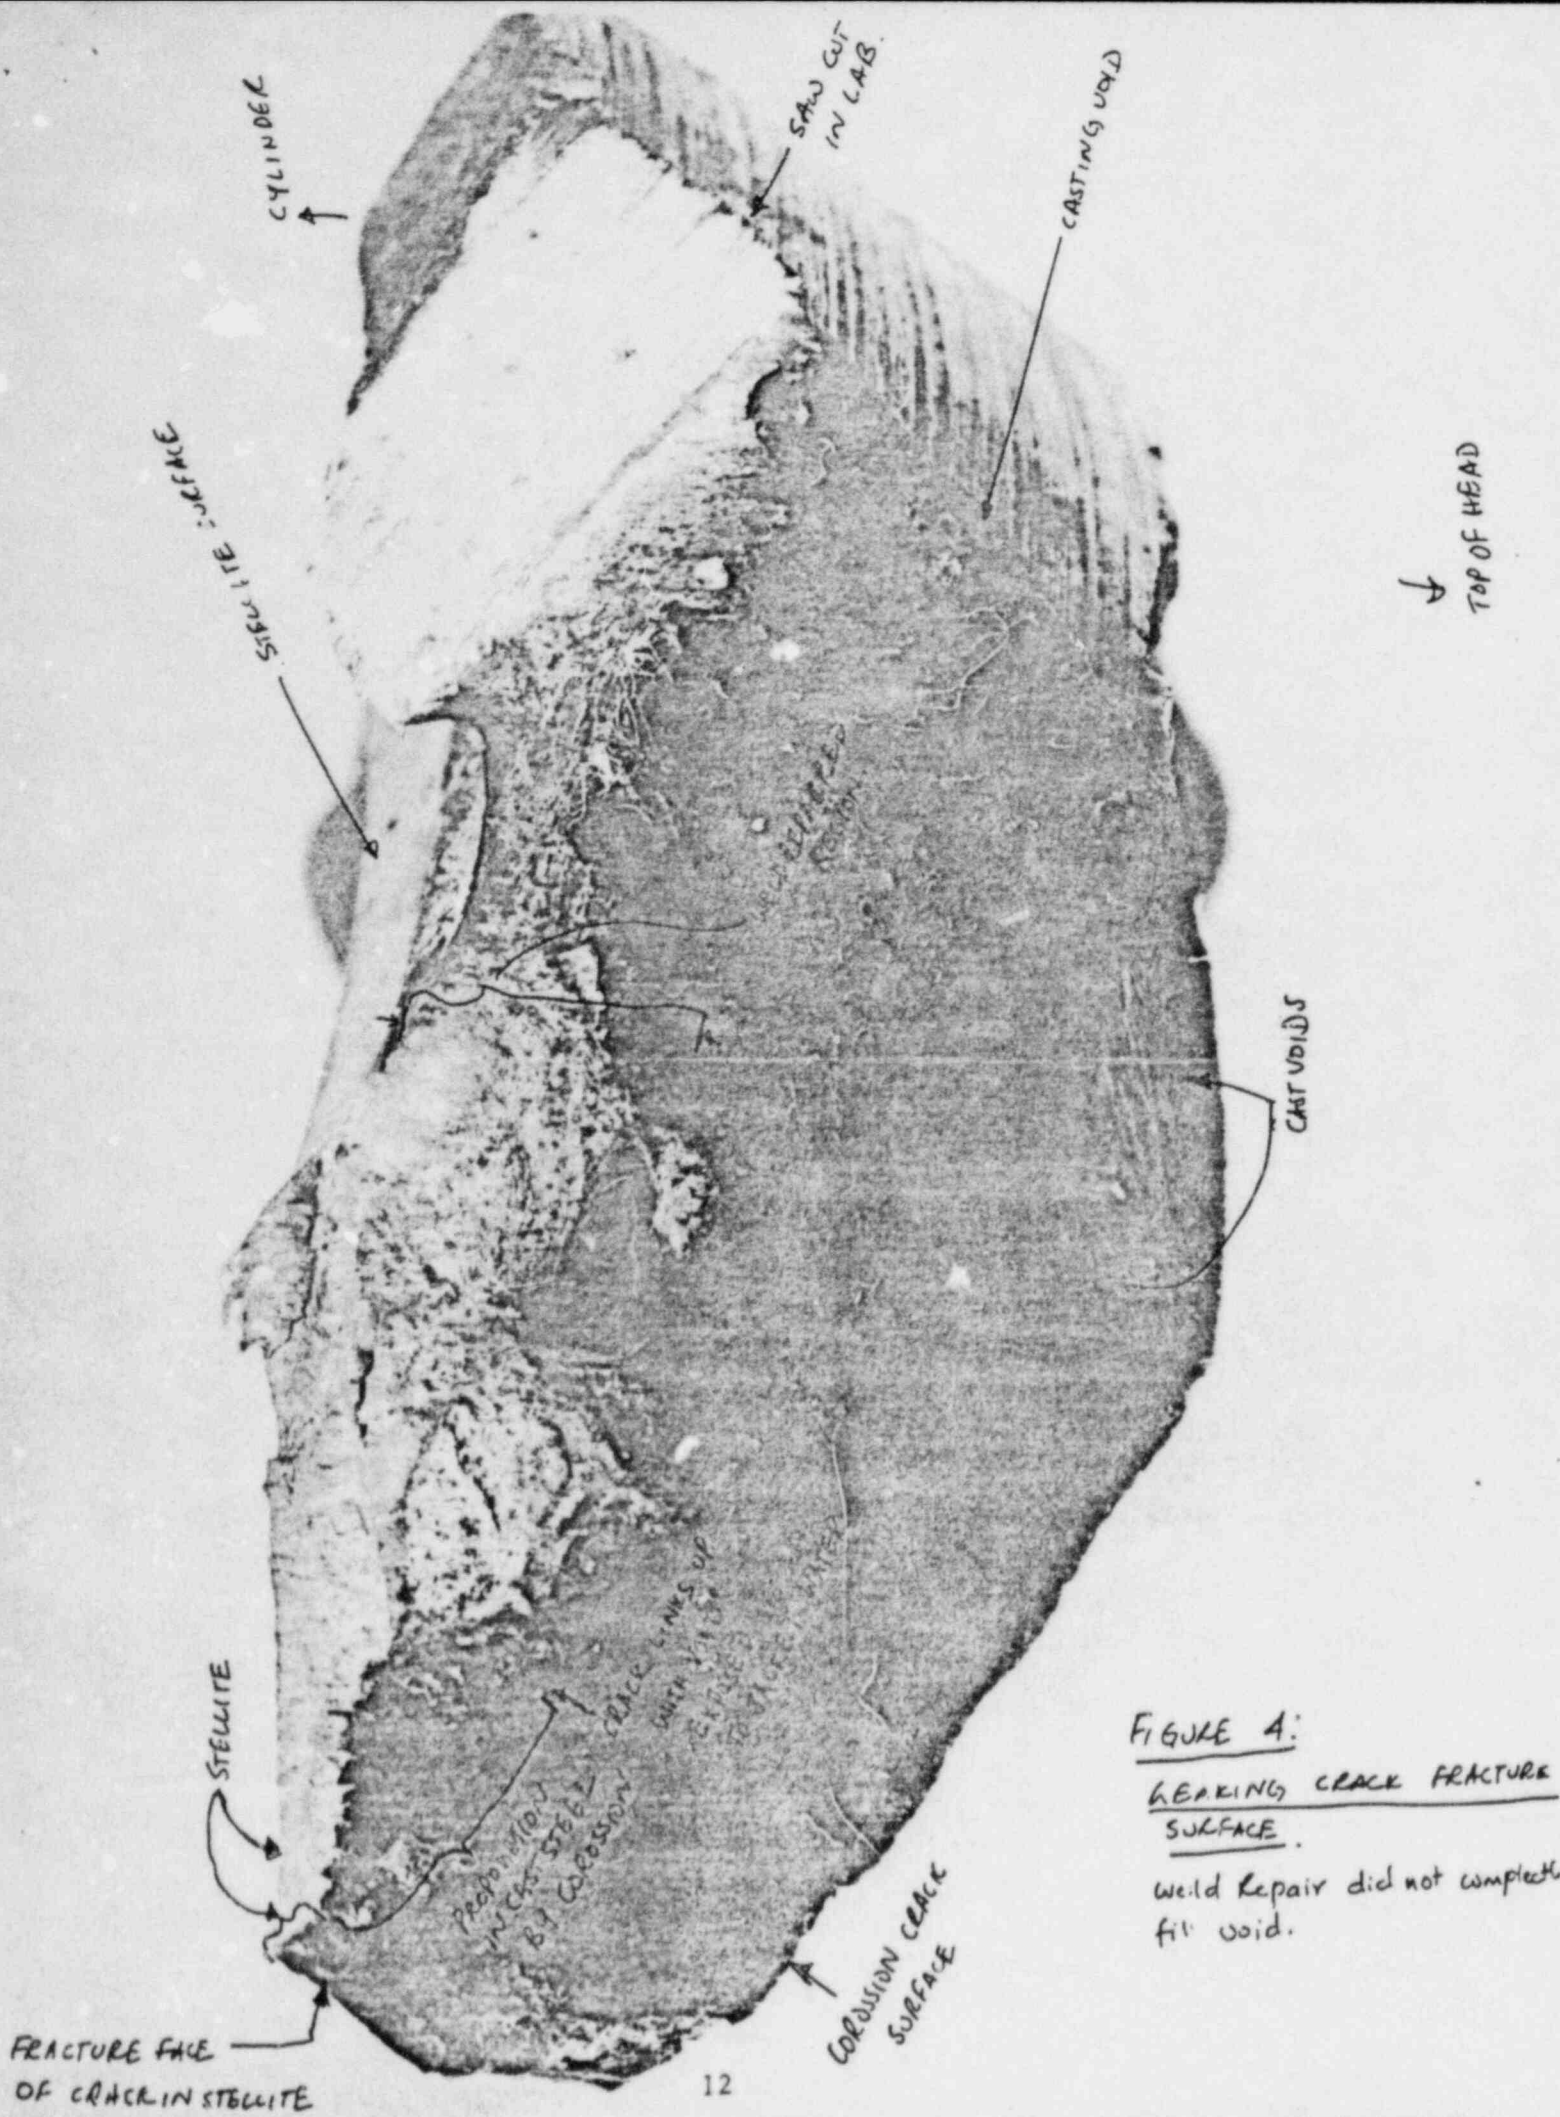
The single crack face was opened in the laboratory by cutting the ligament from the back side of the ring specimen. The fracture surface is shown in Figure 4. The following features were revealed:

- o There were two casting defects (voids), one above the other on the back side of the seating surface.
- o The stellite fracture surface was covered with black adherent oxide film. Also portions of the casting fracture surface was covered with this oxide film.
- o There was a distinct difference in fracture surface appearance of the laboratory fracture surfaces at the bottom and top of the base material of the ring. The appearance at the top was indicative of a ductile weld material. This indicates that there was some weld repair performed in this region.
- o The crack appears to have propagated from the stellite casting interface to the casting void by corrosion. The cause for corrosion is the exhaust combustion gases.

As mentioned earlier, it appeared that the cylinder head, in one area of this exhaust valve seat was repaired by welding. The need for weld repair may have been to fill the casting void such that an even surface for weld deposition of stellite was obtained. Though the weld repair achieved the objective of providing an even surface, the weld metal did not appear to have filled the entire void (See Figure 4). Furthermore, the casting void below this repaired void was untouched since it did not penetrate the exposed surface of the seat area. A section of this region was obtained using a diamond impregnated metallurgical saw. The section was used to perform metallography so as to confirm the existence of weld metal (from repair welding). The metallographic section is shown in Figure 5. Areas where microstructural evaluations were performed are also shown on this figure. No evidence of a soft butter weld between the cast steel and the stellite was observable. Figure 6 is a micrograph obtained in a area that shows the microstructure of the cast steel. The microstructure consists of a ferrite matrix with pearlite grains. Figure 7 is a micrograph obtained

**FIGURE 4:**  
HEAVING CRACK FRACTURE SURFACE.  
 Weld repair did not completely fill void.

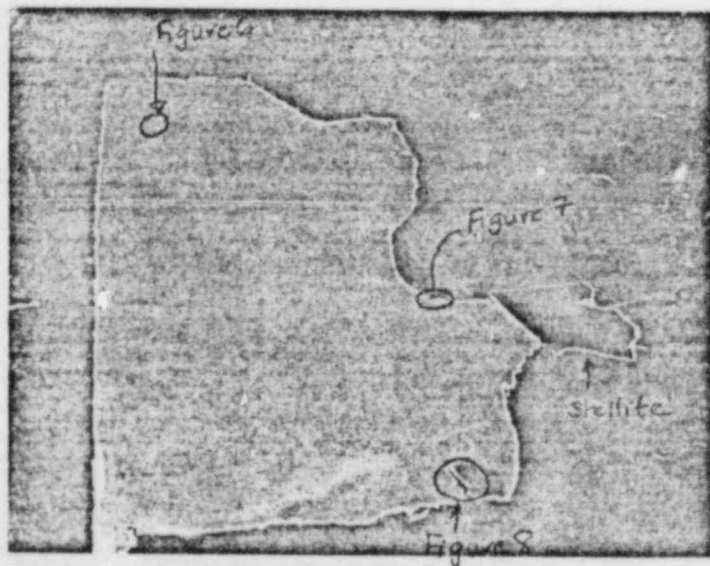
FIGURE 5: Cross Section of Valve Seat Surface

Section taken adjacent to the leaking crack.

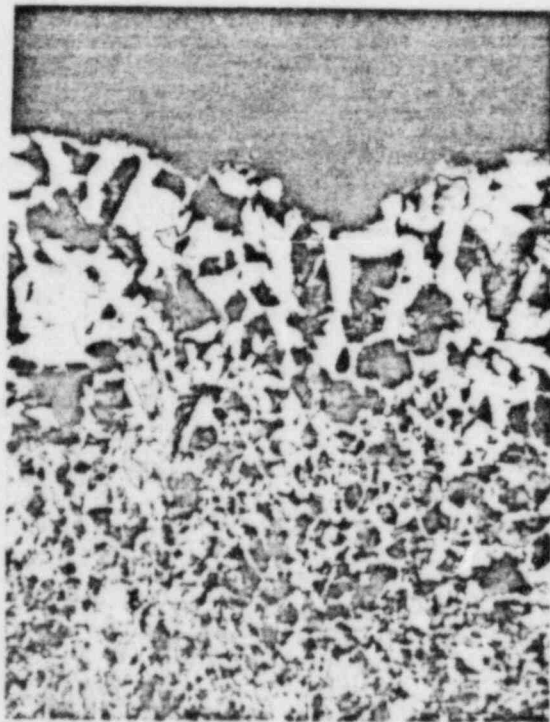
FIGURE 6: Microstructure of Cast Steel

Ferrite matrix with pearlite grains. Grains at surface are coarser than the interior, as is to be expected.

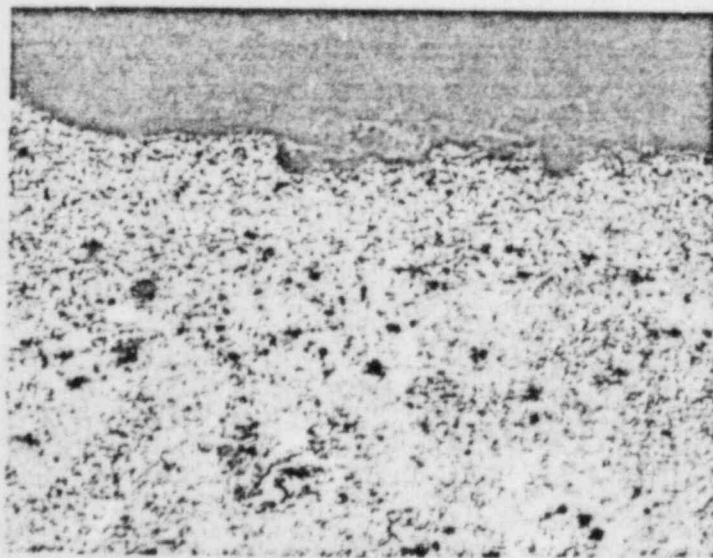
from an area on the top side of the stellite. The microstructure is acicular and representative of a weld material. Similarly, Figure 8, a micrograph obtained from an area below the stellite, shows a microstructure representative of a weld material. This finding confirms the existence of a weld repair, in the casting.

FIGURE 7: Microstructure Behind Stellite Top Surface  
Microstructure typical of a weld.

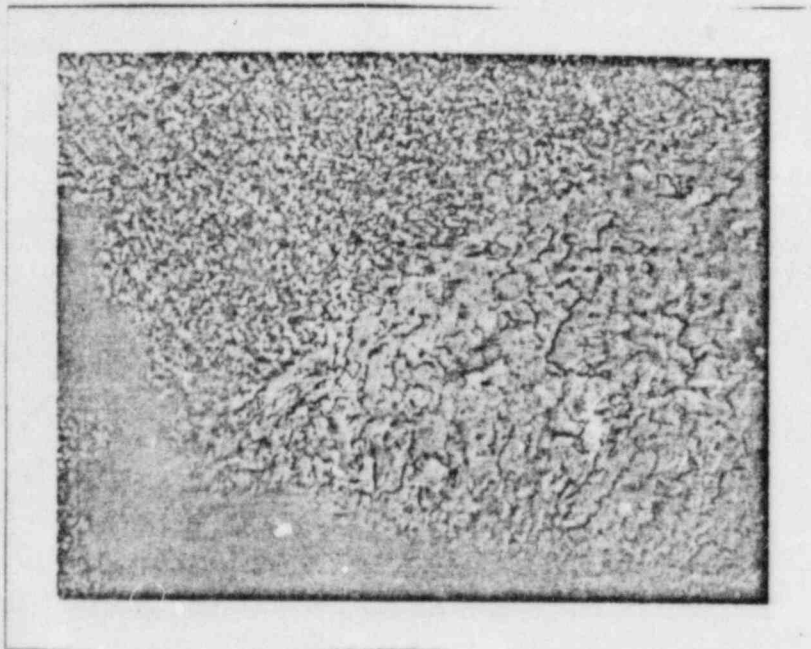
FIGURE 8: Microstructure Behi 1 Stellite Bottom Surface  
Microstructure typical of weld metal.

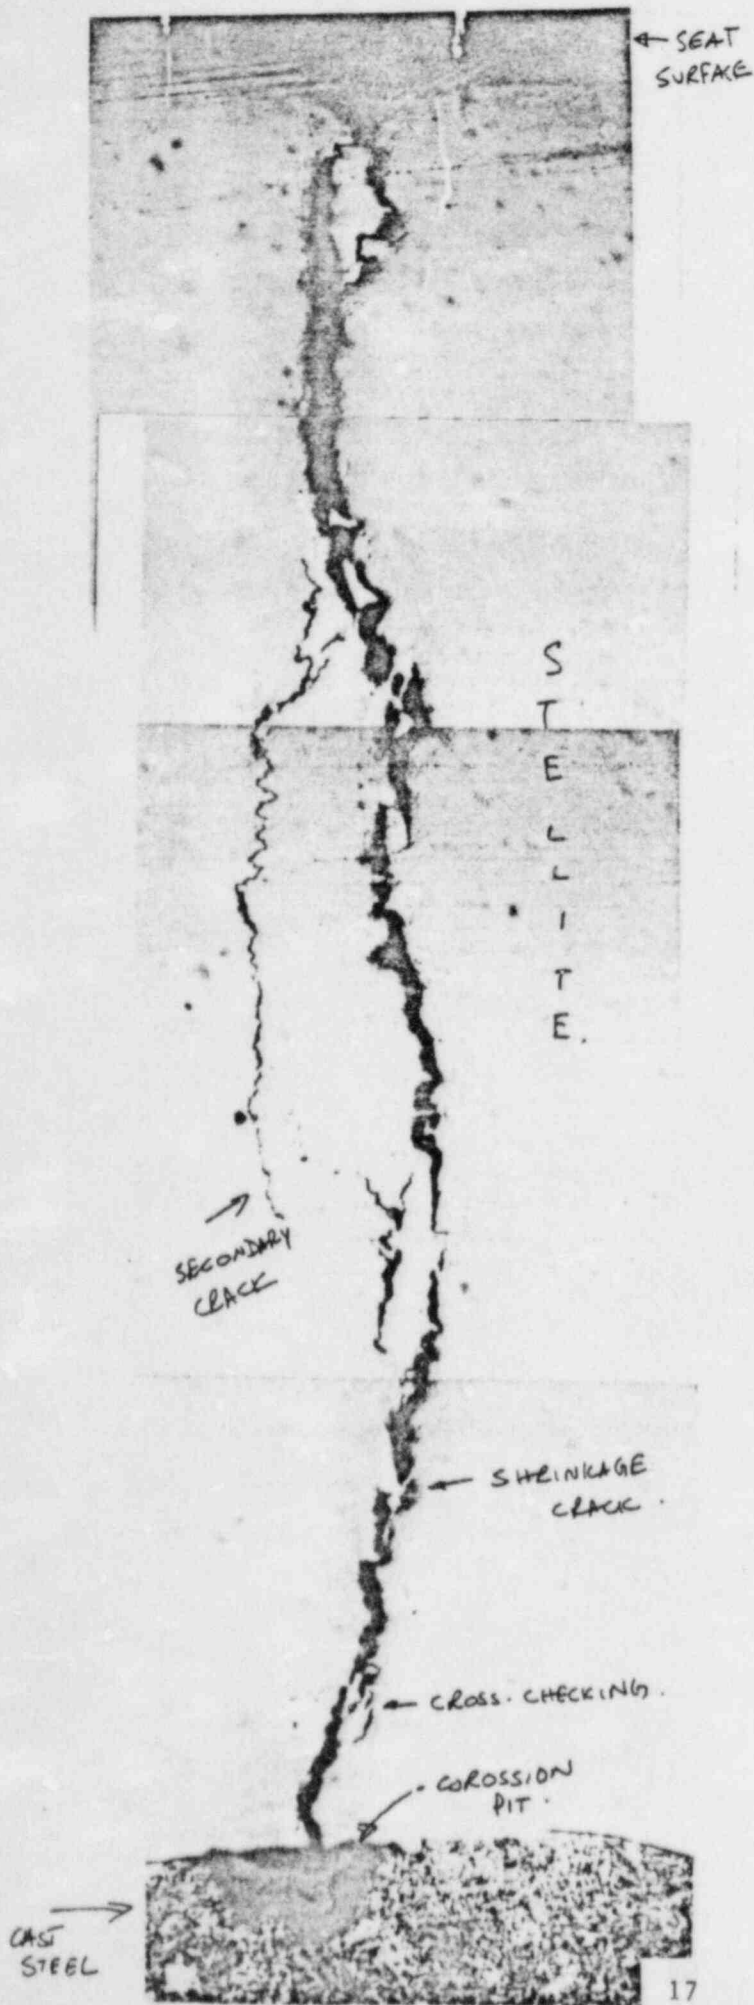
FIGURE 9: Montage - Shrinkage Crack in Stellite

A typical crack in stellite. Jagged path and secondary cracks.

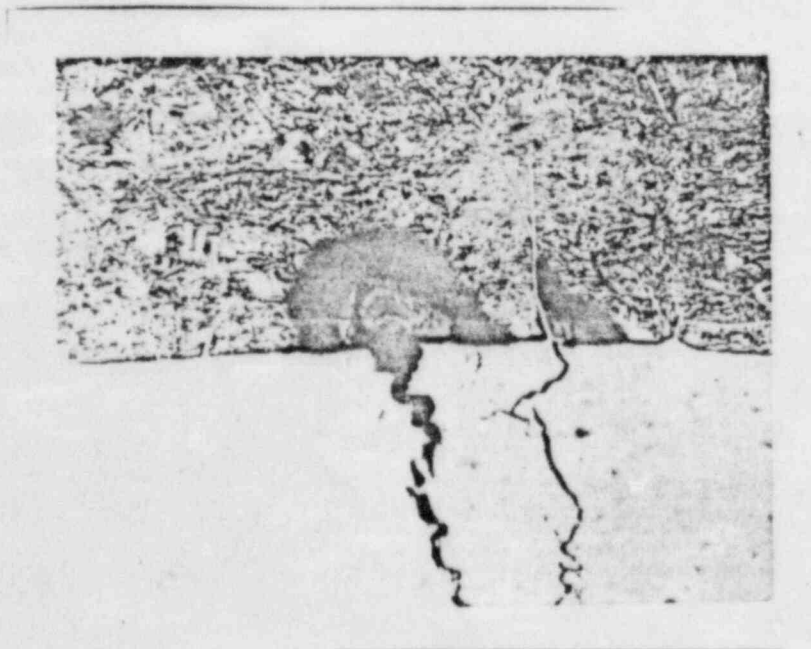
FIGURE 11: Micrograph Near Stellite Cast Steel Interface

However, it was also shown (Section 4.0) that corrosion pits existed at the tail end of the stellite cracks and that the fractography (Section 3.0) showed evidence of corrosion on the fracture surface of the cast steel on the leaking crack. Therefore, the mechanism that would lead to failure is by corrosion of the cast steel by the hot exhaust gases. Gases formed by combustion of the diesel fuel include; oxides of sulphur and nitrogen. These oxides and water vapor formed during combustion form respective acids which enter the stellite cracks and attack the underlying cast steel. Hence, the cracking mechanism that can cause failure is corrosion.

Corrosion pit at the end of shrinkage crack.  
Evidence of stellite intrusion into cast steel.  
Fusion line between stellite and cast steel  
in regions other than cracks and pits is good.

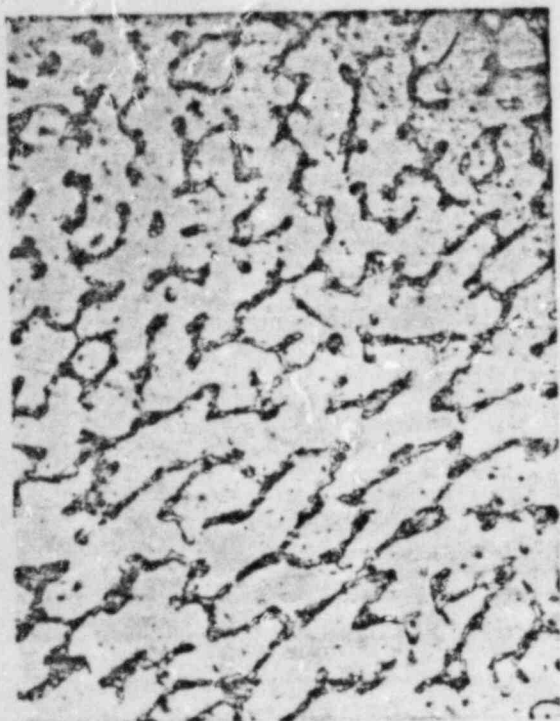
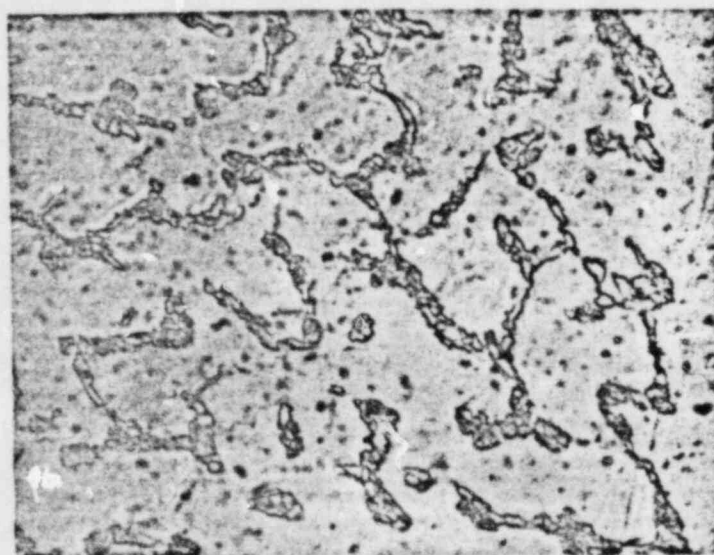
FIGURE 12: Microstructure of Stellite

Figure 12 shows the microstructure of the stellite. The microstructure shows that the material is a cobalt base, hard facing alloy deposited by a shielded arc process (SMAW).<sup>2</sup> The microstructure is austenitic with a carbide grain boundary network. Figure 13 is a micrograph showing both the crack and the microstructure. It can be seen from this micrograph that the crack runs along the grain boundary following the carbide network. From reference 2 it is observed that brittle hardfacing alloys when deposited by the SMAW process can crack and cross check during cooling to relieve the large strains in the stellite. This aspect is discussed in a later section. Thus, these cracks form in the regions where the material is still in the liquidus state. The carbide rich grain boundary is the last to solidify and hence these cracks form along the grain boundaries and are characterized as shrinkage cracks.

Shows carbide network at grain boundaries.

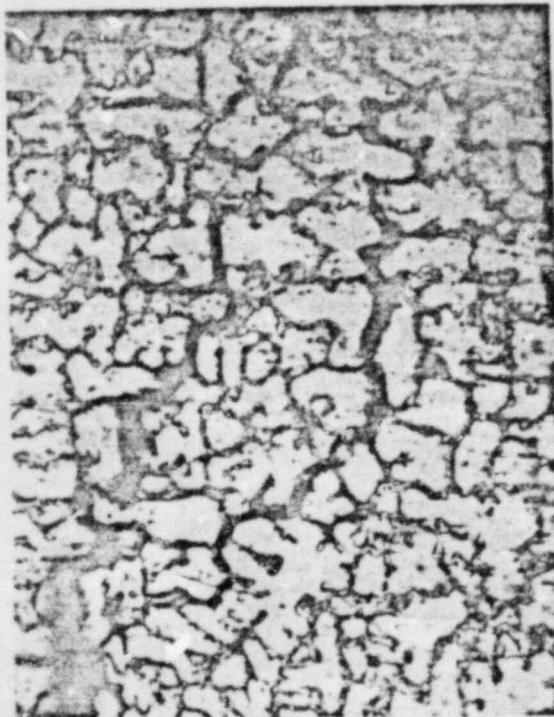
FIGURE 13: Crack in Stellite and Microstructure

Crack is clearly in carbide network  
at Grain Boundaries.

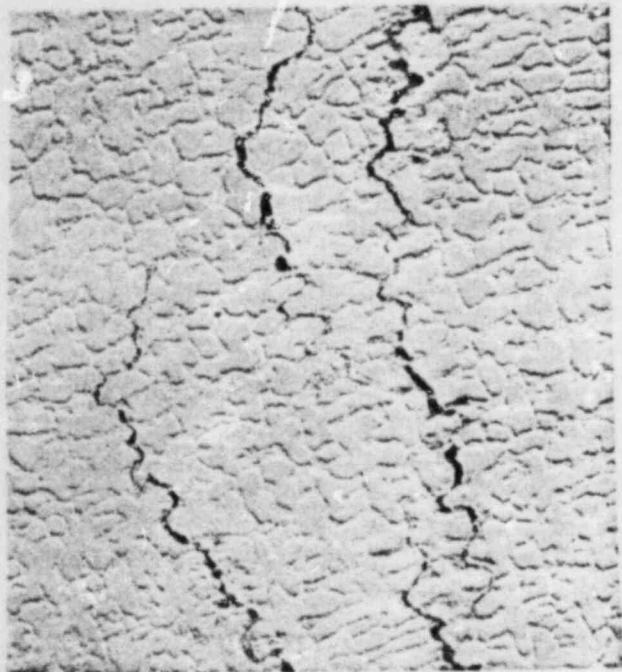
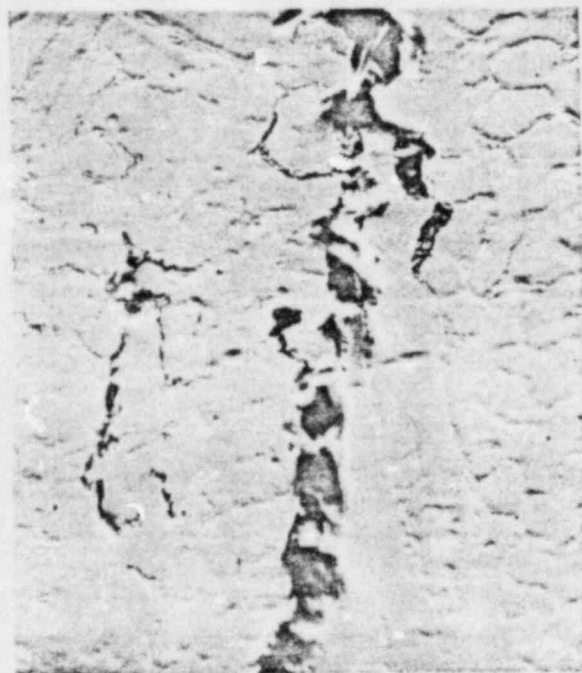
FIGURE 14: SEM Metallograph of Stellite Crack

The etched stellite specimen was examined using a scanning electron microscope (SEM). The purpose of this examination was to determine the morphology of the cracks. Figure 14 shows the SEM micrographs at two magnifications. The grain boundaries are clearly visible as a raised network. At the higher magnification the cracks shows a tearing type behavior which confirms the causal mechanism to be one of shrinkage cracking. The edges of the cracks are sharp and show no sign of corrosion or erosion. The extensive cross checking of the crack is also visible.

Metallograph taken after etching per reference 1. Grain boundary cracks and extensive cross-checking in cracks are evident.
