UNITED STATES OF AMERICA  
NUCLEAR REGULATORY COMMISSION

In the Matter of	)	
	)	
LONG ISLAND LIGHTING COMPANY	)	Docket No. 50-322-0L
	)	
(Shoreham Nuclear Power Station,	)	
Unit 1)	)

SUPPLEMENTAL TESTIMONY  
OF  
SPENCER H. BUSH AND ADAM J. HENRIKSEN  
CONCERNING  
CYLINDER BLOCKS OF THE TDI EMERGENCY DIESEL GENERATORS  
AT THE  
SHOREHAM NUCLEAR POWER STATION

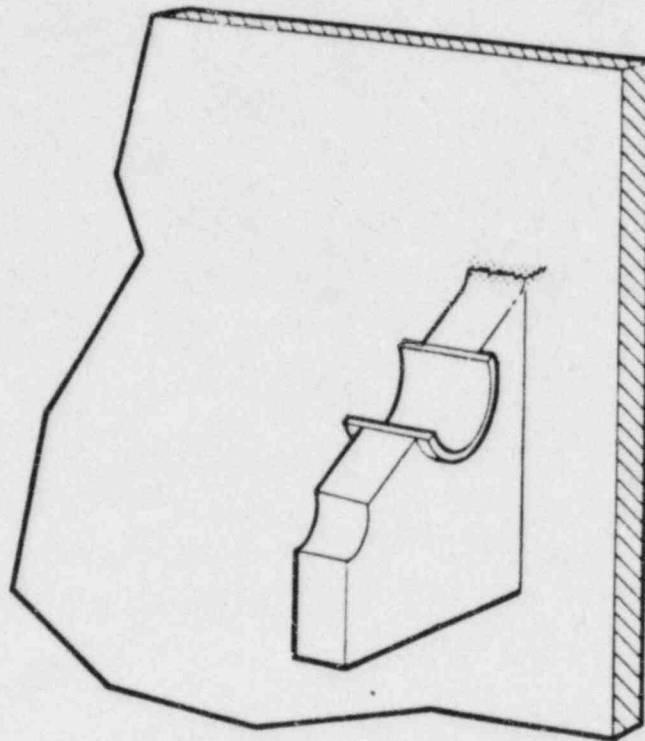
CAMSHAFT GALLERY SADDLE

Our perception of the geometry of the bearing saddles in the cam gallery was based on an examination of TDI engine drawings. An examination of the original EDG 103 block on Friday, September 21, revealed that our interpretation was incorrect. The attached figure presents the actual versus the perceived geometries. In the actual geometry, the high compressive stresses from bolt-up of the cylinder block to the engine base should neutralize or exceed the alternating tensile and/or bending stresses in the vicinity of the cracks. Our perceived geometry approximated a cantilever, so the vector of cam loads would always be positive. The latter geometry could result in continued growth of the existing cracks.

As perceived in  
preparation of  
original testimony

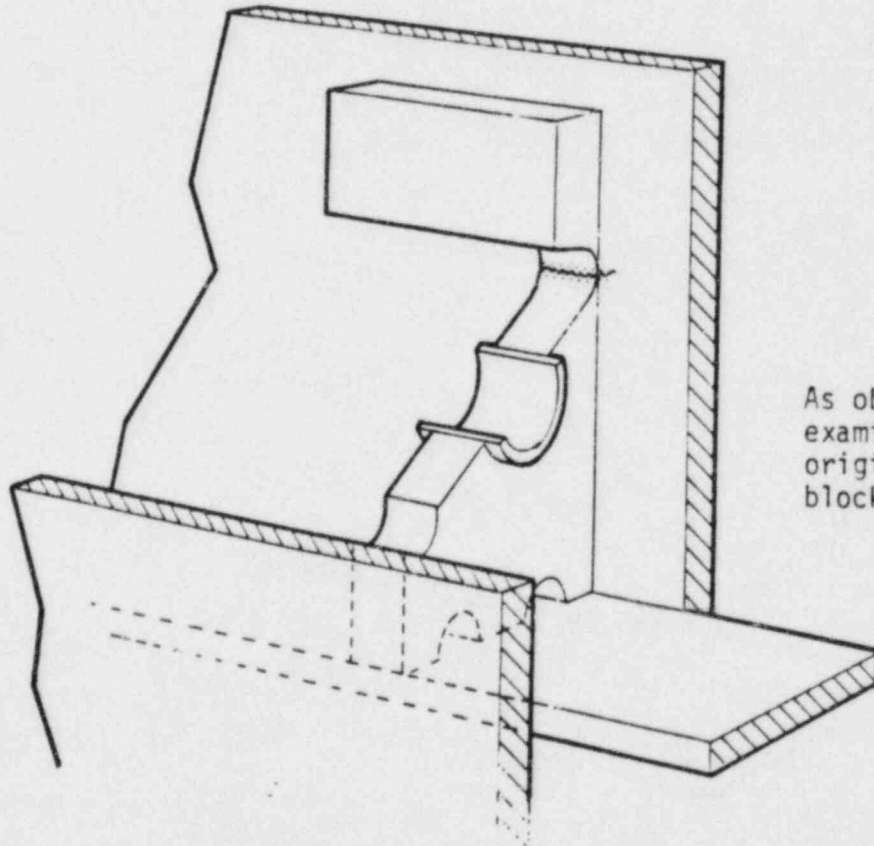
As observed in  
examination of  
original EDG 103  
block on 9/21/84
