FACILITY: Pilgrim Nuclear Power Station

SUBJECT: MEETING ON JUNE 15, 1984 WITH BOSTON EDISON COMPANY  
REGARDING CRACKS IN INCONEL WELD MATERIAL AT THE  
PILGRIM NUCLEAR POWER STATION

NRC MEETING  
PILGRIM SAFE END REPAIRS  
6/15/84

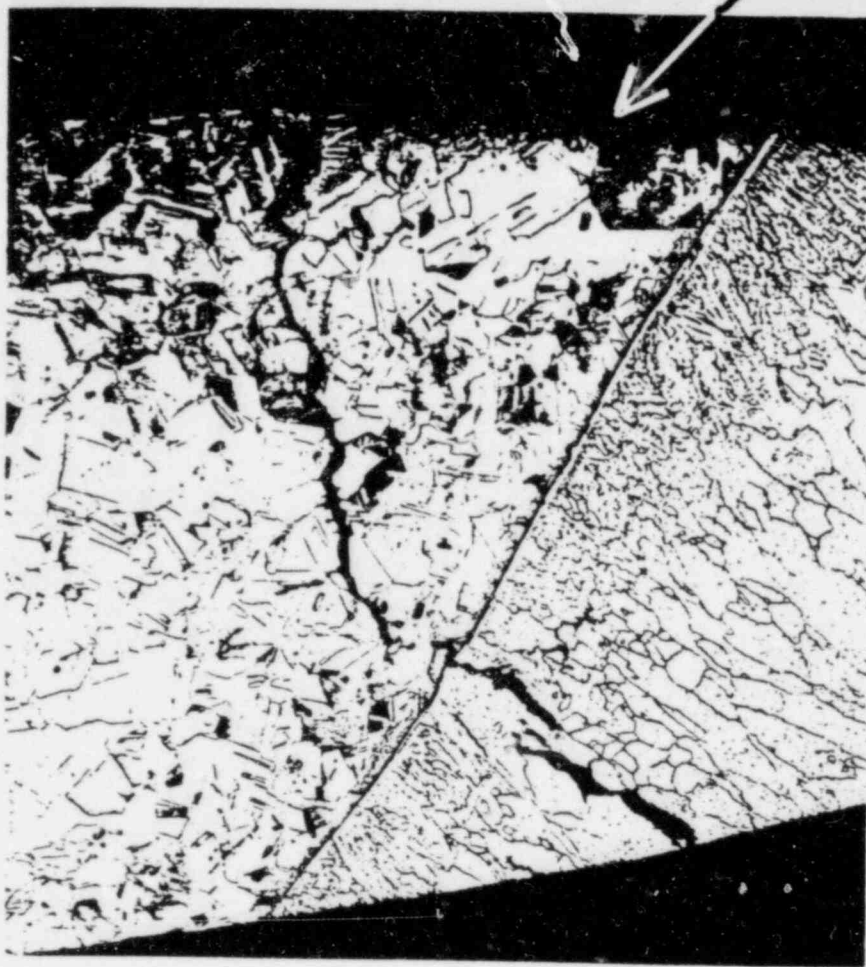
PILGRIM NOZZLE N1-B

AXIAL INTERDENDRITIC  
CRACKING IN INCONEL 182  
BUTTER WITH  
INTERGRANULAR  
PENETRATION INTO 304SS  
SAFE-END.

(PIPE INNER SURFACE IS  
PLANE OF POLISH)

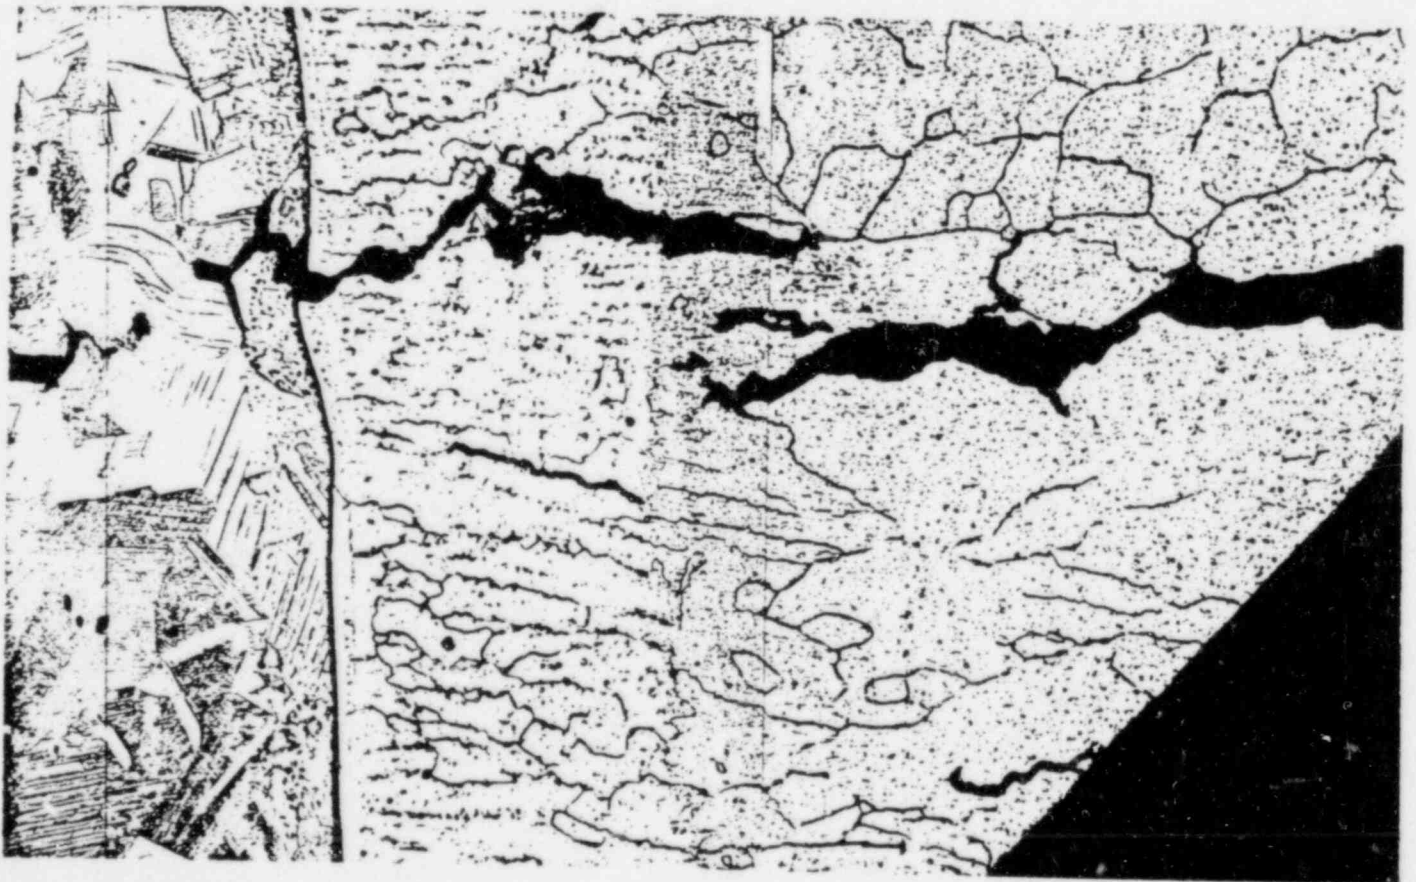
INTERGRANULAR CRACKING IN INCONEL 182 BUTTER

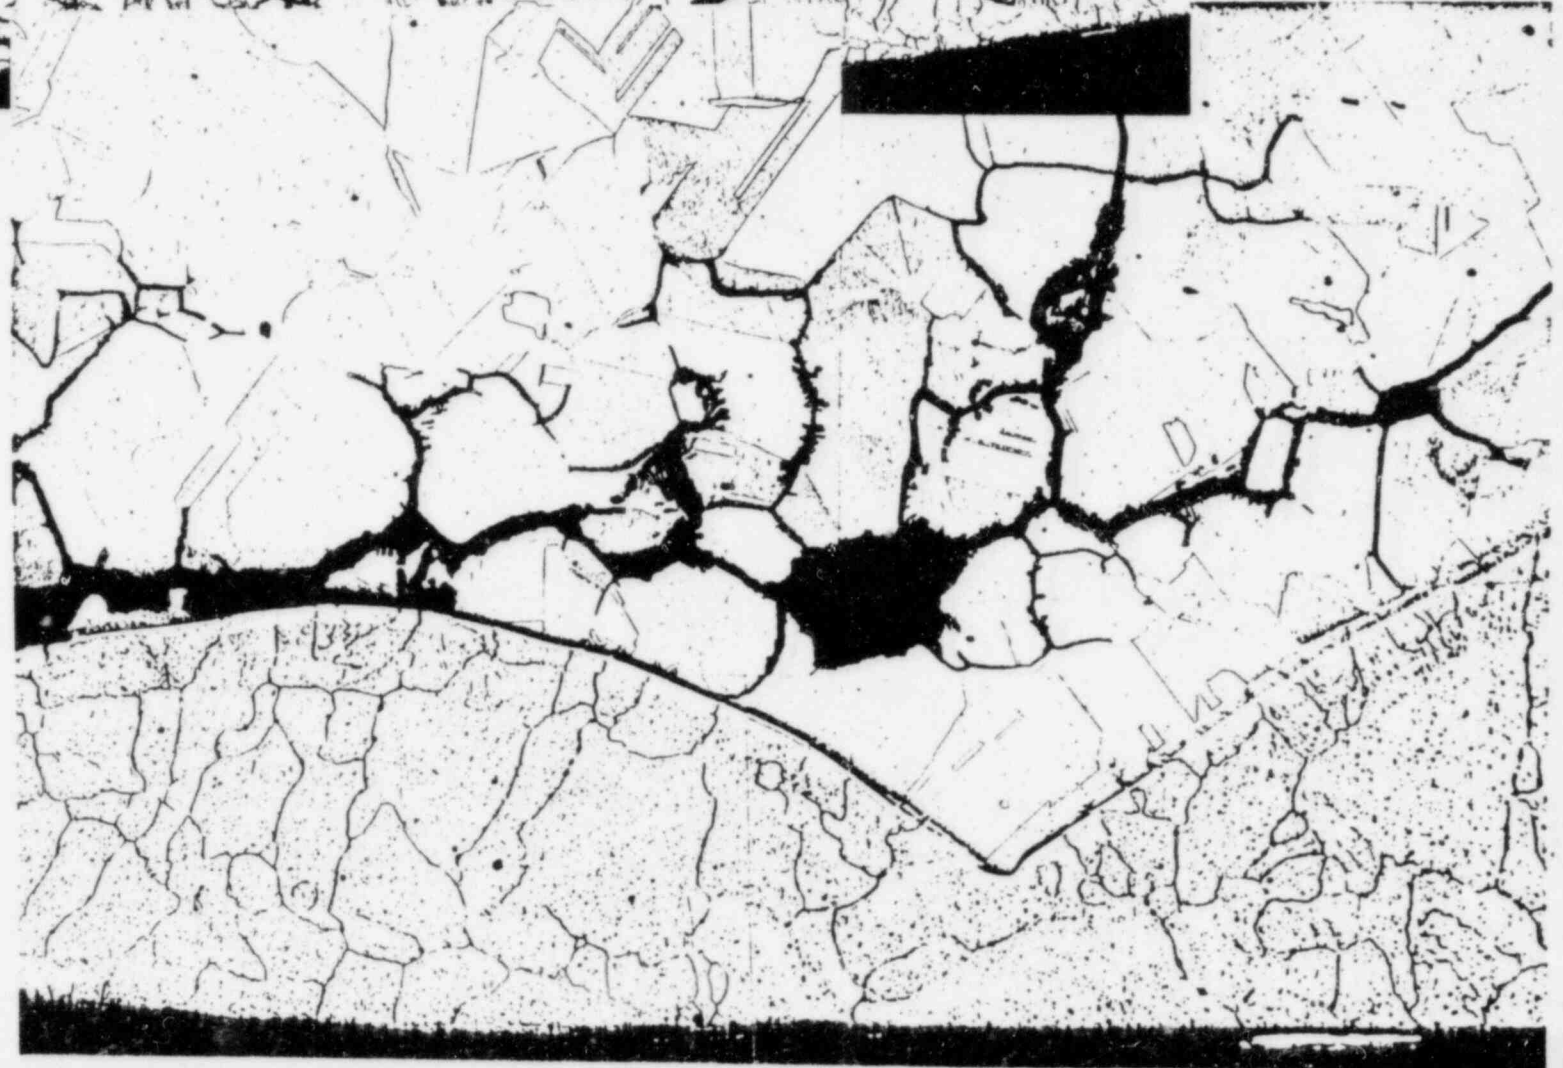
PILGRIM NOZZLE N1-B

CIRCUMFERENTIAL  
INTERGRANULAR CRACKING  
AT INCONEL 182/304SS  
SAFE END INTERFACE

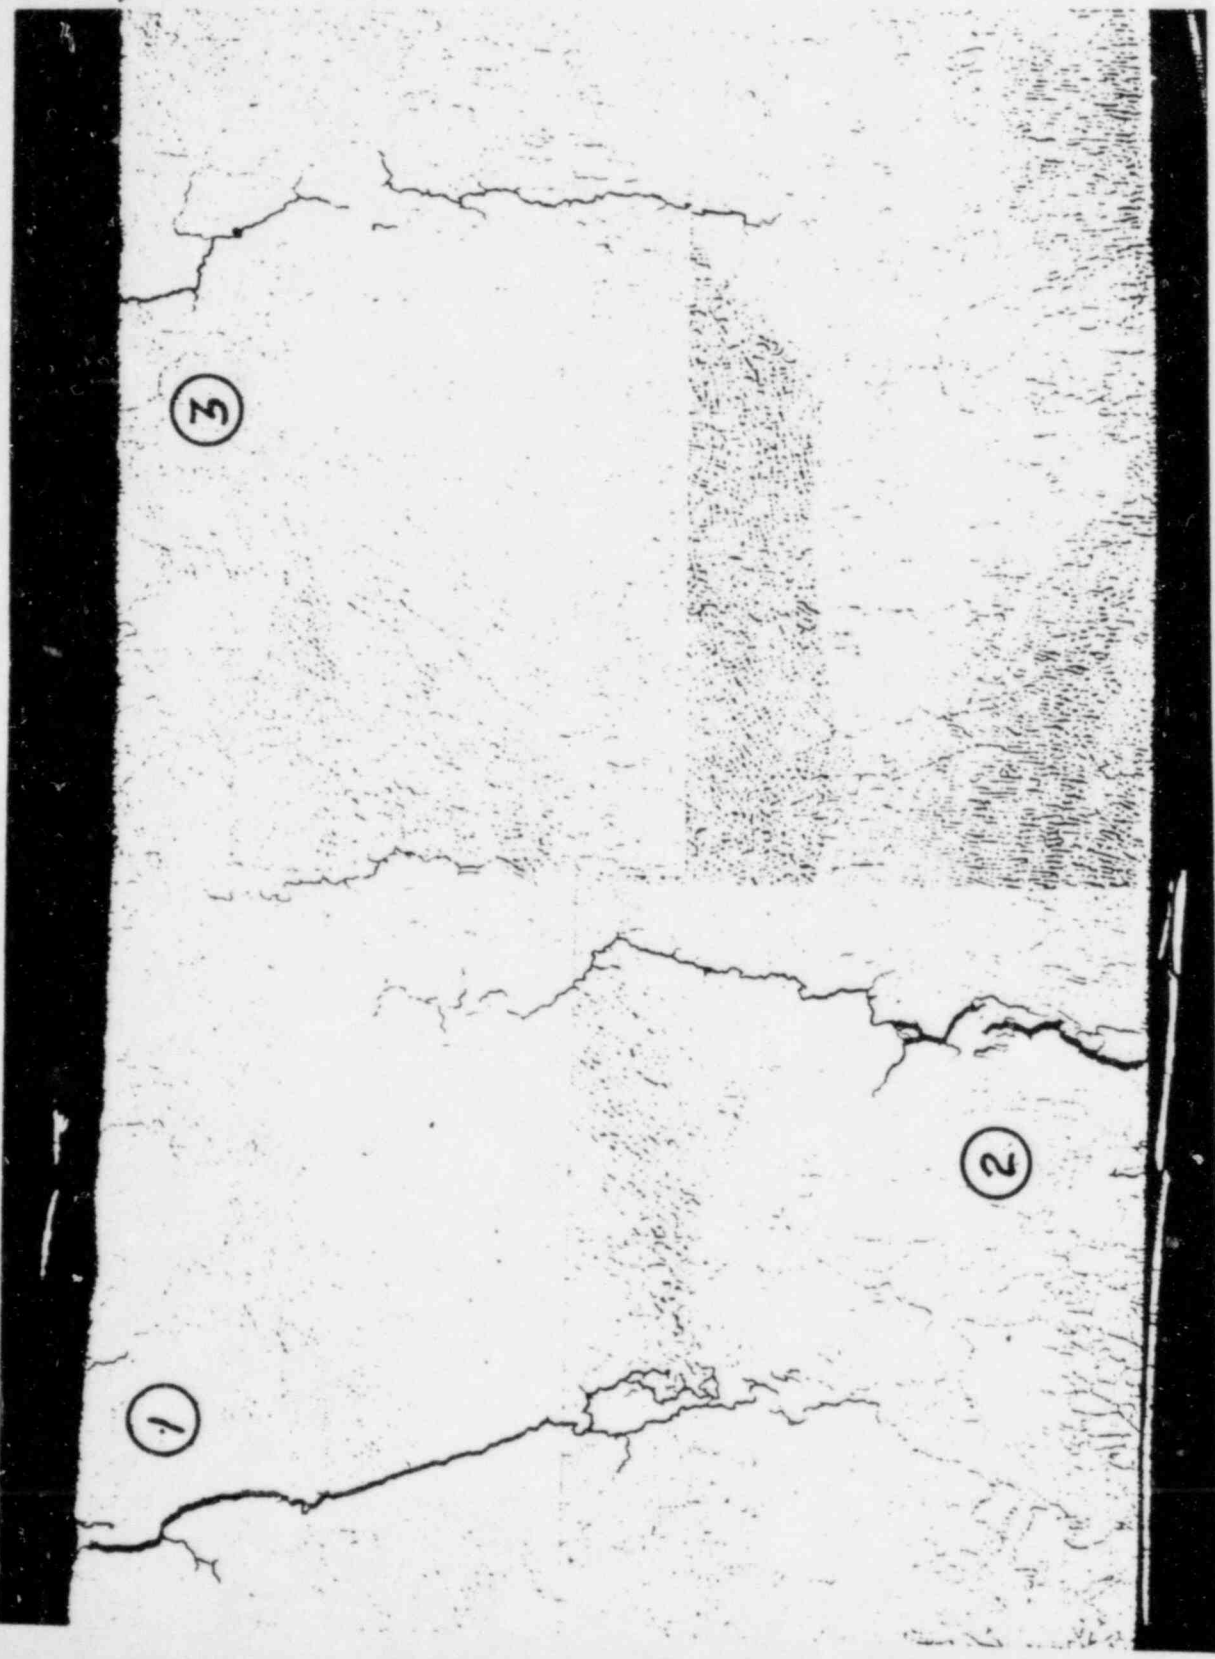
PILGRIM NOZZLE N1-B

AXIAL INTERDENDRITIC CRACKING IN INCONEL 182 BUTTER ADJACENT TO WELD ROOT ON SAFE END SIDE  
CRACK IN CENTER OF PHOTO INITIATION IN INCONEL 182 BUTTER ON THE NOZZLE SIDE OF THE WELD.

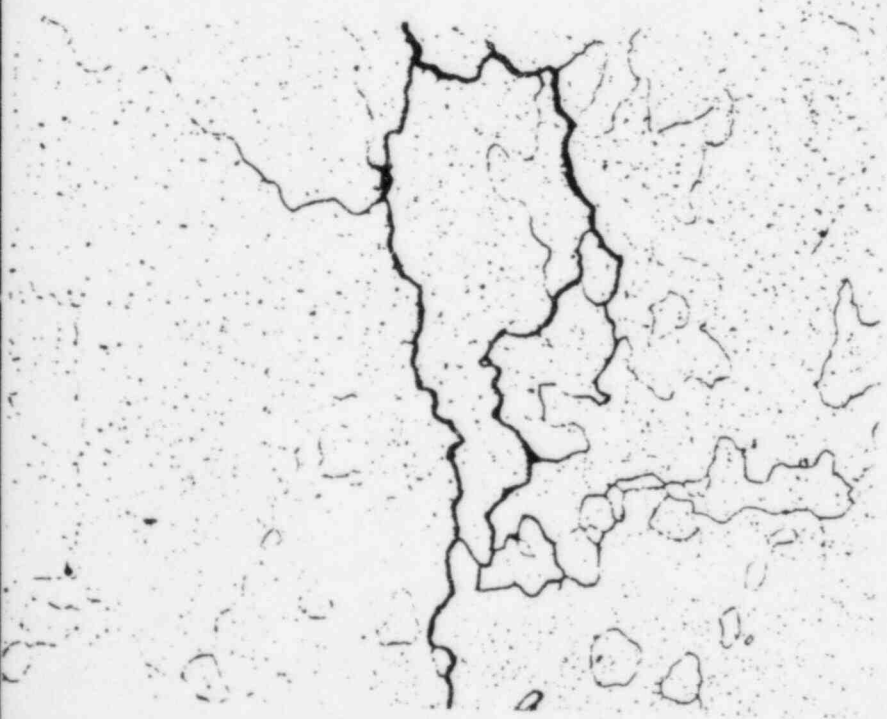
HIGH MAGNIFICATION VIEW OF INTERDENDRITIC CRACK #1 OF 33X  
COMPOSITE - INCONEL 182 BUTTER

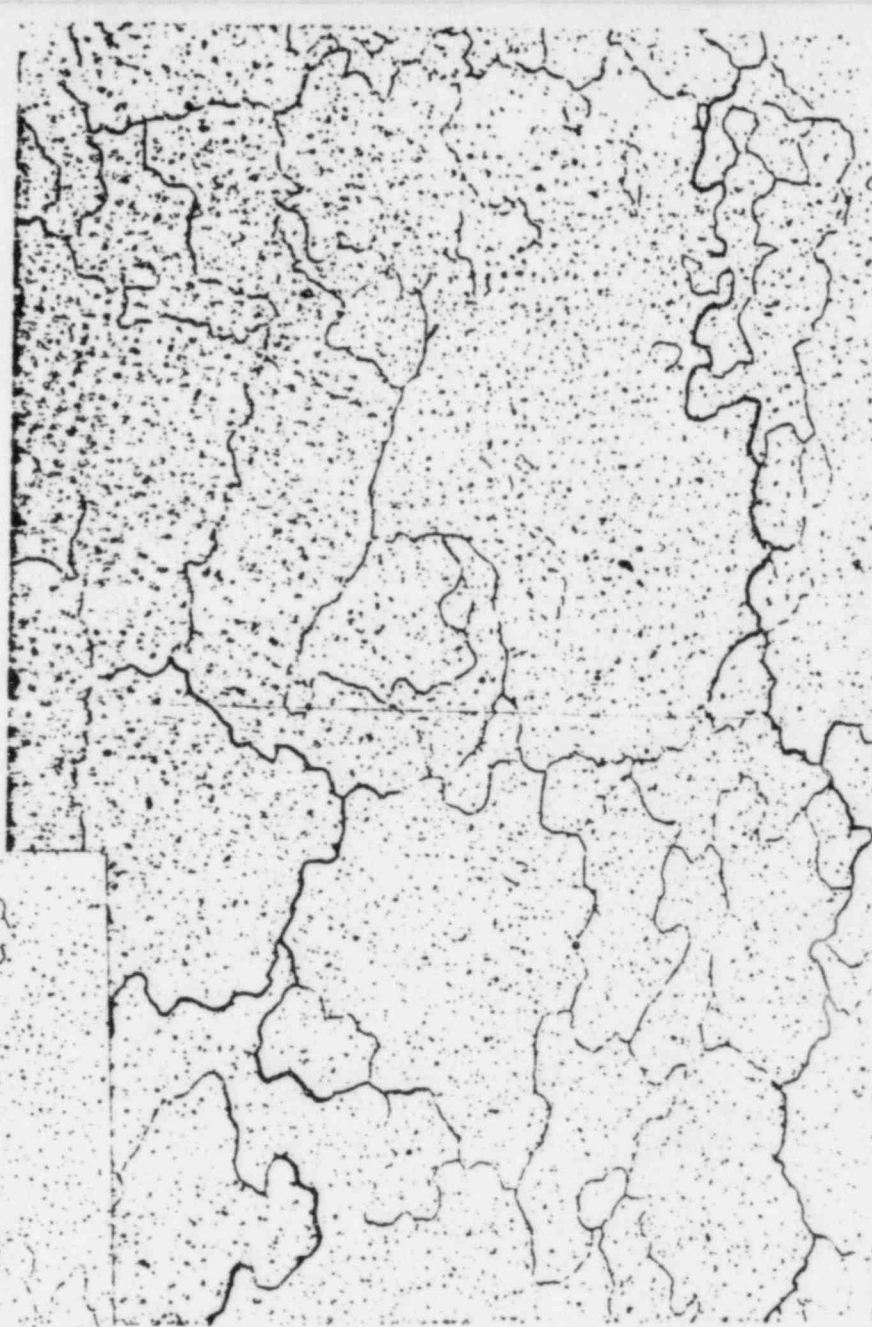
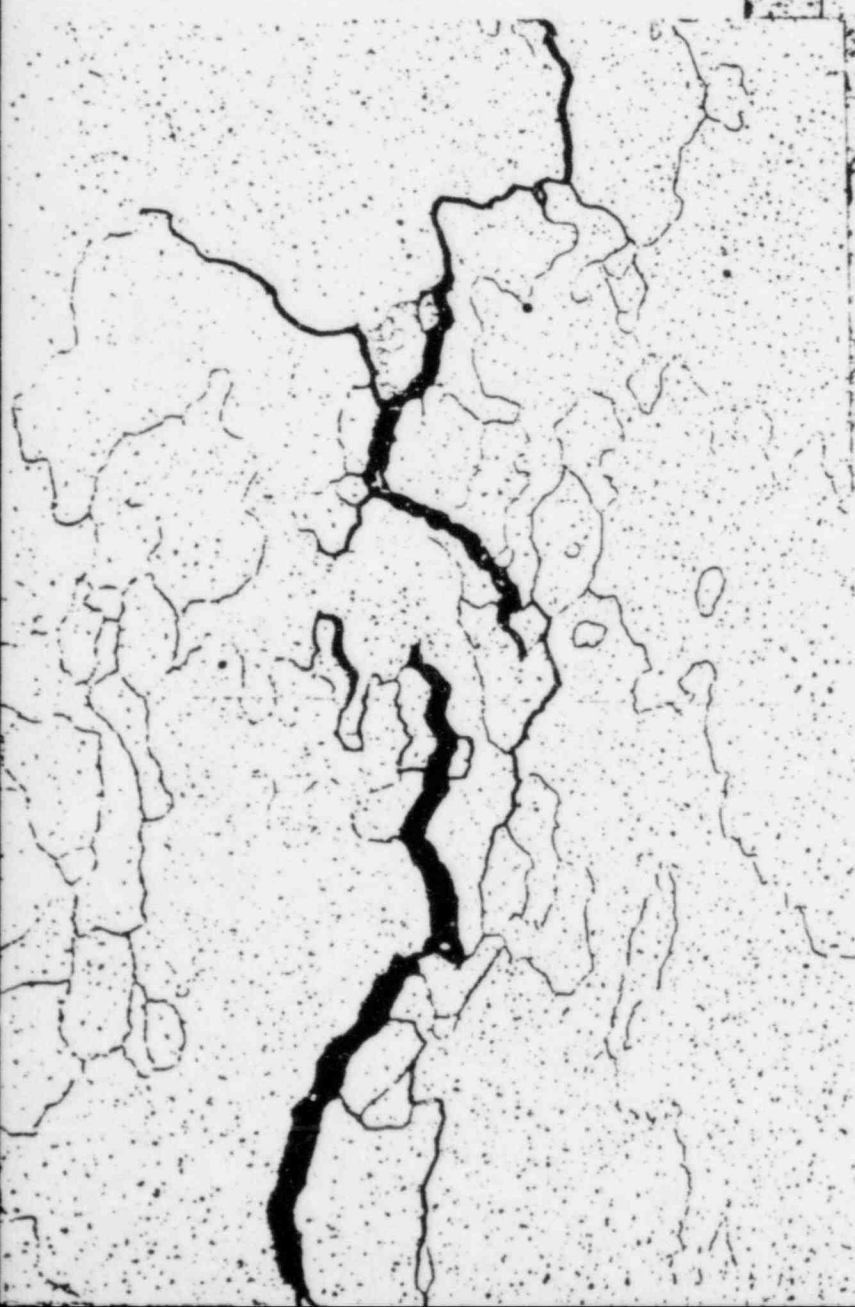
CRACK #2

INTERDENDRITIC CRACKING IN INCONEL  
182. THIS CRACK INITIATED ON  
NOZZLE SIDE OF WELD AND APPARENTLY  
TUNNELED TOWARDS THE SAFE END SIDE  
OF WELD

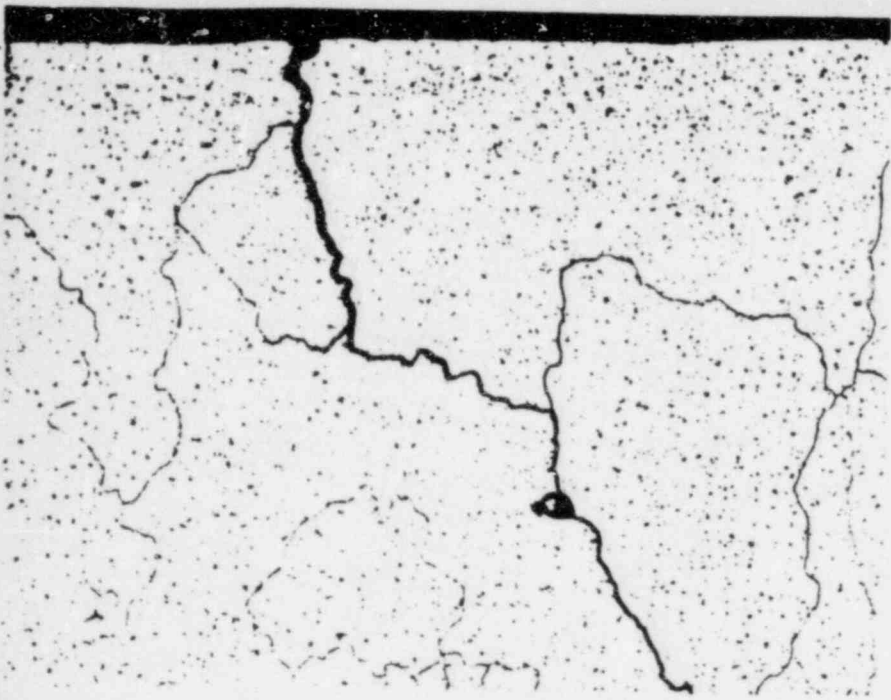
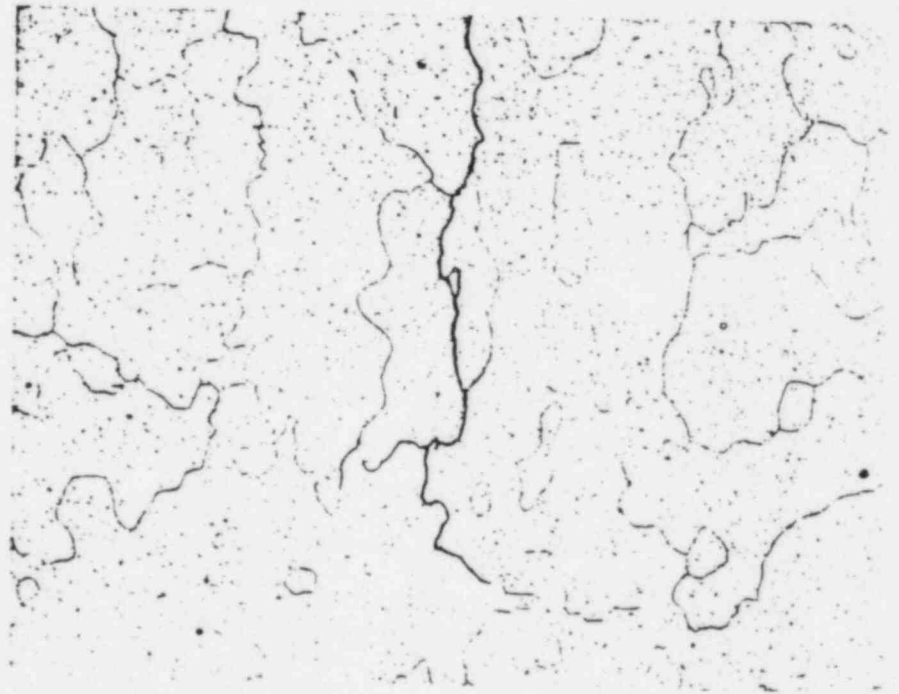
HIGH MAGNIFICATION VIEW OF INTERDENDRITIC CRACK #3 OF 33X  
COMPOSITE - INCONEL 182 BUTTER.

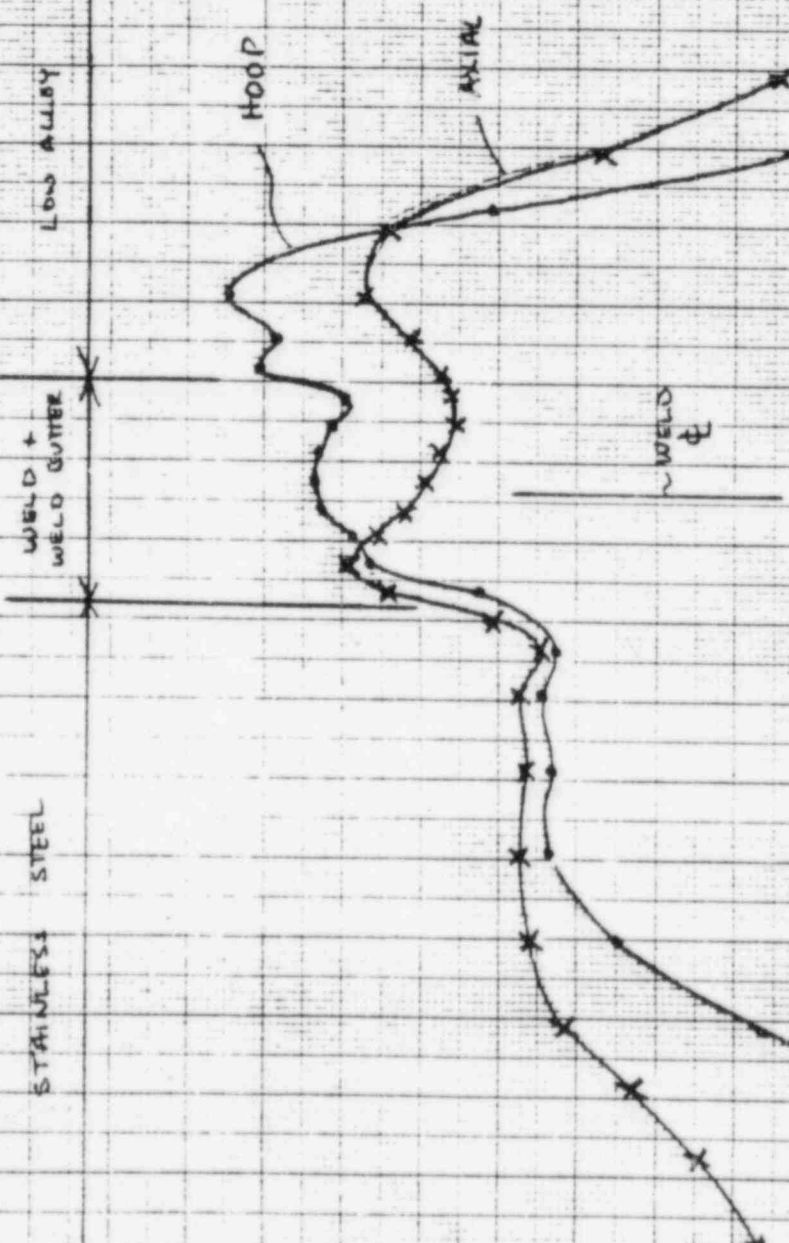
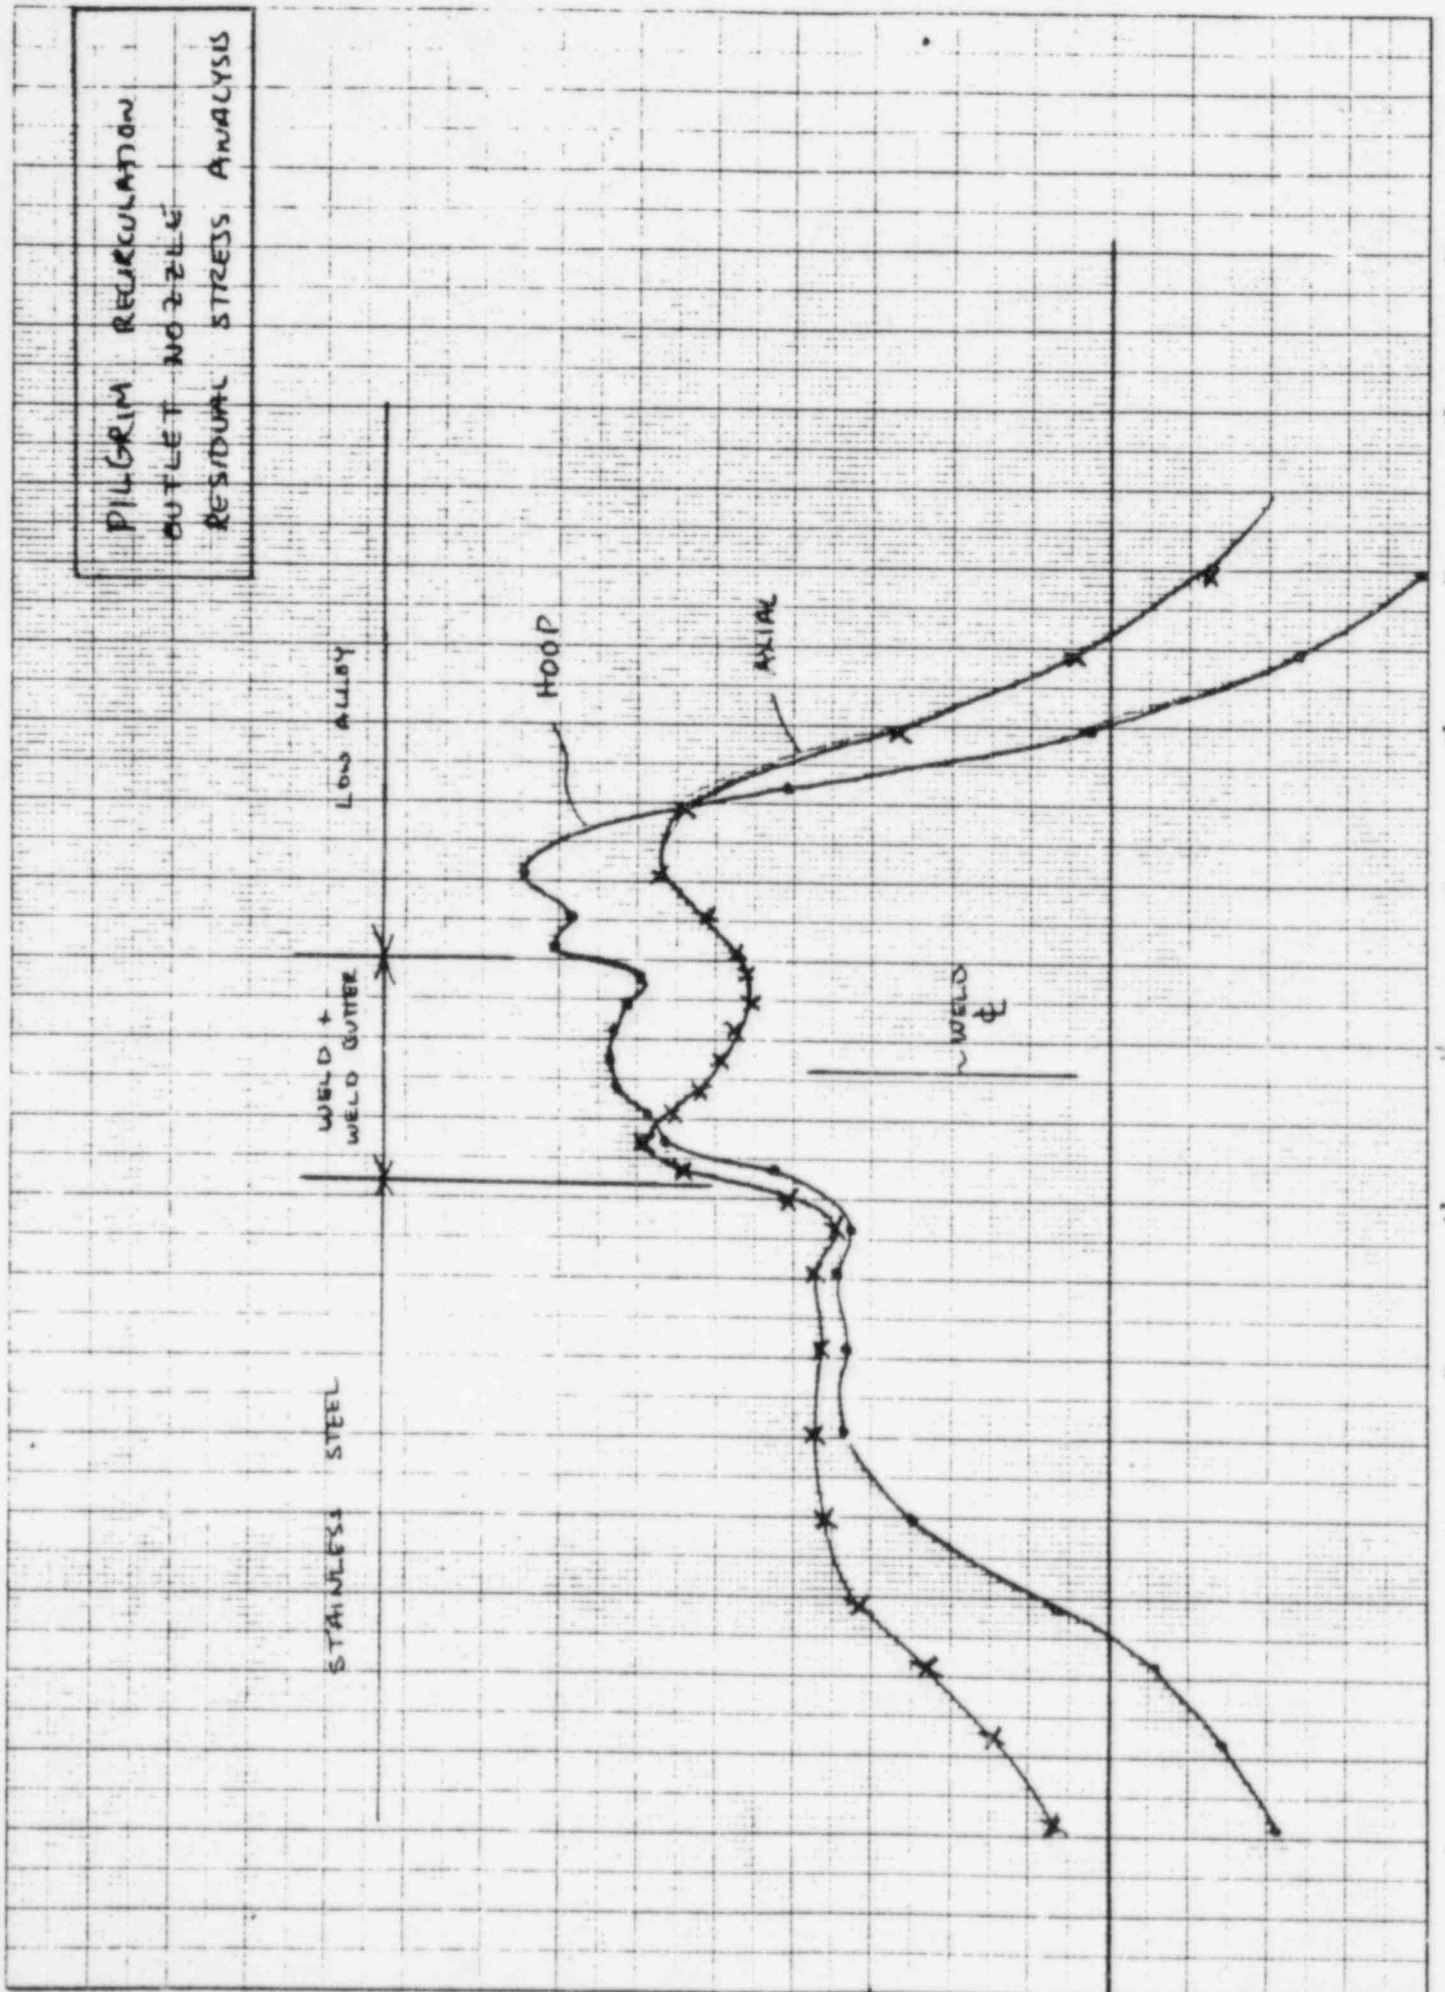
PILGRIM RECIRCULATION  
 OUTLET NOZZLE  
 RESIDUAL STRESS ANALYSIS

- PRIMARY HOOP STRESS DUE TO PRESSURE 10 KSI
- WELD RESIDUAL STRESS 50 - 70 KSI
- CIRCUMFERENTIAL STRESSES SUFFICIENT TO EXPLAIN THE OBSERVED CRACKING
- PREDOMINANT AXIAL CRACKING DUE TO HIGHER PRESSURE STRESS AND WELD RESIDUAL STRESS

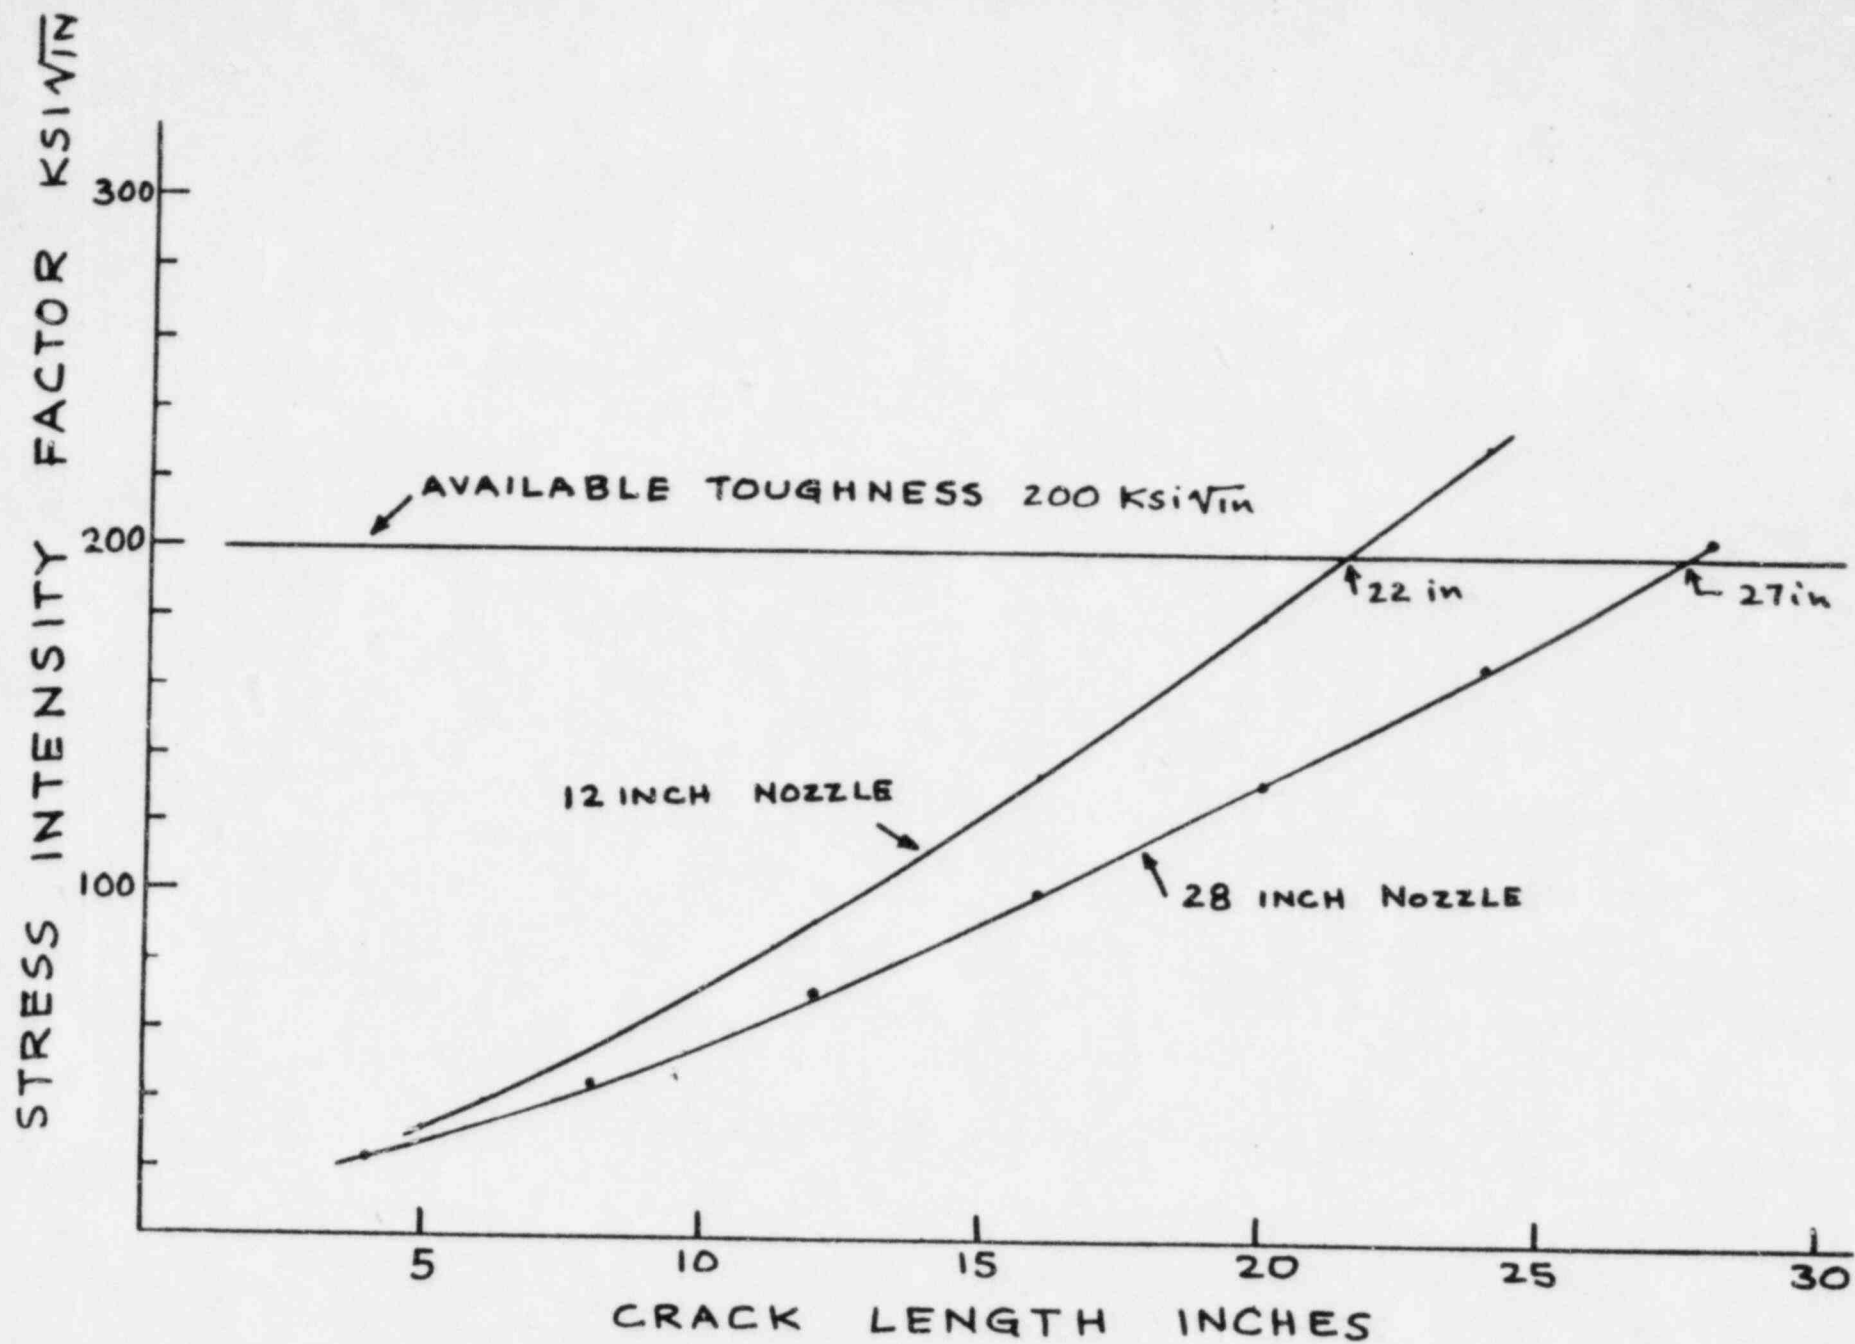
FIG 1 CRITICAL FLAW SIZE ASSUMING LEFM

- AXIAL CRACK SIZE INHERENTLY LIMITED BY THE WIDTH OF THE HAZ AROUND THE WELD
- THROUGH-WALL CRACK CAN BE TOLERATED
- CRITICAL CRACK SIZE CONSIDERING BRITTLE FRACTURE IN THE NOZZLE
  - 22 INCHES IN RECIRC INLET NOZZLE
  - 27 INCHES IN RECIRC OUTLET NOZZLE
- CRITICAL CRACK SIZE IN THE STAINLESS STEEL SAFE END
  - 25 INCHES IN RECIRC INLET NOZZLE
  - 39 INCHES IN RECIRC OUTLET NOZZLE
- AXIAL CRACKS DO NOT POSE SAFETY CONCERN
