Subject: Final Report - DER 83-51
A 50.55(e) Reportable Condition Relating to Unit 1 Auxiliary
Feedwater Pump Failed To Meet Requirements of Hot Functional
Tests.
File: 84-019-026; D.4.33.2

FINAL REPORT - DER 83-51
DEFICIENCY EVALUATION REPORT 50.55(e)
ARIZONA PUBLIC SERVICE COMPANY (APS)
PVNGS UNIT 1

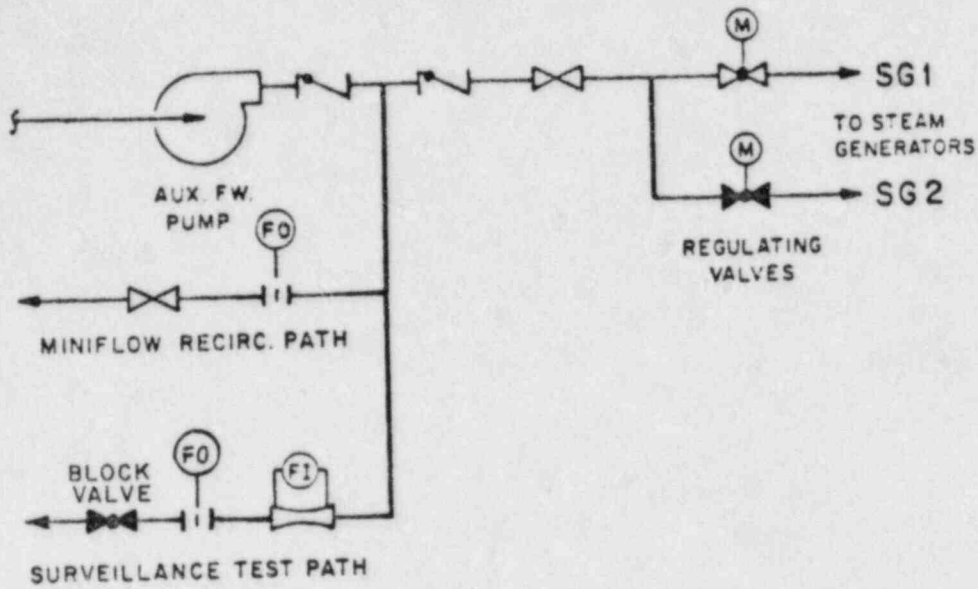
ORIGINAL TEST CONFIGURATION

Further investigation revealed that the root cause of the deficiency was that the surveillance test path block valve 1PAFAV018 was leaking. This condition is noted on NCR SM2961. As a result of the leaking block valve, the flow to the steam generator was reduced.

Investigation of the leaking block valve indicated that the valve leakage was common to both the "A" train and "B" train block valves. Even though the valves were not designed for flow modulation, they had to be throttled to obtain the required flow rates during surveillance testing. The valves did not withstand the conditions that resulted from throttling and as a result, were damaged and leaked. The subject valves were designed for use as isolating valves. As such, the installation of these valves in the surveillance path is a case of misapplication and incorrect installation.

DCPs 1SM-AF-062, 2SM-AF-062, and 3CM-AF-062 have been issued to eliminate the surveillance path by removing the block valves and adding a spectacle blind flange. SARC� 1165 has been issued to delete reference to the surveillance flow path from the FSAR. These DCPs will be implemented prior to fuel load in each unit.

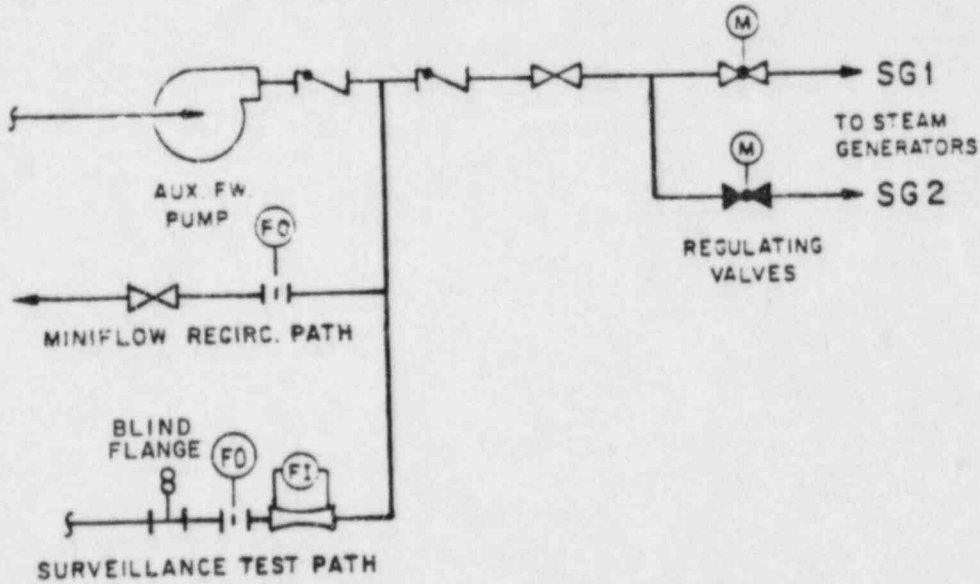
REVISED TEST CONFIGURATION

The surveillance test path was provided to perform full flow, periodic testing of the pump. However, there are no requirements for a full flow surveillance test loop in the ASME Codes and the technical specifications. The overall system operability is demonstrated at 18-month intervals by directly pumping to the steam generators. Therefore a spectacle blind flange was installed in the surveillance path and the block valves were removed. The pump was tested again in the same configuration as before except for the addition of the spectacle blind flange to eliminate the leak path as shown in the attached sketch. Evaluation of the test data indicates that the pump can deliver the required flow at rated head.
