LICENSEE EVENT REPORT (LER)

FACILITY NAME (1)
Susquehanna Steam Electric Station - Unit 2

TITLE (4)
Power Load Unbalance, Reactor Scram.

SUSQUEHANNA STEAM ELECTRIC STATION
LICENSEE EVENT REPORT 84-018-00
ER 100450 FILE 841-23
PLA-2333

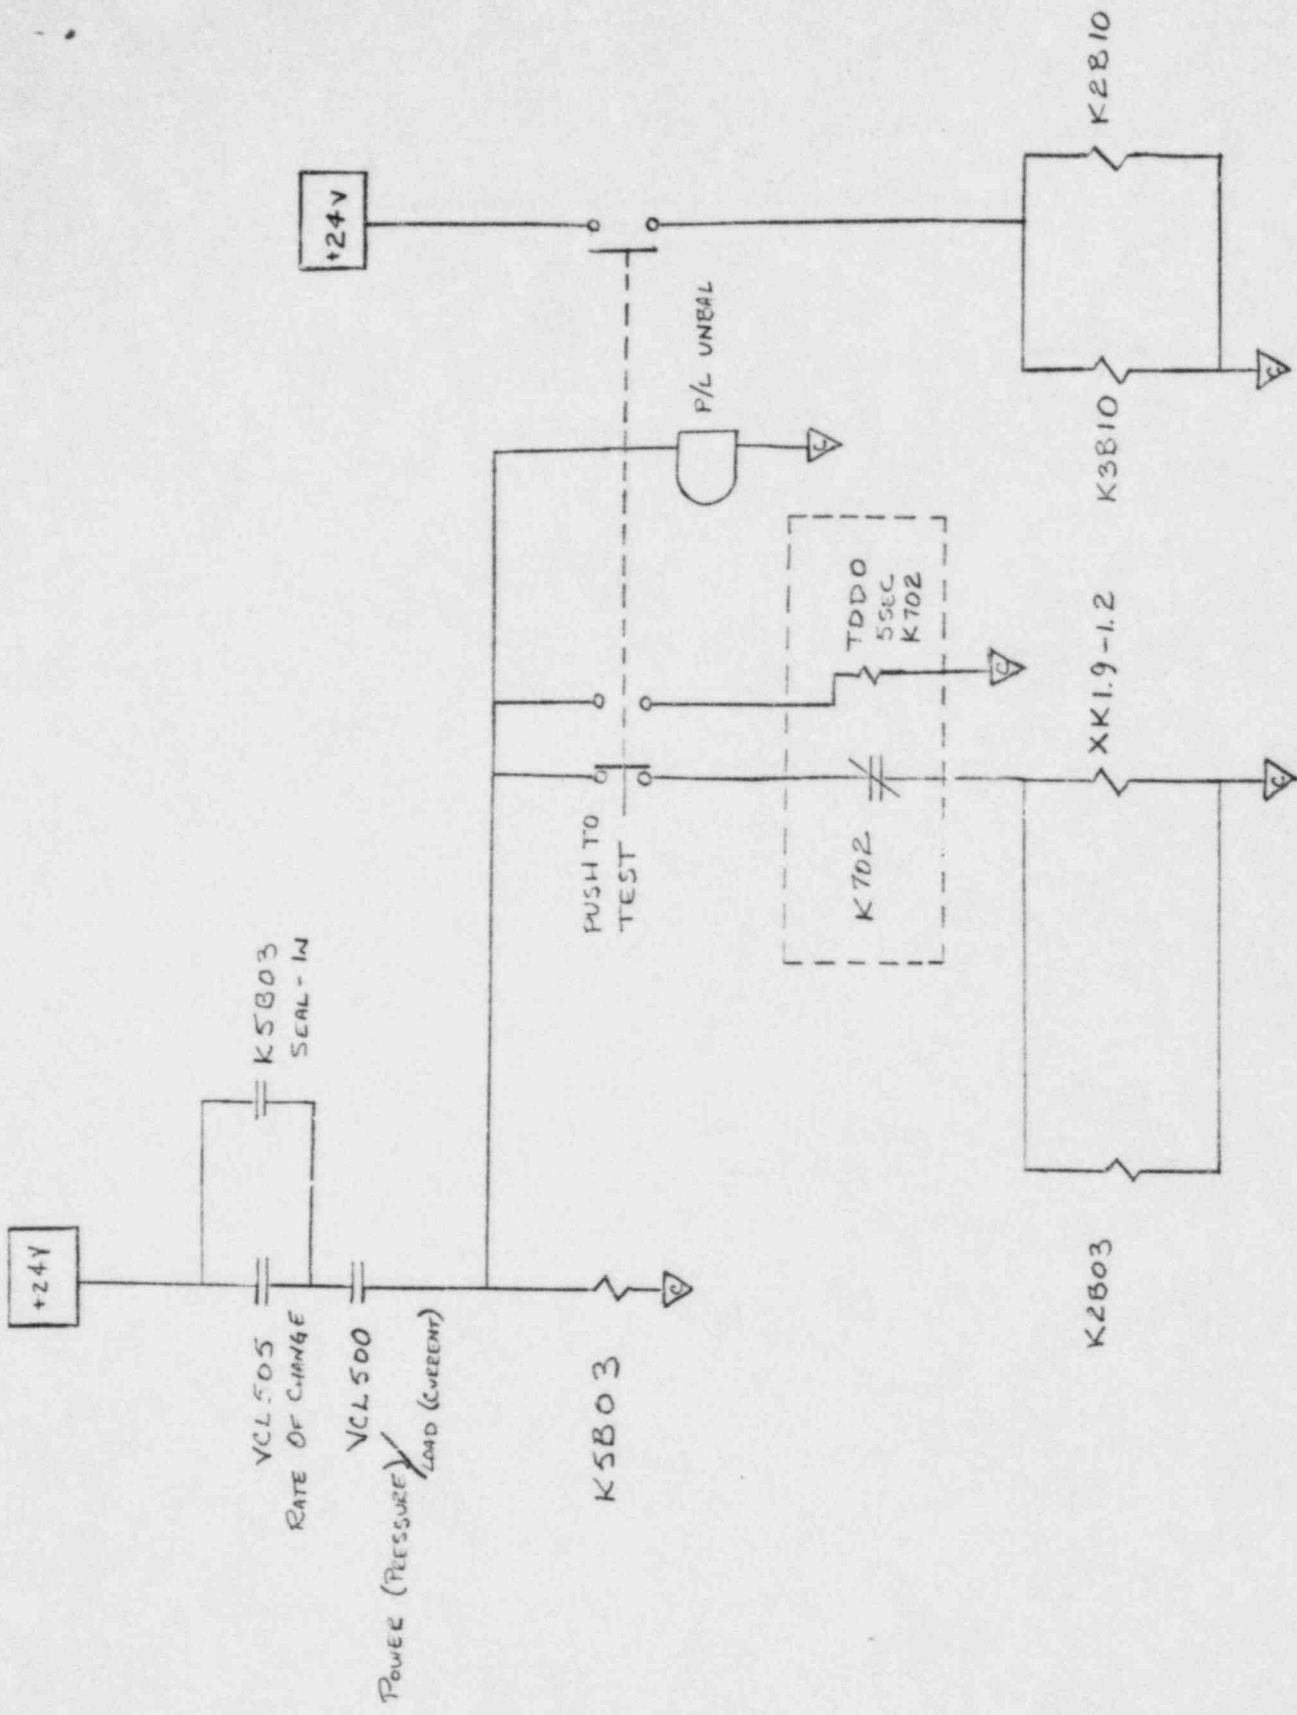
SIMPLIFIED RATE SENSITIVE POWER LOAD UNBALANCE CIRCUIT AND RELAYS

At this point, a discussion of the PLU test would be helpful to the remainder of this report. Refer as necessary to the schematic (attached). During the PLU test, the PLU PUSH-TO-TEST pushbutton is depressed. This action: 1) Inhibits the Fast Closure Relays (X2B03, XK19-1.2), 2) Energizes the Time Delay Relay (K702), and 3) energizes Relays (K3B10, K2B10) which ground the generator current signals to the rate sensitive power load unbalance circuit. With pushbutton depressed and the turbine load greater than 40% (a prerequisite), the two conditions to simulate a load rejection are present: 1) power (cross-around steam pressure) more than 40% greater than load (generator output current), and 2) a change in generator current output equal to 0-100% rated occurring within 39 msec, are satisfied which results in: 1) the Power (pressure)/Load (current) Relay VCL500 contacts close, and 2) the rate of Change Relay VCL505 contacts close.

Since these relays are in series the closure of the contacts results in the test pushbutton light illuminating and energizes Relay K5B03 which seals in the rate function.

To restore the circuit, the PLU Push-To-Test pushbutton is released and the following actions occur: 1) The relays grounding the current input signal are deenergized restoring the signal, and 2) the time delay relay (time delay drop out) is deenergized and a 5 second time delay begins.

The restoration of current input signal to the rate sensitive power/load unbalance circuit resets the voltage comparators. This clears the power/load function and deenergizes its relay. When the relay contacts open: 1) the indicator lamp is extinguished, and 2) relay K5B03 is deenergized removing the seal in on the rate change function. The valve fast closure relays are enabled after, the 5 second delay.

During the performance of OP-293-002 on 9/8/84, the power/load function did not clear. Therefore, when the valve fast closure relays were enabled the circuit was in the tripped condition. The test was performed at approximately 45% load. Because of the "zero shift" previously described, PT-20107 would have an output which appeared to the PLU circuit as greater than 100%. Thus, the power/load mismatch appeared to be at least 55% ($\geq 100-45$). When the pushbutton was released, the power/load function was in and the rate change function seal in was maintained. This maintained the circuit in the tripped condition, which resulted in the Turbine Control Valve Fast Closure. The unit responded per design through out the transient. The Reactor Recirculation Pumps tripped as per design on the end of cycle-recirculation pump trip.
