NYN-95081

Subject: Relief Request From ASME Code Section XI Requirements

ENCLOSURE TO NYN-95081

SEABROOK STATION
FORM FOR RELIEF REQUEST FROM ASME SECTION XI REQUIREMENTS

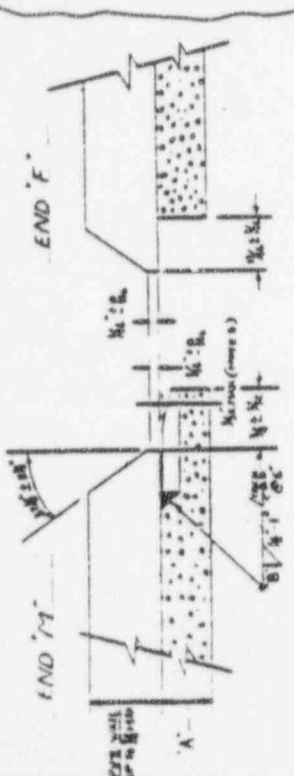
FIELD WELD BEVEL DETAIL FOR 4" THROUGH 36" PIPE & FITTINGS

CEMENT LINING SHALL BE COMPOUND WITH KEMIDO PIPE JOINT COMPOUND SPECIAL FORMULA W/ R PAMBO CORP. 43-45 3/4" ST 20-ME TELL-IB CITY, NY. THAT APPLY TO GAPS PRACTICABLE ON THE I.B. PRIOR TO WELDING PIPE. GAPS ACCEPTABLE ON THE I.B. AFTER WELDING PIPE.

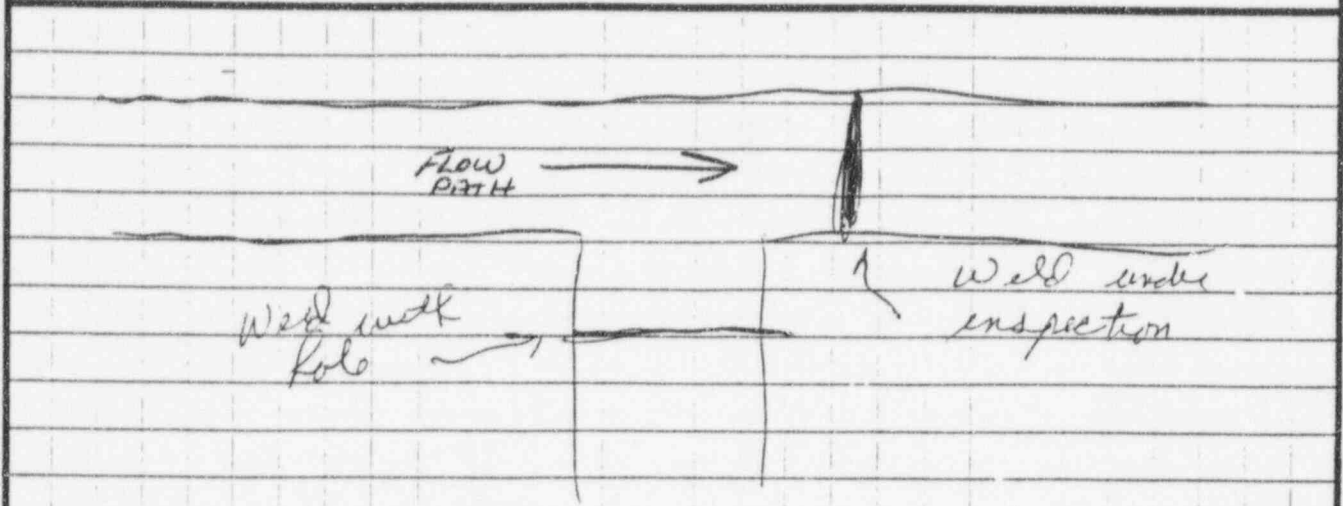
ULTRASONIC THICKNESS EXAMINATION SKETCH

Note
Weld is painted

.511 is the thickness over
over weld, No deterioration found

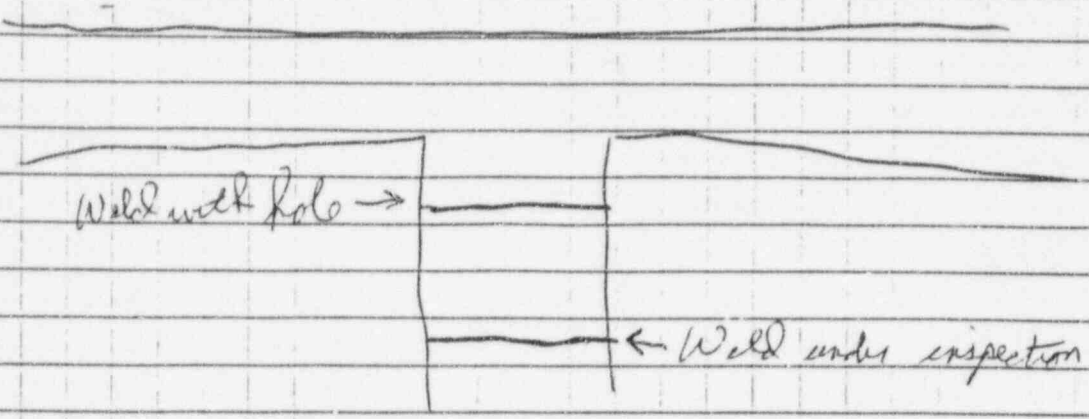
ULTRASONIC THICKNESS EXAMINATION SKETCH

Low point on pipe is .403 and
 weld is is .442 No detection found.

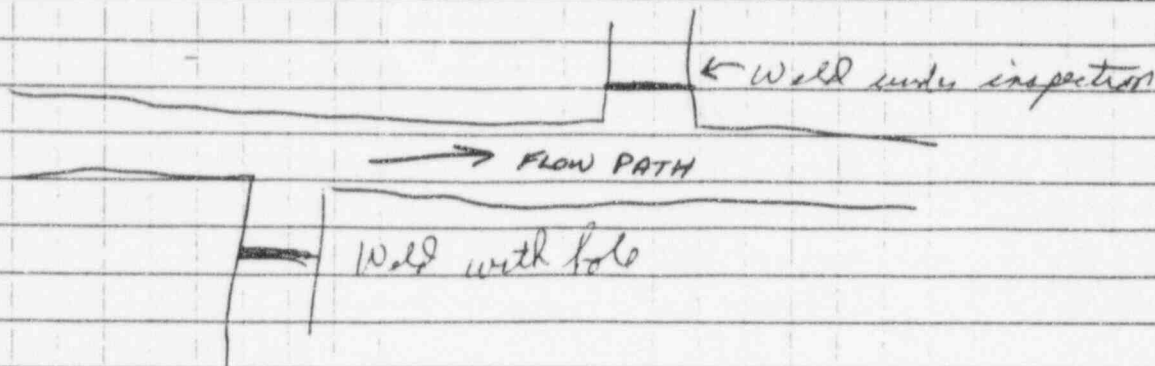
LOCATION 1802-1001 SYSTEM SW WORK REQUEST _____

General area lowest points
Pipe .362
Weld .313
tee = .500

No deformation found

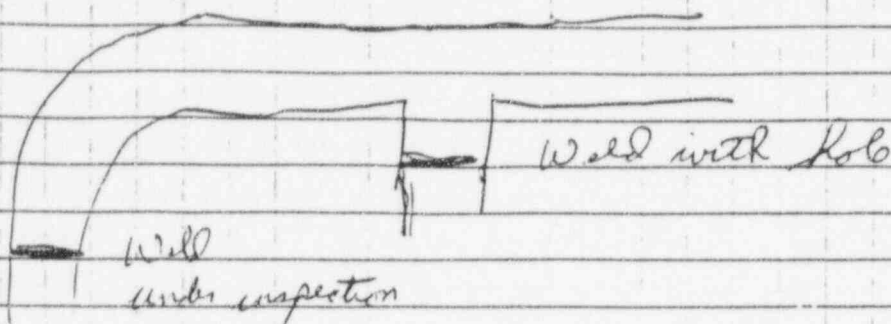
LOCATION 1802-F0301SYSTEM SLD

General area scan is
 elbows .330
 weld .290

No deformation noted

Subsurface indication interfering with UT
 yield found reading is .097.
 Indication most likely due to lack of
 fusion Area ~ 1 1/2" location is
 on upper elbow lower joints outside
 radius
