TMI-1 REACTOR COOLANT PUMP SHAFT FAILURE ANALYSIS

RESEARCH AND DEVELOPMENT DIVISION
LYNCHBURG RESEARCH CENTER

SPONSORED BY
GENERAL PUBLIC UTILITIES

Lynchburg Research Center Report
RDD:84:5183-06:01

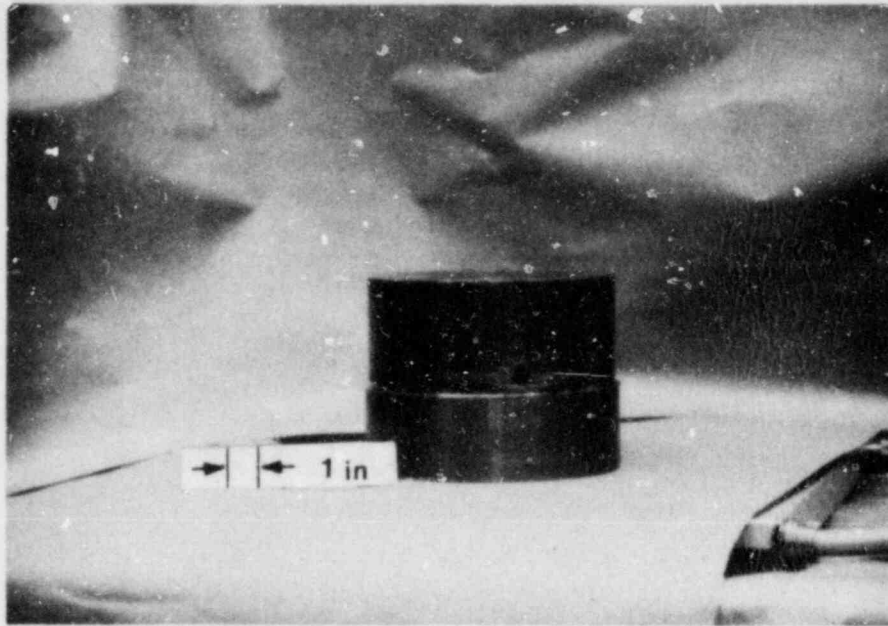
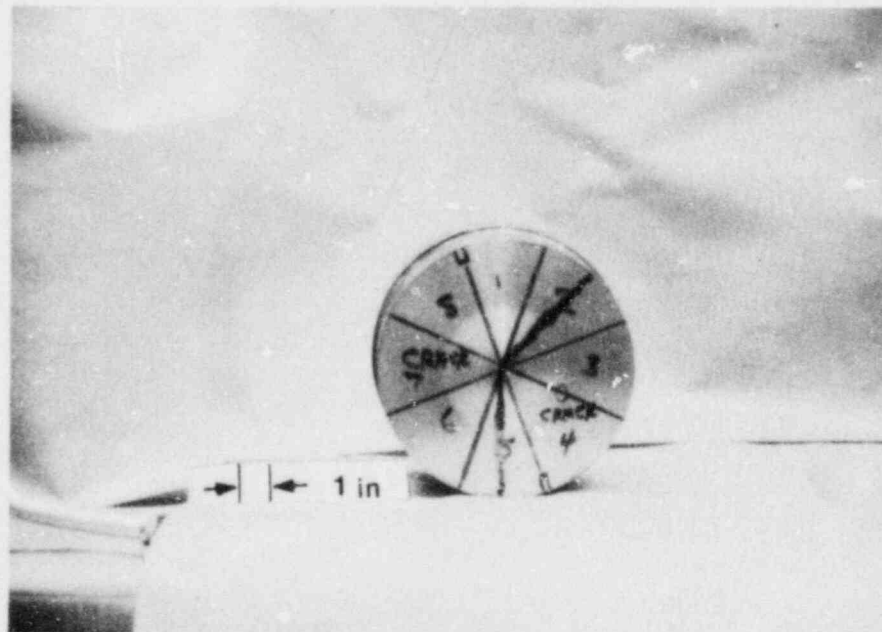
Figure 3.1-1. Reduced Magnification View of Pump Shaft
Section Containing Crack at Pin Hole in A;
B Shows Orientation Markings

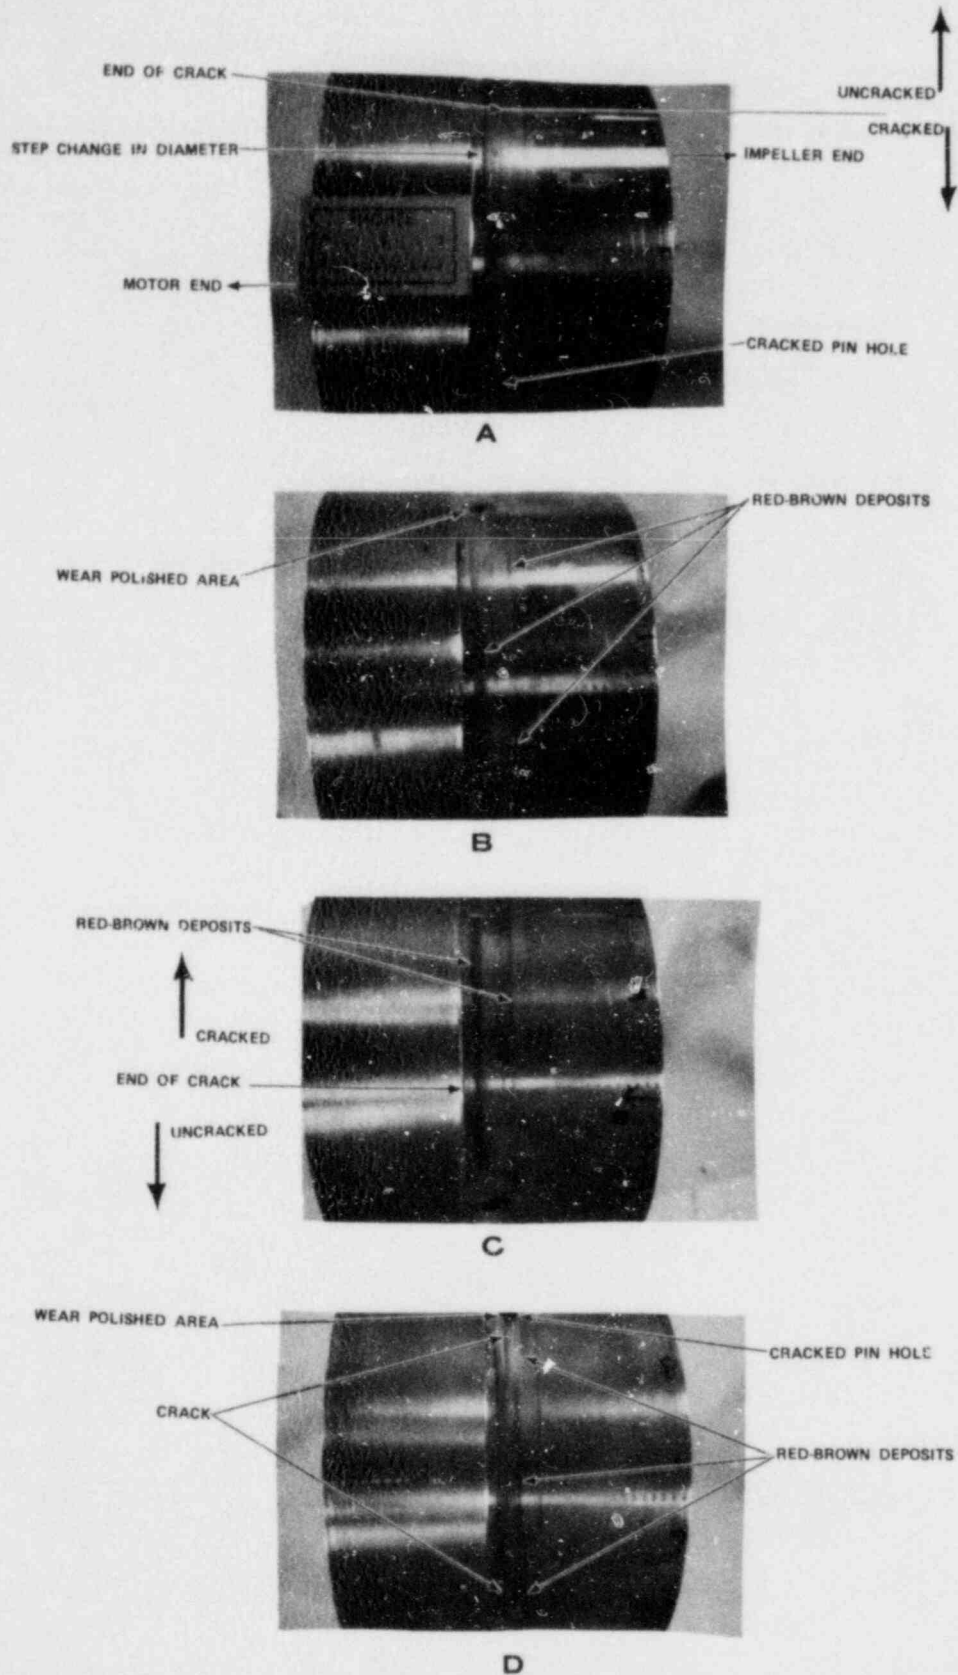
Figure 3.1-2. Reduced Magnification Views of Pump Shaft;
Rolled Down the Page From A to D

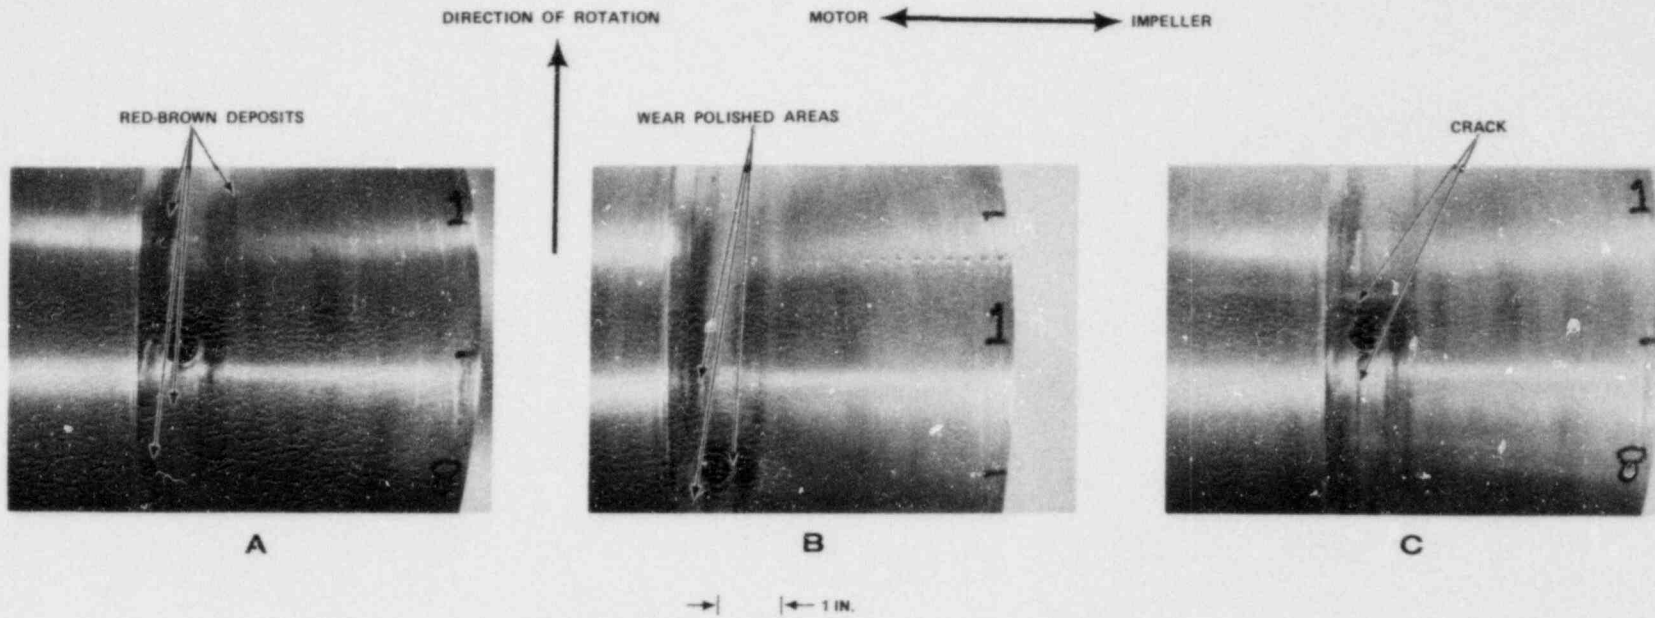
Figure 3.1-3. Enlarged Views of Pin Holes. A, B, and C Shot at Different Angles or Different Illumination at Cracked Pin Hole. D and E Shot at Uncracked Pin Hole

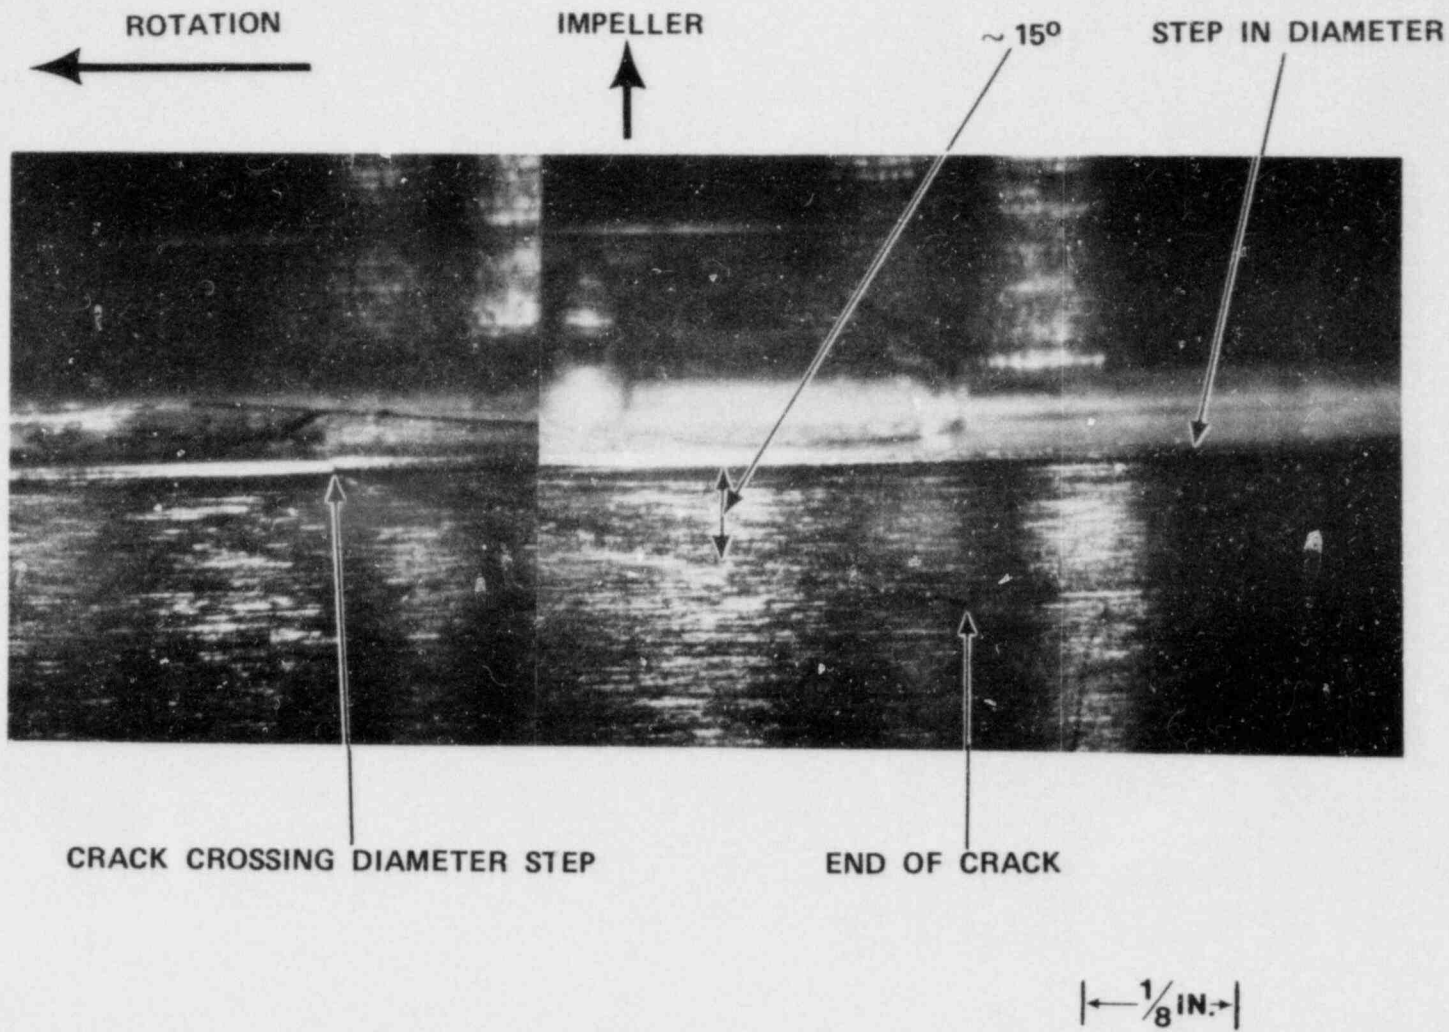
Figure 3.1-5. End of Crack at Surface in Octant 5

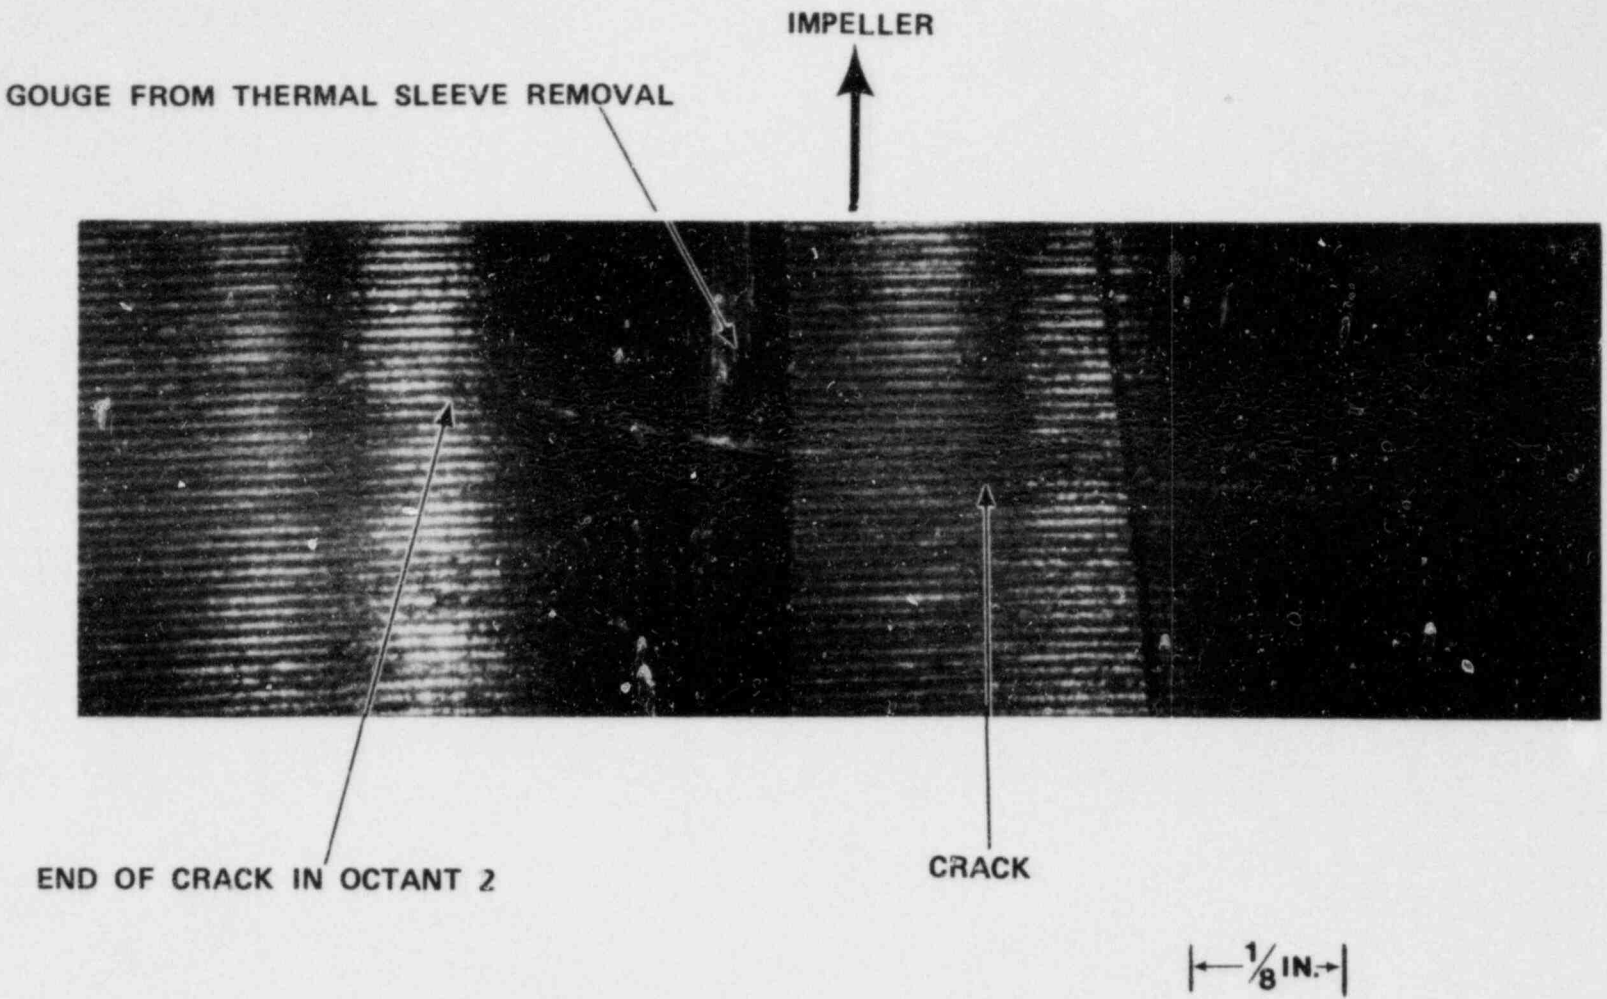
Figure 3.1-6. End of Crack at Surface in Octant 2

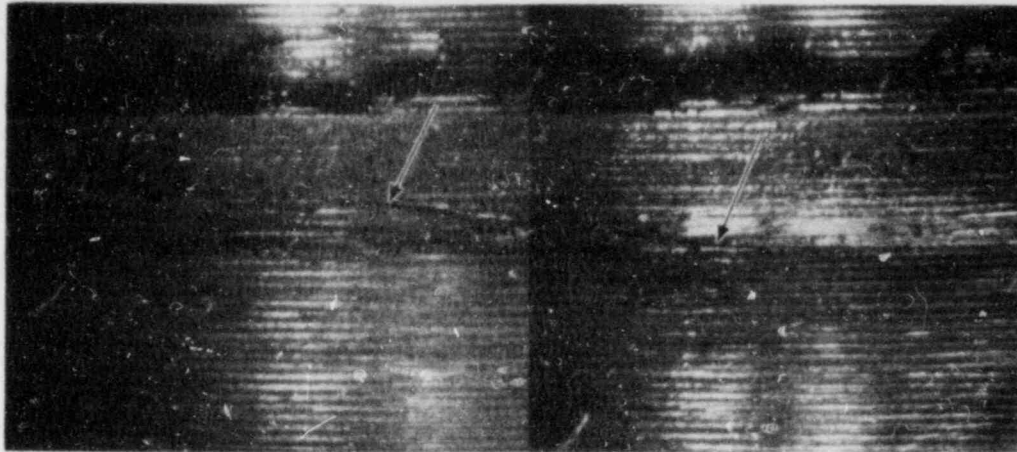
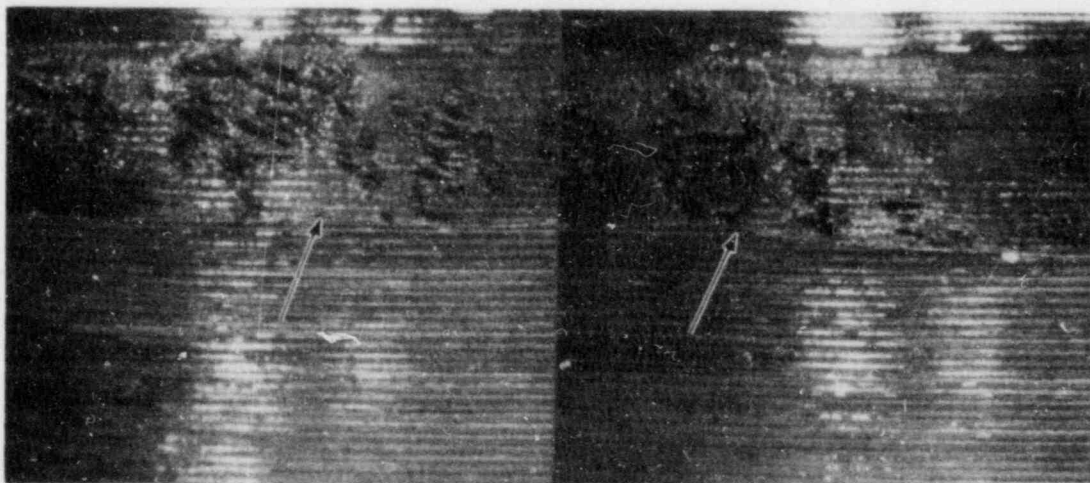
The sharp changes in crack path noted suggest that changes in stress state on fracture mode were occurring in these areas. The sharp change at the extremes of the crack are in the directions expected for entering shear overload. The general orientation of the crack path suggests a predominantly axial stress is driving crack growth. However, the slight pitch of the crack path indicates that a small torsional stress may also be influencing crack growth direction.

Figure 3.1-7. Local Change in Crack Path Direction at Arrows A in Octant 8, B in Octant 1

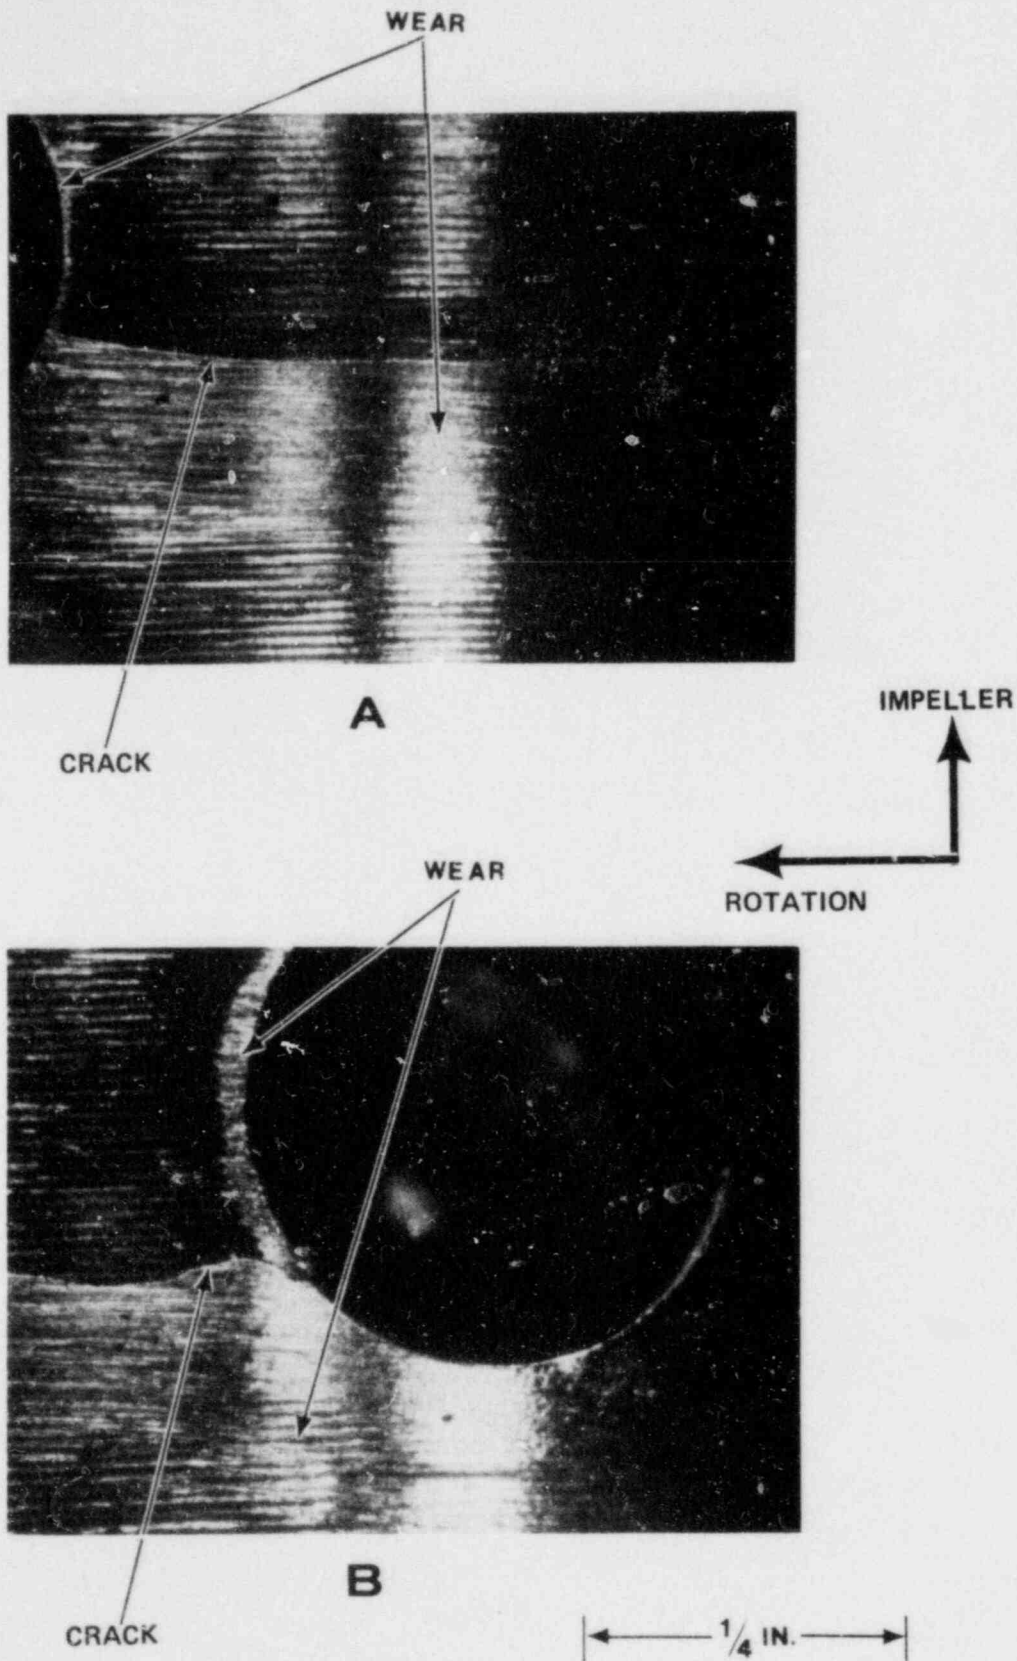
Figure 3.1-8. Change in Crack Path Near Pin Hole
A. Octant 8 Side of Pin Hole
B. Octant 1 Side of Pin Hole

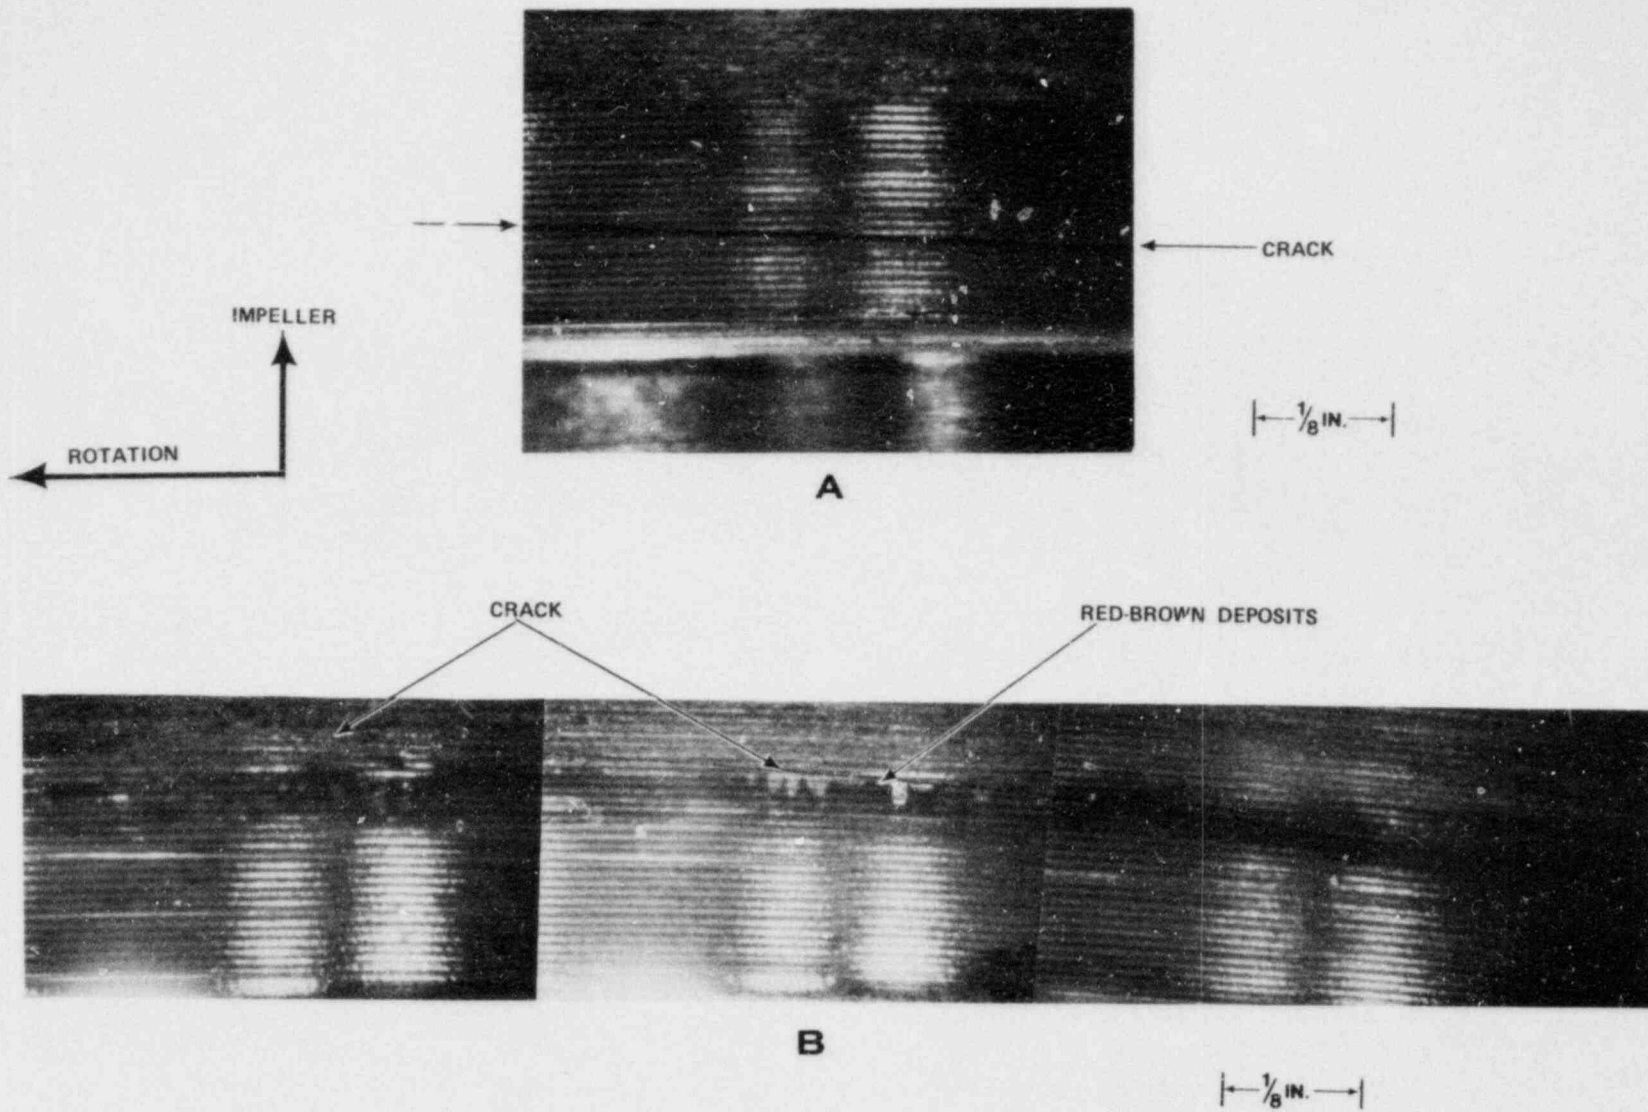
Figure 3.1-9. Surface Appearance of Shaft Near Crack
A. Unworn and Un-corroded Area With Crack
B. Crack Passing Through Spalled Deposits

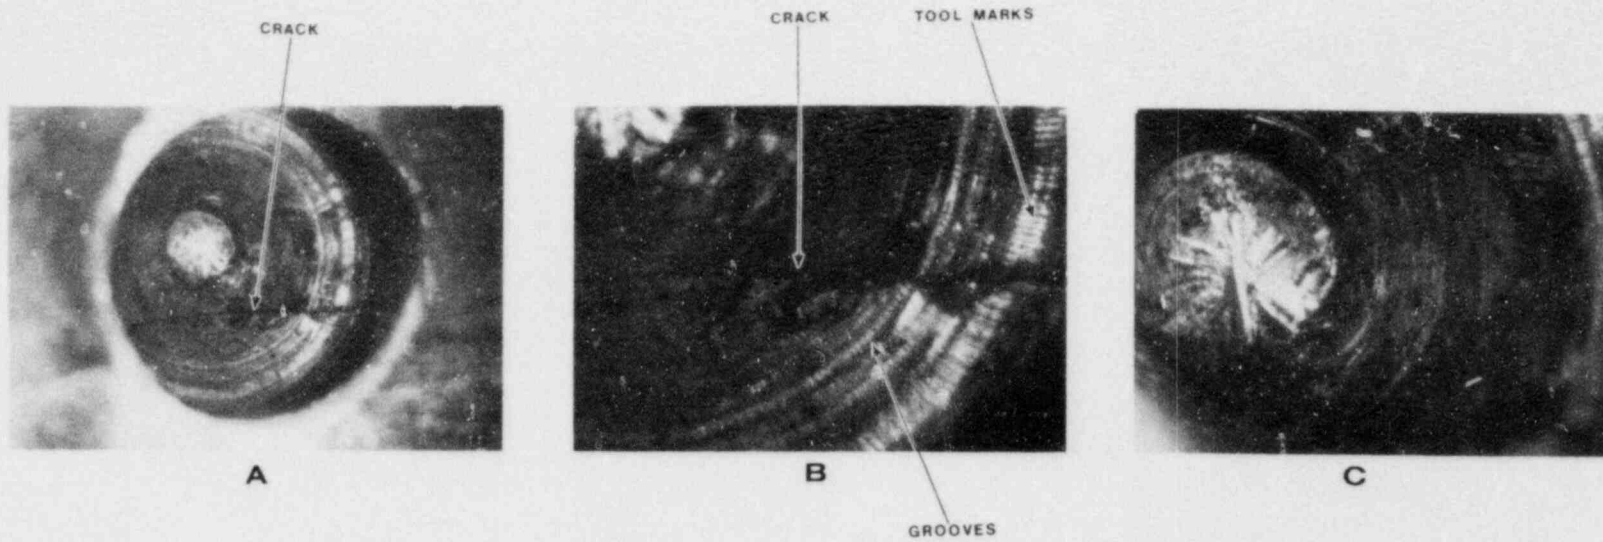
Figure 3.1-10. Internal Surface Condition of Cracked Pin Hole
A. General View Showing Crack
B. Enlarged View of Crack
C. View of Hole Bottom

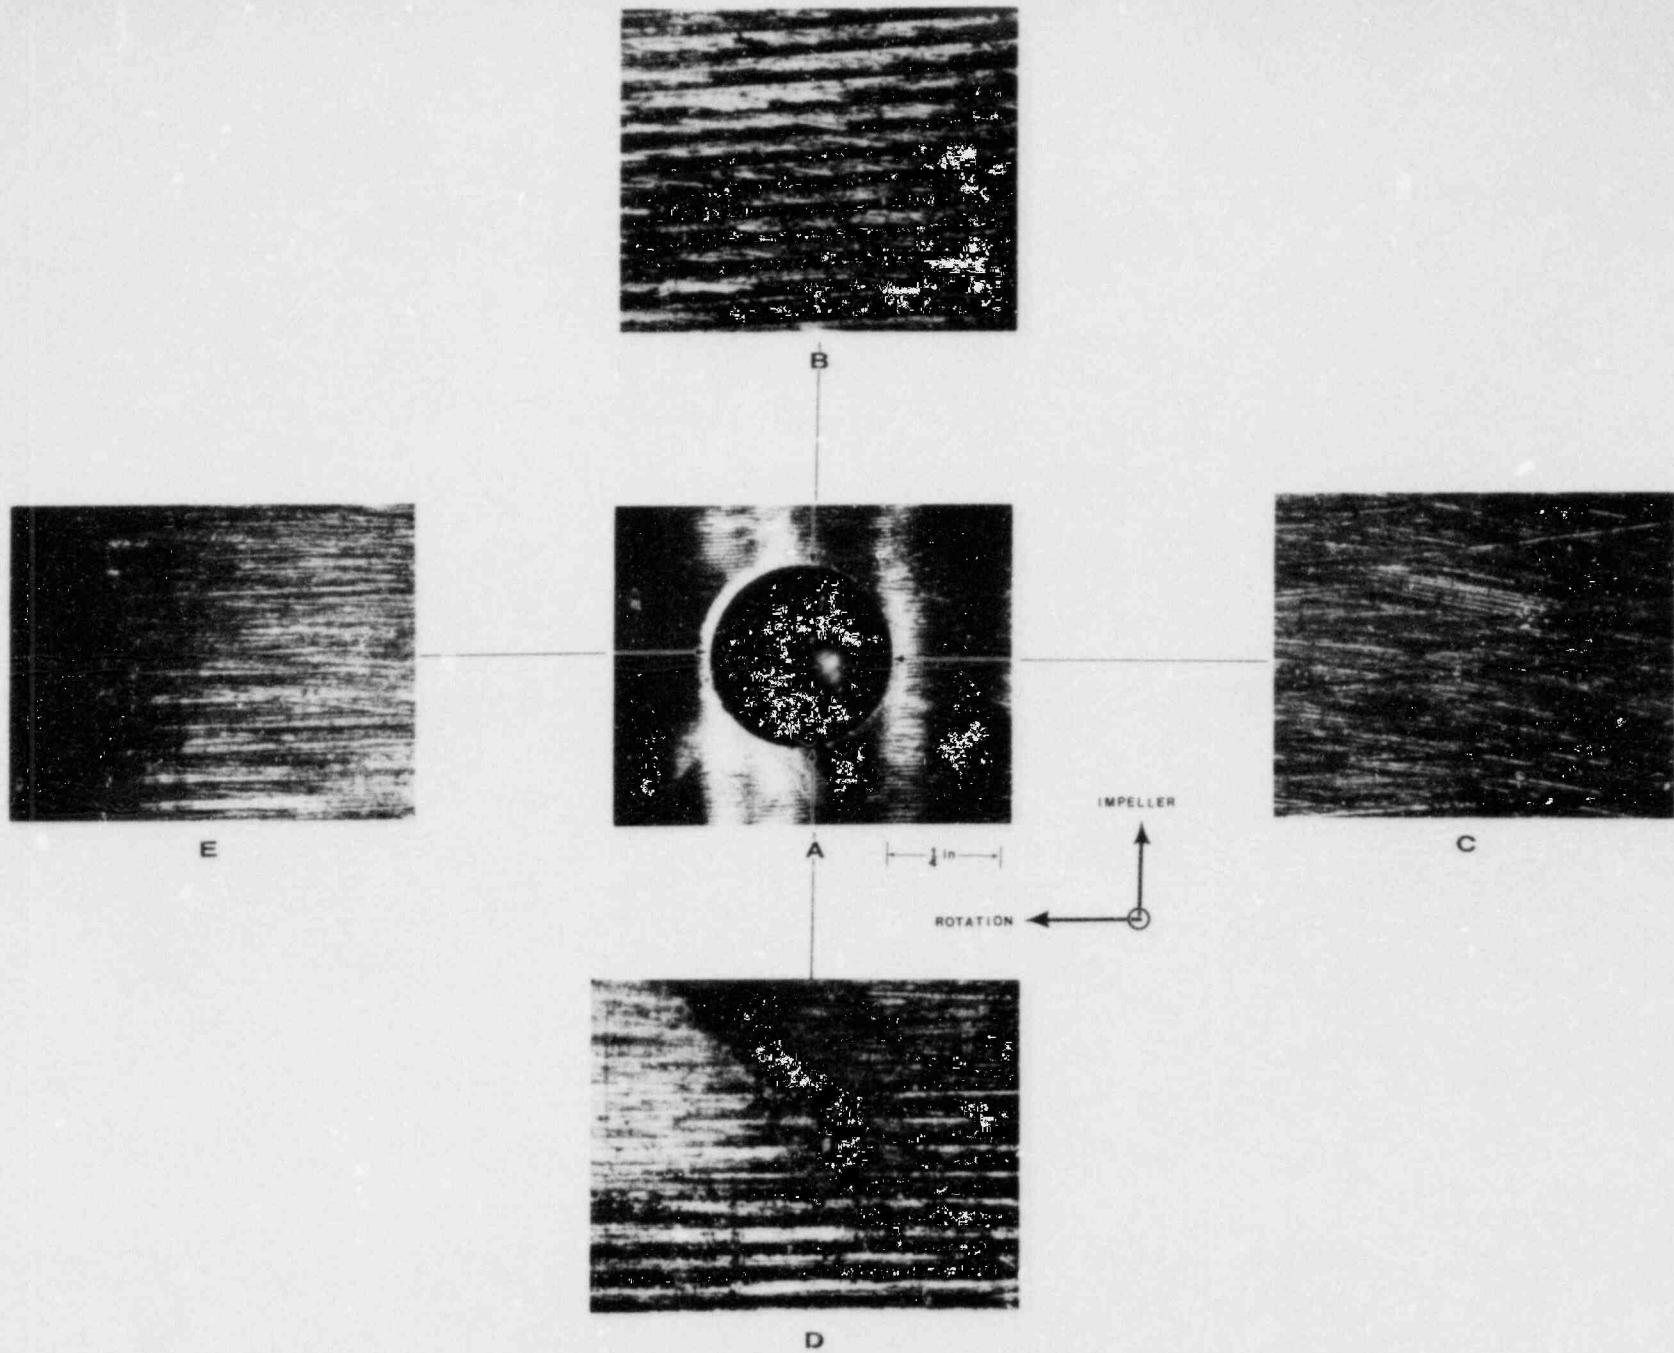
Figure 3.1-11. Shaft Surface Appearance Near Uncracked Pin Hole. View A Shows Pin Hole. Views B, C, D, and E Show Coarse Tooling Marks. Views C and E Show Wear Marks

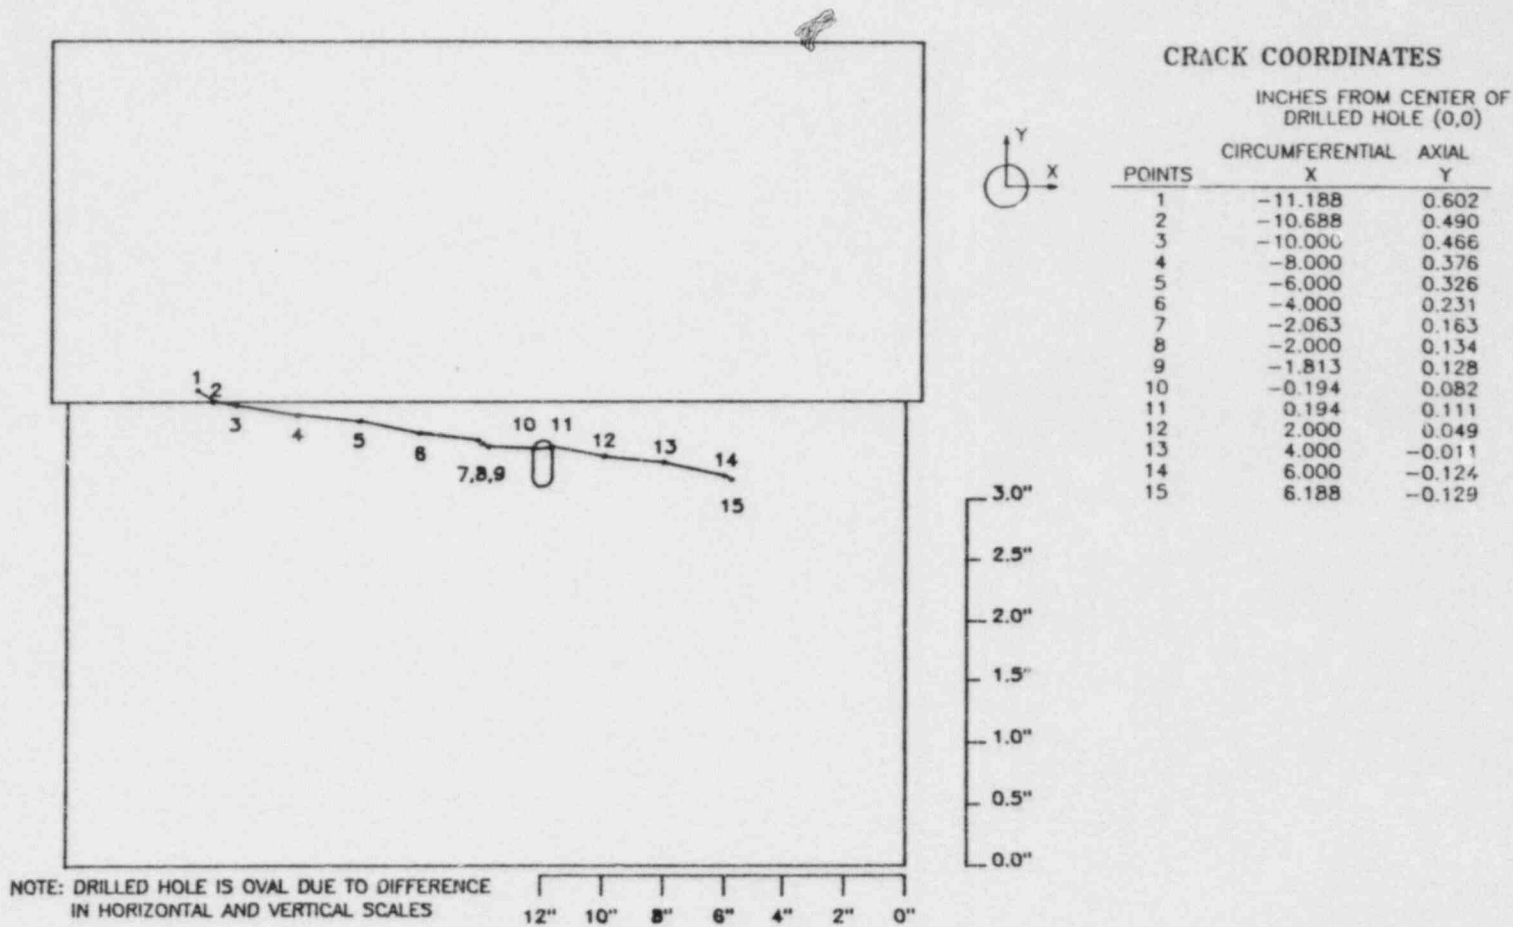
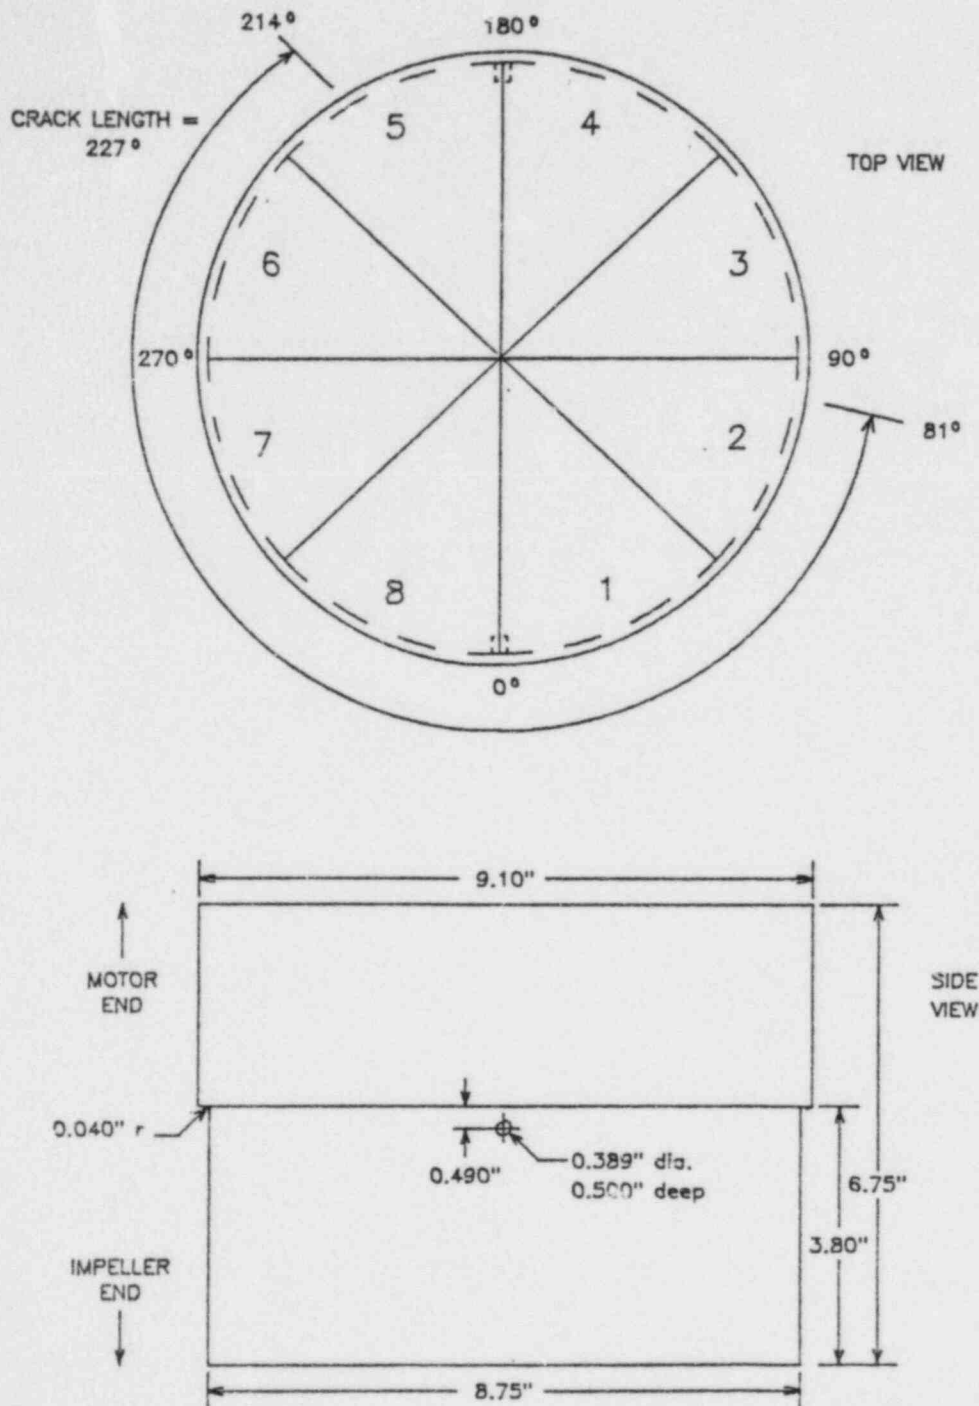
Figure 3.1-13. Pump Shaft Dimensions and Crack Location

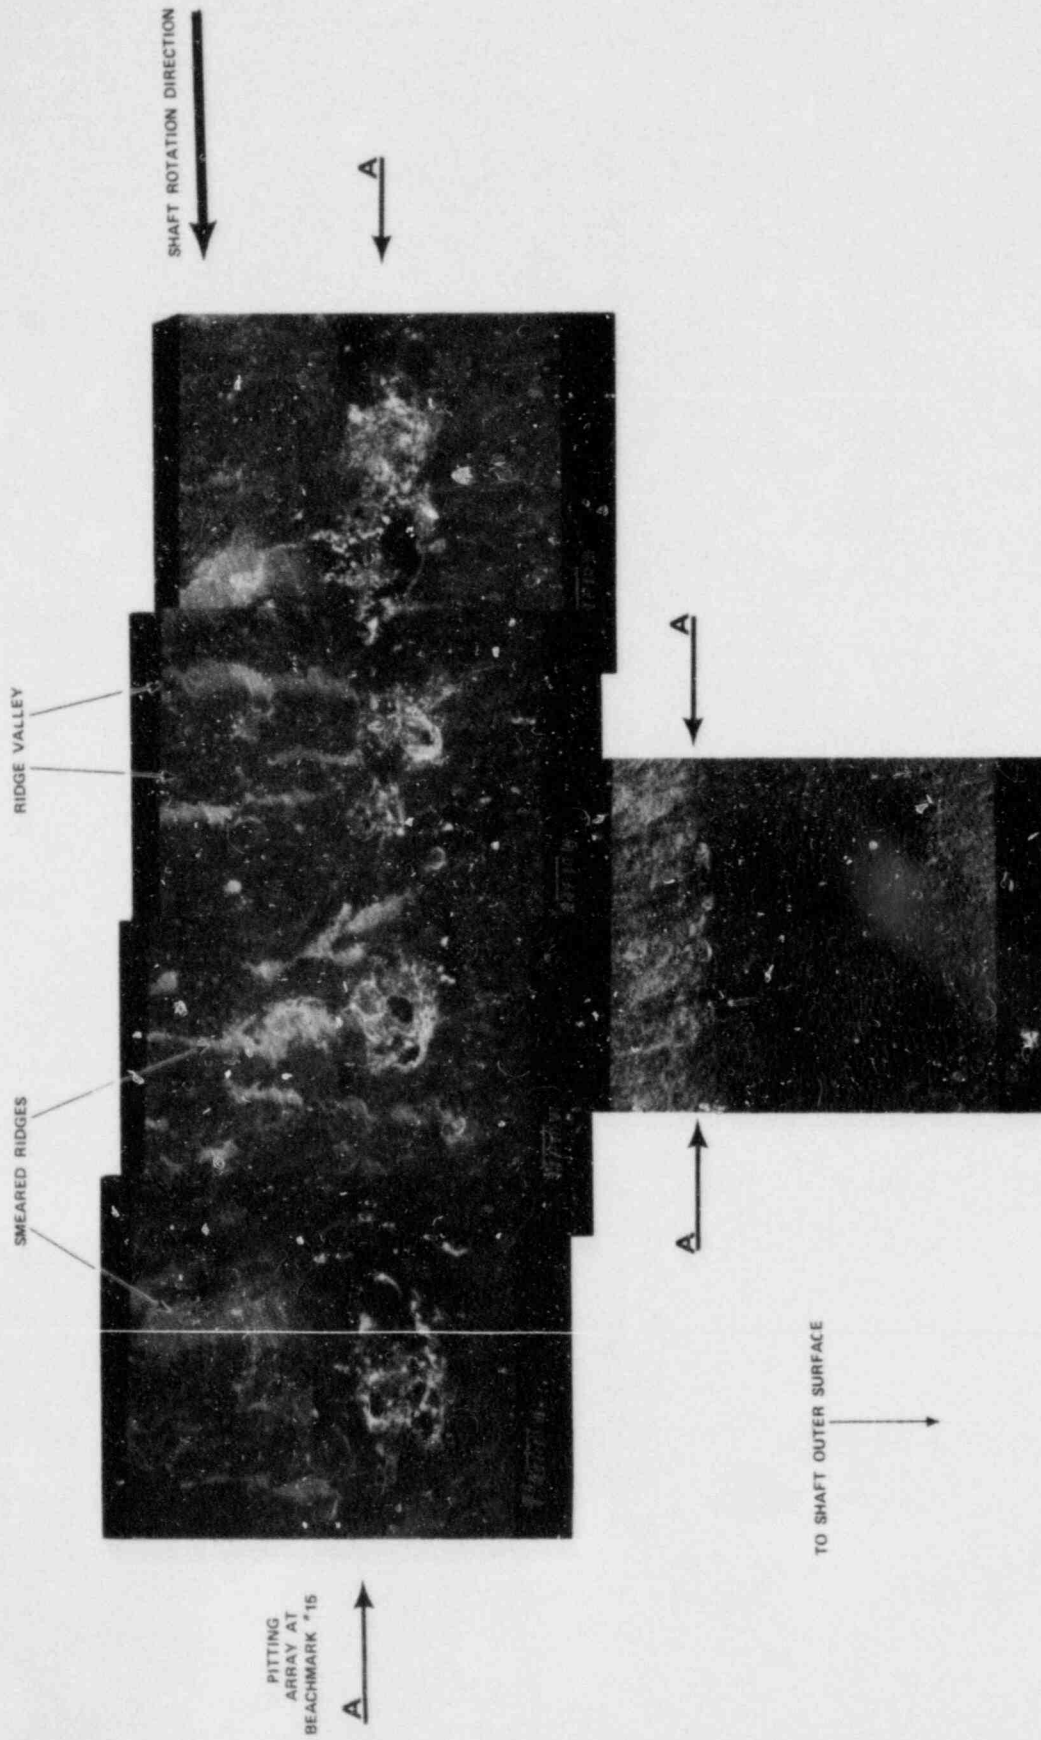
Figure 3.3-8. Transition From Flat Fracture Surface to Ridge and Valley Structure at Pitted Beachmark #15

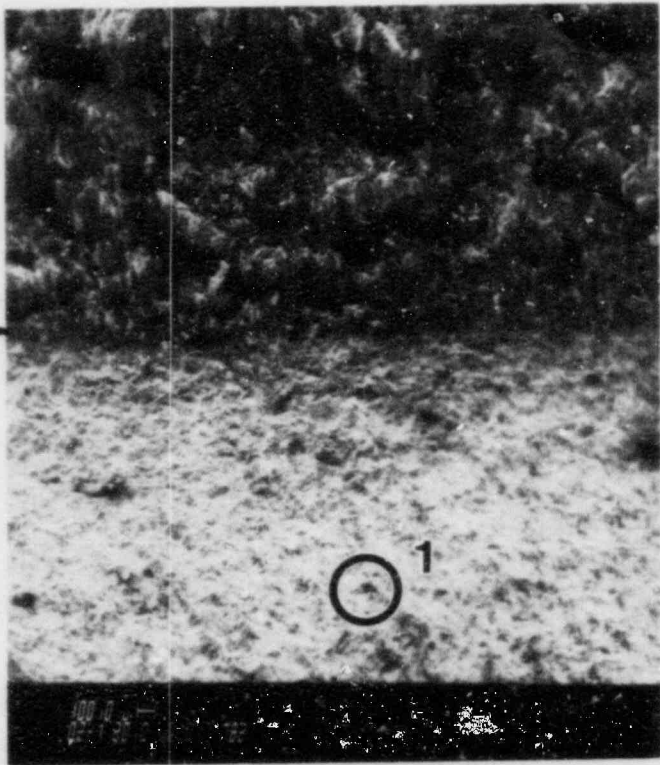
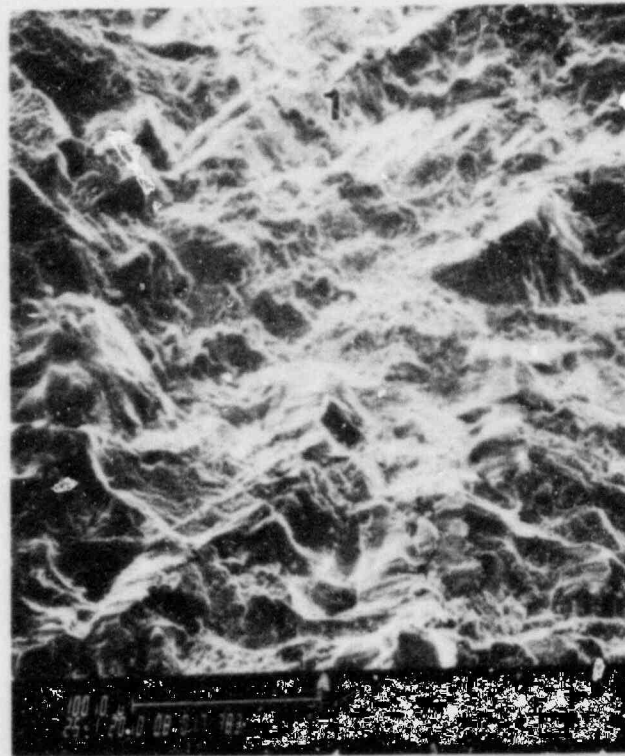
Figure 3.3-13. Typical Fracture Structure on Specimen 17-20.
B Shows Enlarged View of Location 1 in A

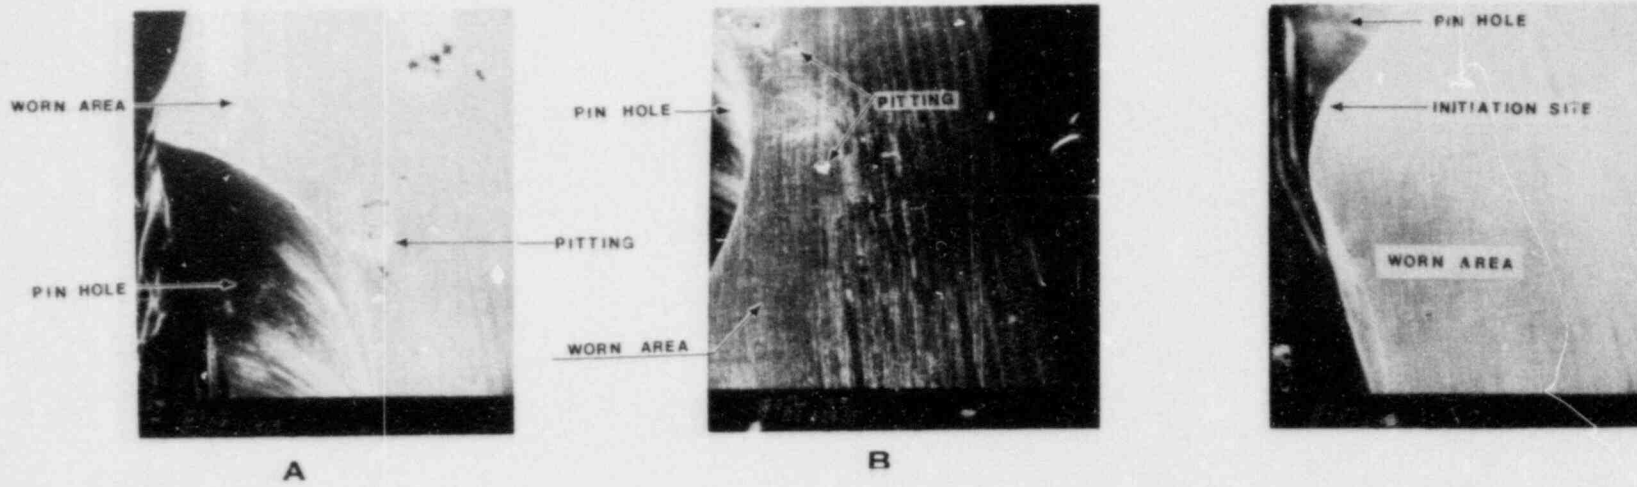
Figure 3.3-15. Shaft Surface Condition Near Cracked Pin Hole. View A on Octant 2 Side; B in Octant 81, Boundary; C on Octant 1 Side

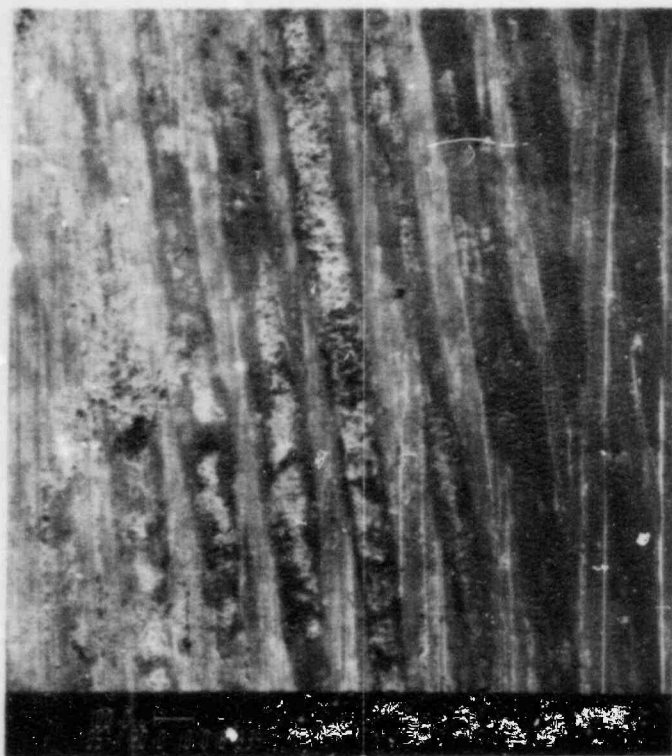
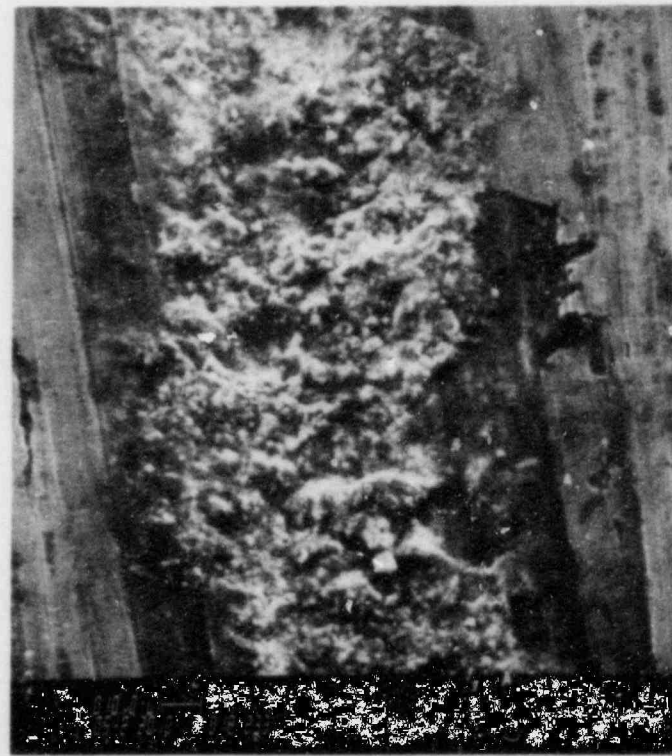
Figure 3.3-17. Debris or Corrosion Product Accumulation in Coarse Machine Marks
