TMI-1 REACTOR COOLANT PUMP SHAFT FAILURE ANALYSIS

RESEARCH AND DEVELOPMENT DIVISION
LYNCHBURG RESEARCH CENTER

SPONSORED BY
GENERAL PUBLIC UTILITIES

Lynchburg Research Center Report
RDD:84:5183-06:01

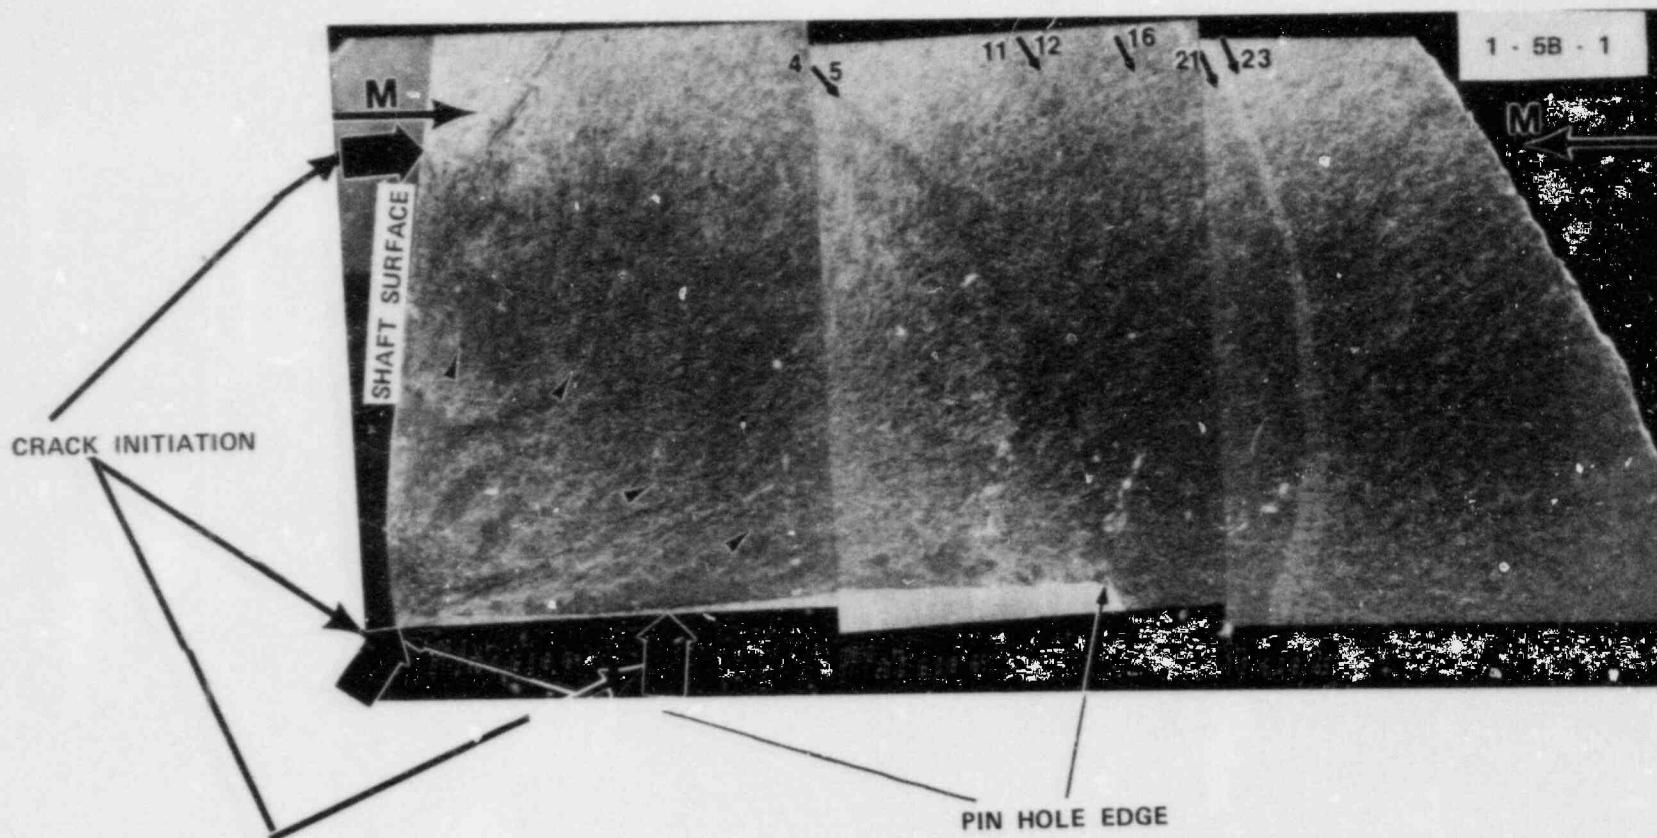
Figure 3.3-19. SEM Photomontage of Crack Initiation Area and Examination Path Along Line M-M. Prominent Crack Arrest Marks Seen by SEM Are Numbered

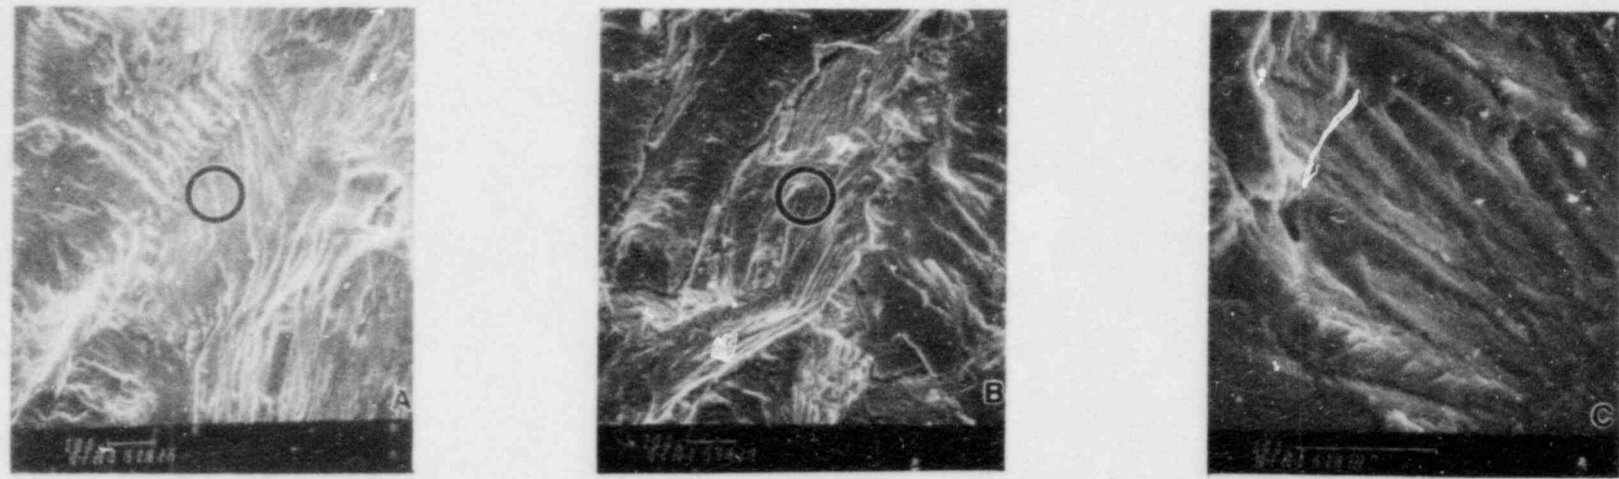
Figure 3.3-20. Typical Fractography in Crack Initiation Area. Locations A, B, and C Show in SEM Views of Initiation Area

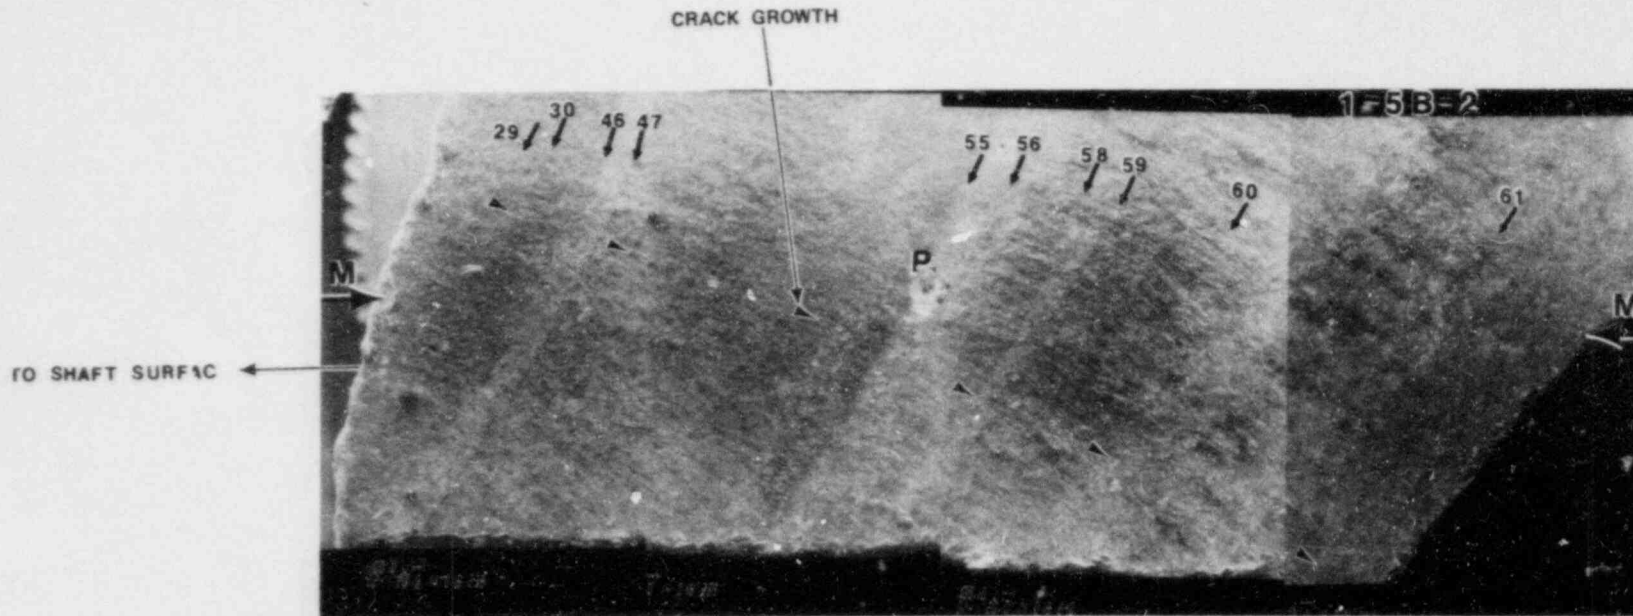
Figure 3.3-23. SEM Photomontage of Specimen 1-5B-2. Fracture Examination Along Line M-M. Prominent Crack Arrest Marks Are Numbered

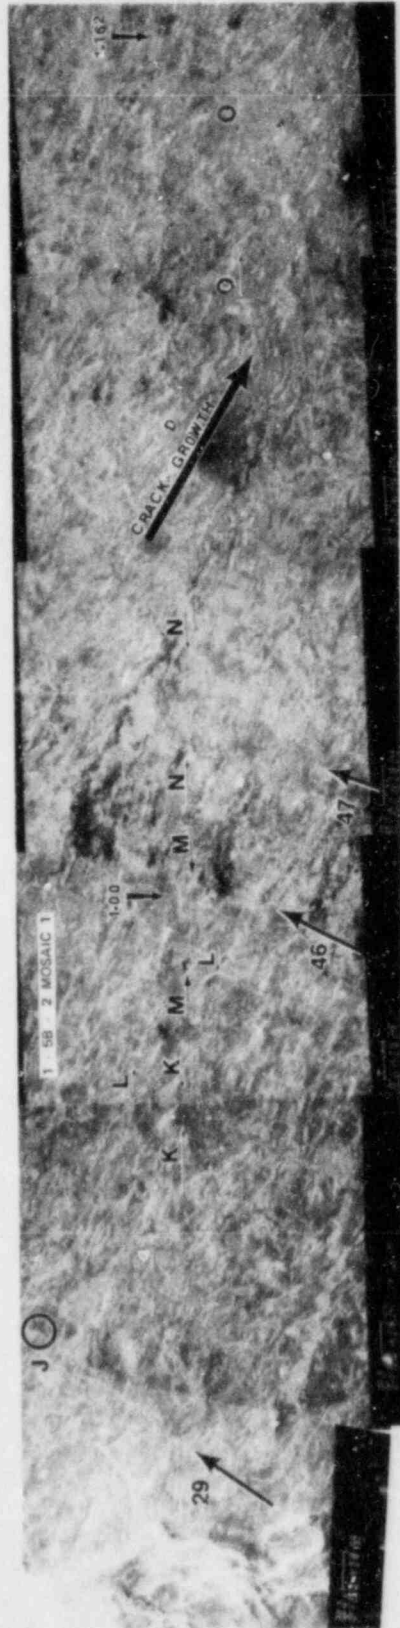
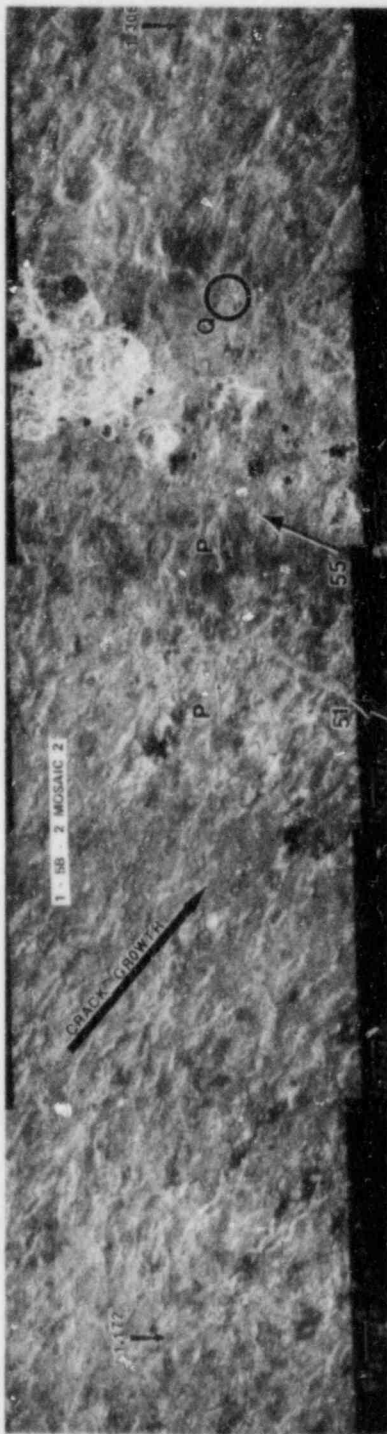
Figure 3.3-24. SEM Photomontages of Fracture Along Line M-M on Specimen 1-5B-2
A. Montage 1, B. Montage 2, C. Montage 3, Pitting Near P on Montage 2, D. Montage 4, E. Montage 5

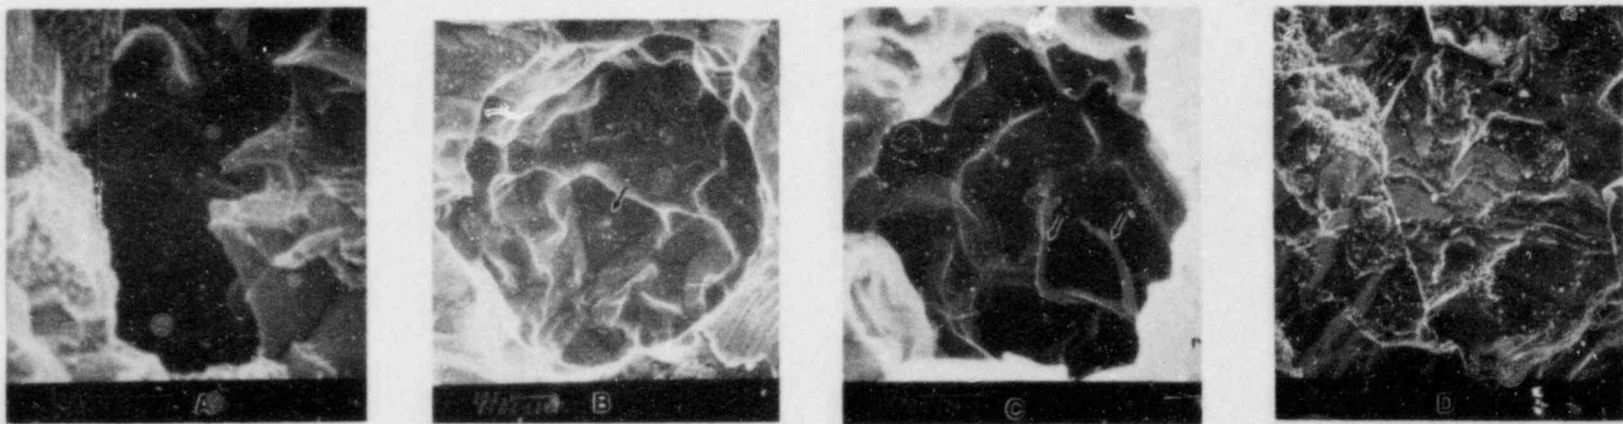
Figure 3.3-26. Typical Structure Inside Pits in Specimen 1-5B-2.
Arrows Show Inclusions or Inclusion Sites

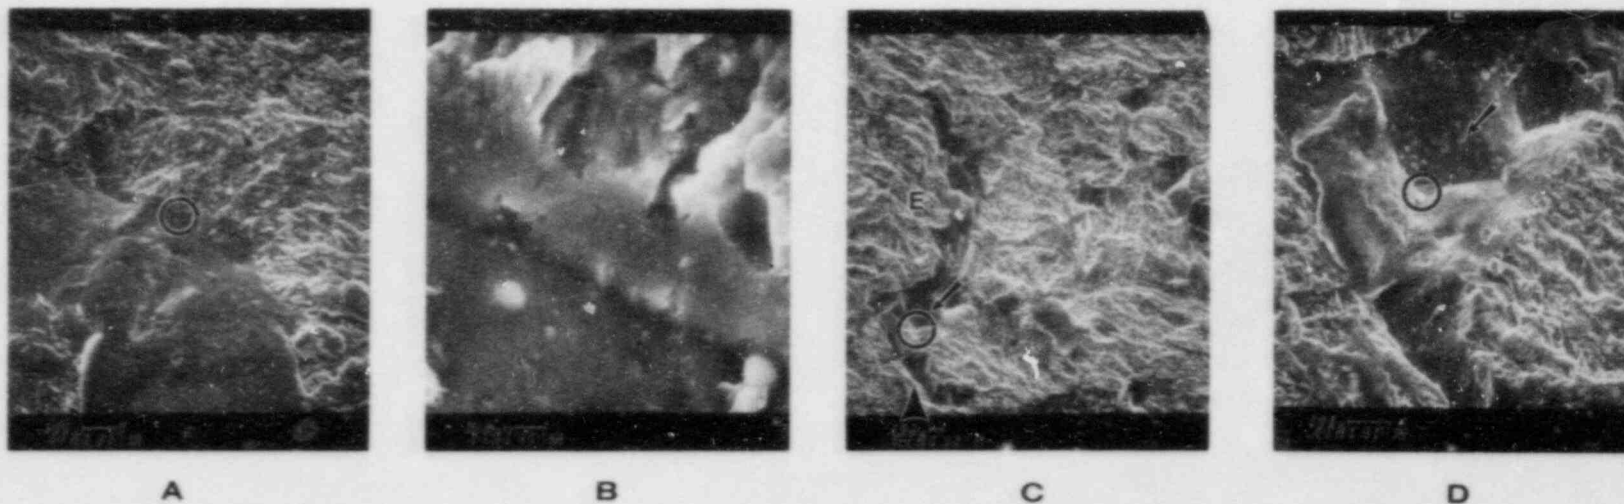
Figure 3.3-31. Typical Mixed Mode Fractography Seen on Specimen 10-13. Letter at Top of Photo Refer to Location on Previous Montage). Cleavage and Intergranular Separation Facets Occur in Colonies Surround by a Fine Transgranular Structure. A. Intergranular Separation, Enlarged in B, C. Intergranular Separation, Enlarged in D

E,F. Intergranular, Plus Some Cleavage
G. Enlarged View of F Showing Possible
Crack Arrest Points on Facet Surface
(Arrows)
