REPORT NO. DECO-12-2191

ENRICO FERMI ATOMIC POWER PLANT

UNIT NO. 2

**EVALUATION OF
CONTAINMENT COATINGS**

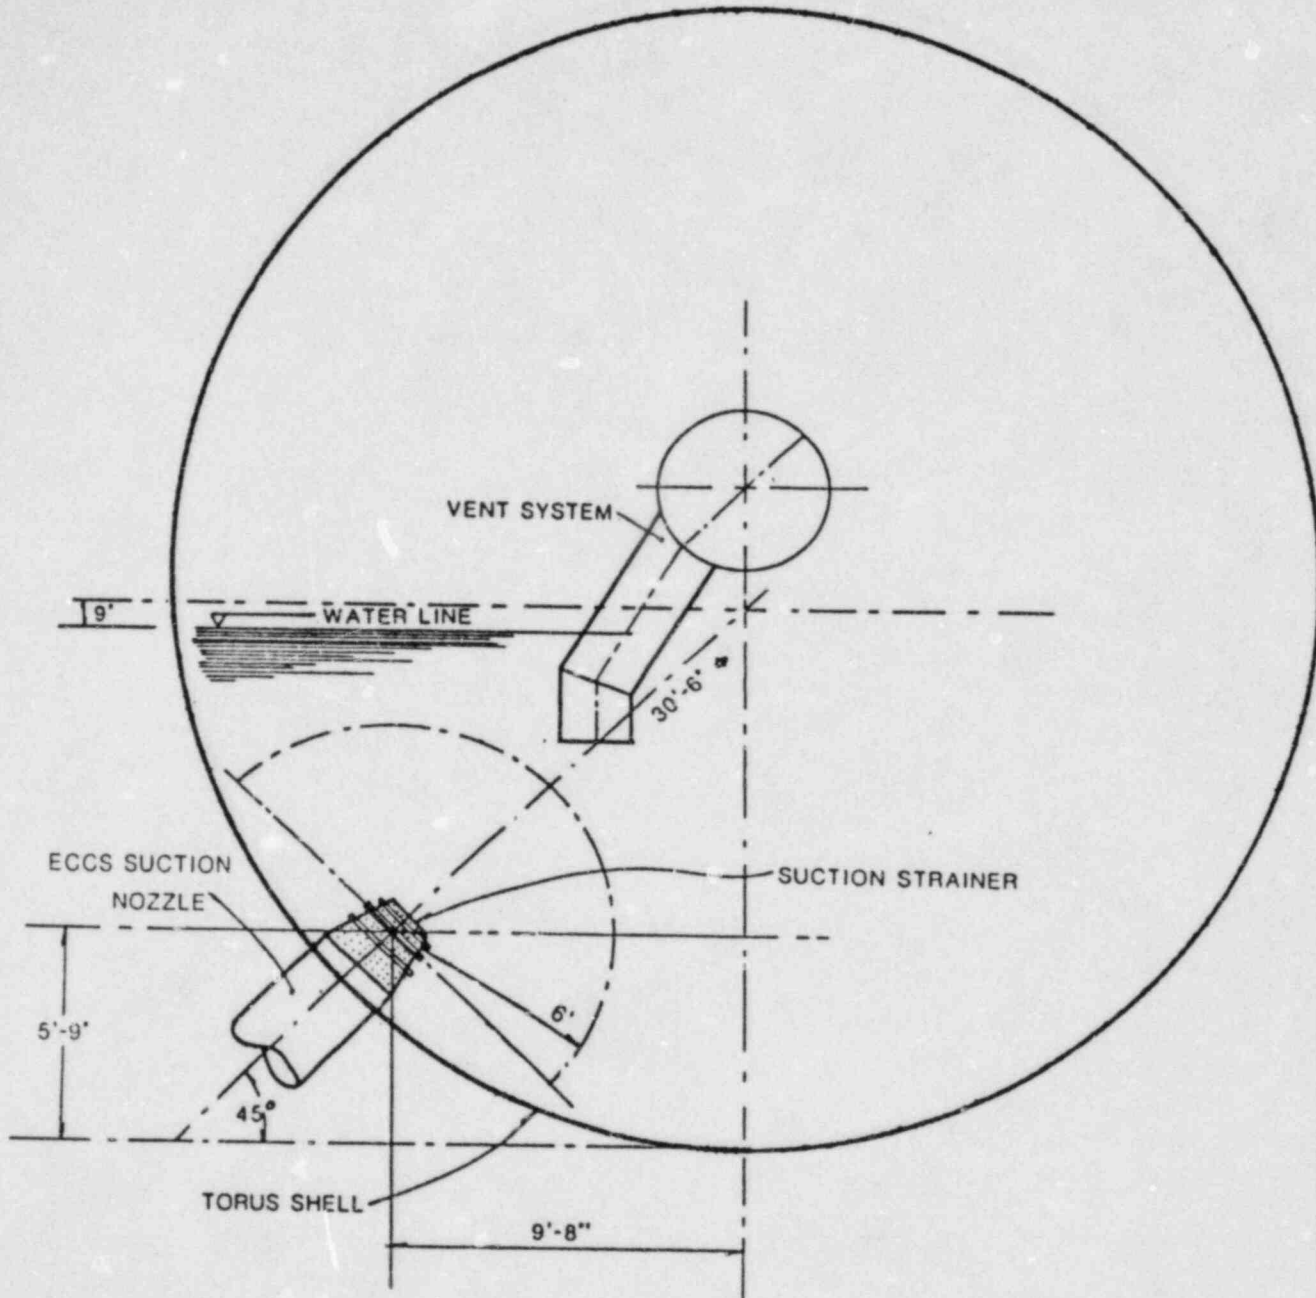
FIGURE 1

Average water velocities within the torus following the initial transient are below 0.25 ft/sec, but approach 0.3 ft/sec within a 4 foot hemisphere of the largest suction strainers at maximum RHR pump capacity. Refer to Figure 1 for the dimension and arrangement within the torus. The maximum surface velocity at the strainer surface was calculated to be 2.5 ft/sec. The strainer intakes are located 9'-8" from the center of the torus and 5'-9" above dead bottom. For these pool velocities hydroxide type particles are therefore not postulated to reach the strainers in a realistic situation.

ECCS SUCTION STRAINER LOCATION
