LICENSEE EVENT REPORT (LER)

FACILITY NAME (1) Fort St. Vrain, Unit No. 1	DOCKET NUMBER (2) 0 5 0 0 0 2 6 7	PAGE (3) 1 OF 1 1
---	--------------------------------------	----------------------

TITLE (4)
High Reactor Pressure Scram & Ensuing Control Rod Automatic Insertion Failures

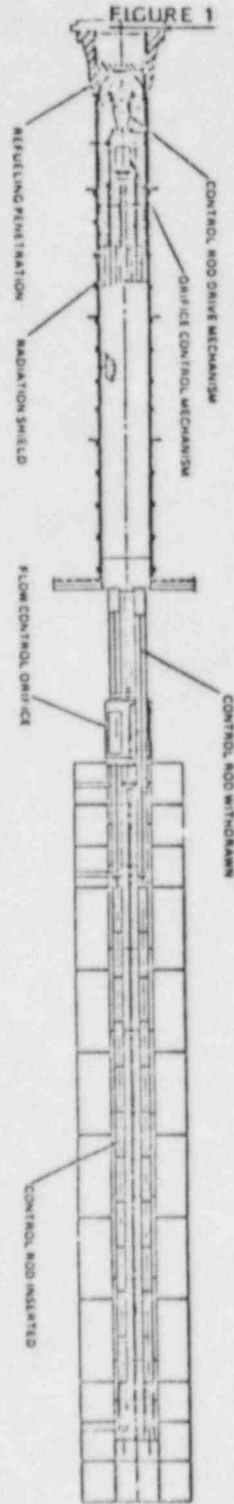
The control rod drives are essentially electrically powered winches, which raise and lower the control rods by means of flexible steel cables. Gravitational force acts to propel the control rods into the core during a scram, the free-fall speed being controlled by a velocity limiting system (Figure 1). All control rod drives are of identical design and have the same operating characteristics.

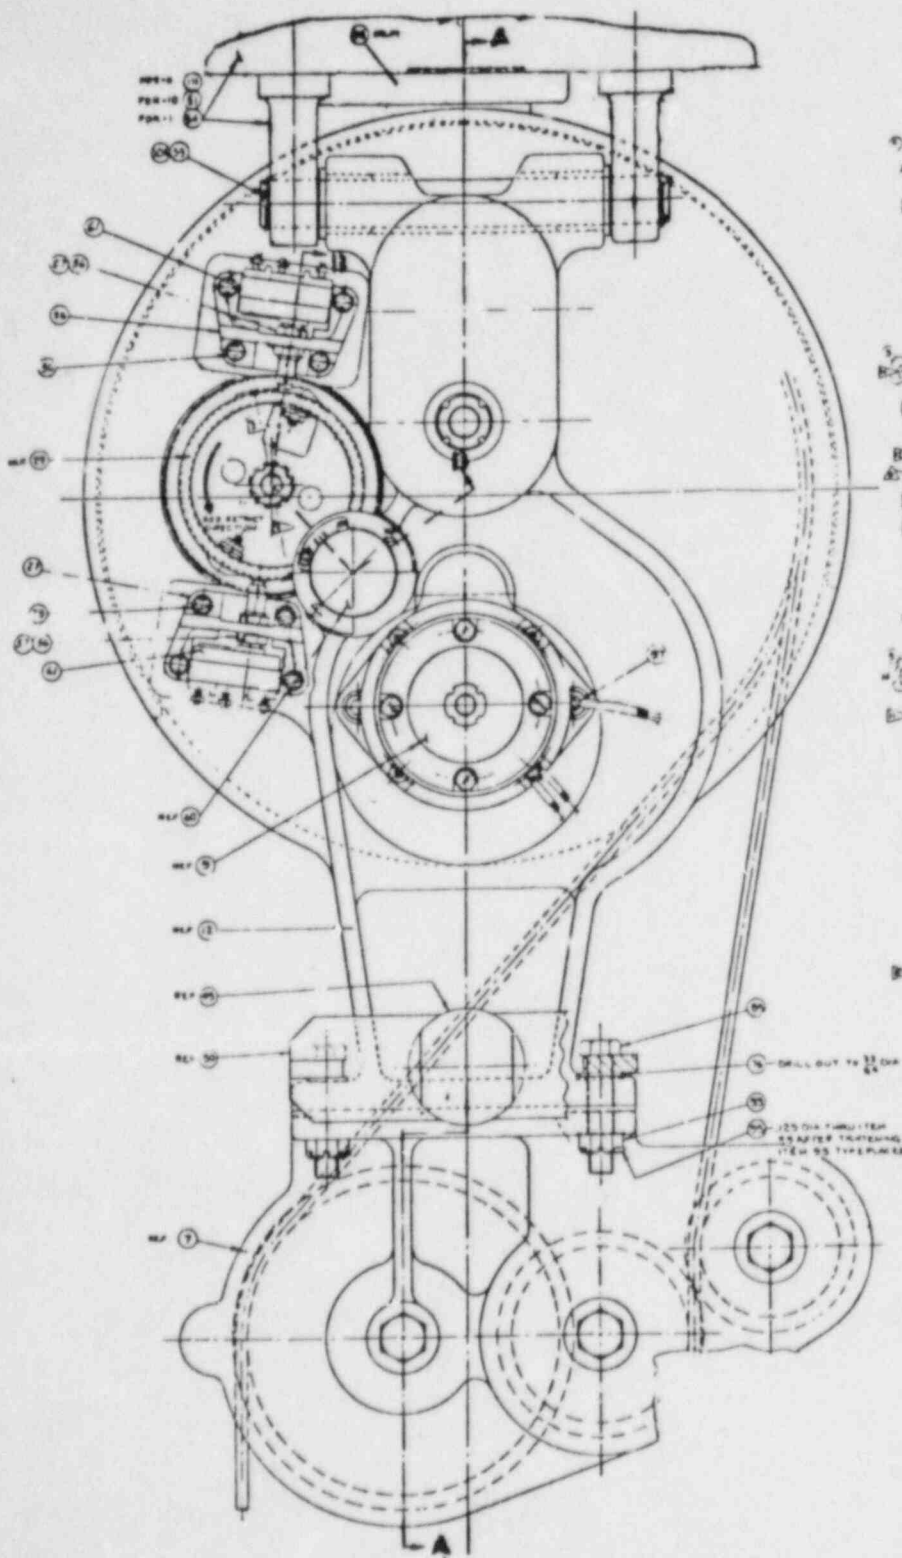
FIGURE 2

The control rod drive mechanism operates in a helium environment within the PCRV at reactor pressure (Figure 2). Ambient temperature is nominally maintained at approximately 150 degrees Fahrenheit by the refueling penetration cooling system and a thermal barrier between the drive and the reactor core. Shielding, interposed between the drive and the reactor core, limits the radiation level at the control rod drive to approximately 1 rad per hour. A helium-purge flow of about 5.5 pounds per hour floods the drive assembly and prevents the ingress of contaminated reactor helium coolant (Figure 3).

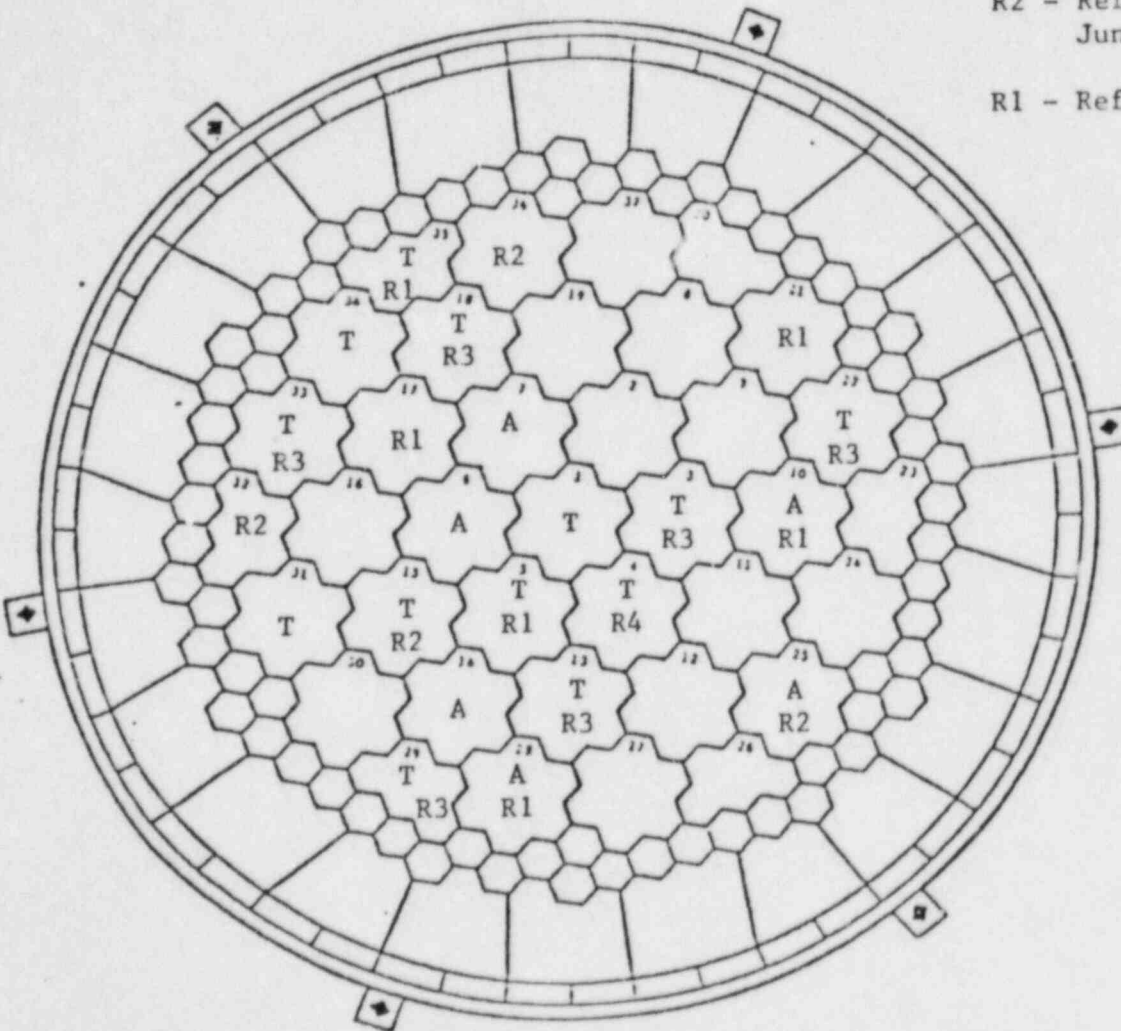
FIGURE 4

At 0029, with reactor power at 23% and being decreased, the reactor automatically scrammed on programmed vessel pressure high. Although the reactor was verified subcritical following the automatic scram, it was noted that 6 of the 37 control rods (in Regions 6, 7, 10, 14, 25, and 28) had failed to automatically insert and these were manually driven in over the following 20 minute interval (see Figure 4). A subsequent calculation using a computer code analysis (Gauge) verified that a shutdown margin of 0.0225 Δp ($K_{eff} = 0.976$) existed even with the above rods not scrammed. The Fort St. Vrain Technical Specifications consider 0.01 Δp to be an acceptable shutdown margin.

CORE MAP

A - Affected Regions
