LICENSEE EVENT REPORT (LER)

FACILITY NAME (1) Limerick Generating Station, Unit 2		DOCKET NUMBER (2) 05000 353	PAGE (3) 1 OF 6
--	--	--------------------------------	--------------------

TITLE (4) Reactor SCRAM and Actuation of Various Engineered Safety Features Resulting from a Relay Coil Failure and Inappropriate Action By a Licensed Reactor Operator.

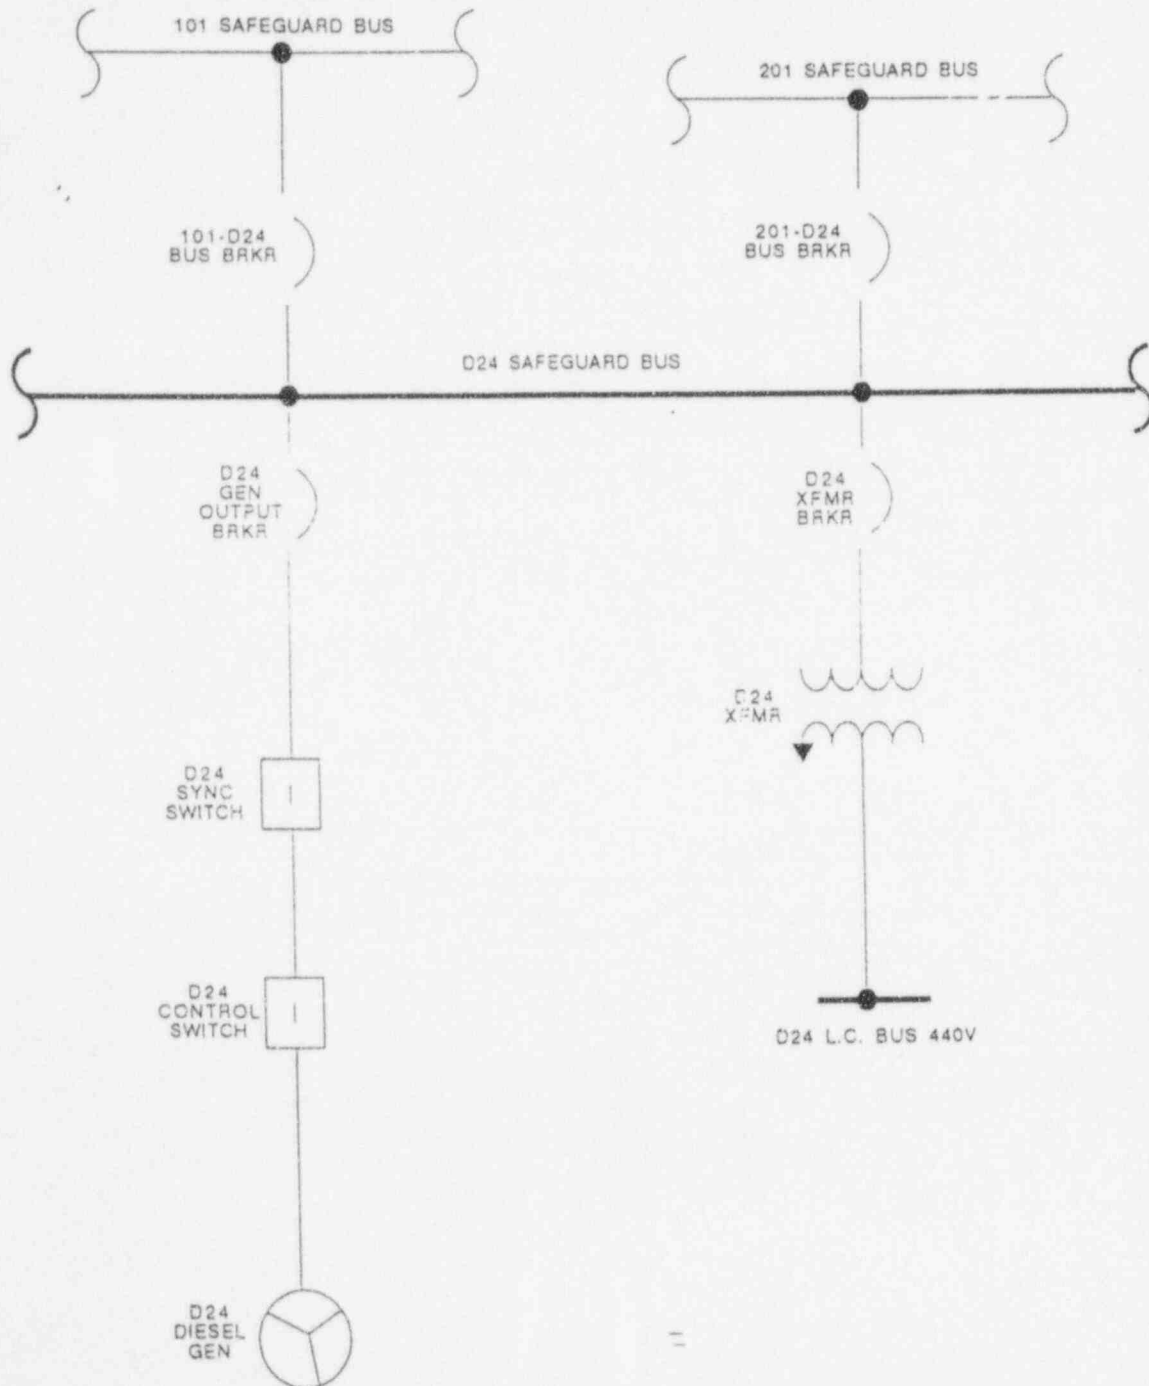
Attachment 1
D24 Diesel Generator Panel 2DC661 Arrangement

De-energization of D24 Safeguard Bus occurred due to an inappropriate action by a MCR LO when securing the D24 EDG following surveillance testing. This action requires manipulation of several handswitches on MCR panel 2DC661 (See Attachment 1, "D24 Diesel Generator Panel 2DC661

Arrangement"). The procedure directed the LO to open the D24 Generator Output Breaker, then place the D24 Control Switch to "STOP." Instead, the LO opened the 101-D24 Bus Breaker and the D24 Generator Output Breaker Switch, de-energizing the D24 Safeguard Bus. The LO did not verify that he was operating the correct switches. Had the procedure steps been performed as written, the bus would have remained energized.

3. The LO was disciplined for his failure to conform to the management expectation to ensure that he manipulates the correct equipment, in accordance with approved procedures.

4. Long term initiatives to enhance human performance and self checking behaviors of plant personnel are in place and continue.
