LICENSEE EVENT REPORT (LER)

FACILITY NAME (1) Fort St. Vrain, Unit No. 1 DOCKET NUMBER (2) 050002671 OF 015 PAGE (3)

TITLE (4) Inoperable Loss Of Bearing Water Switch - LCO 4.4.1

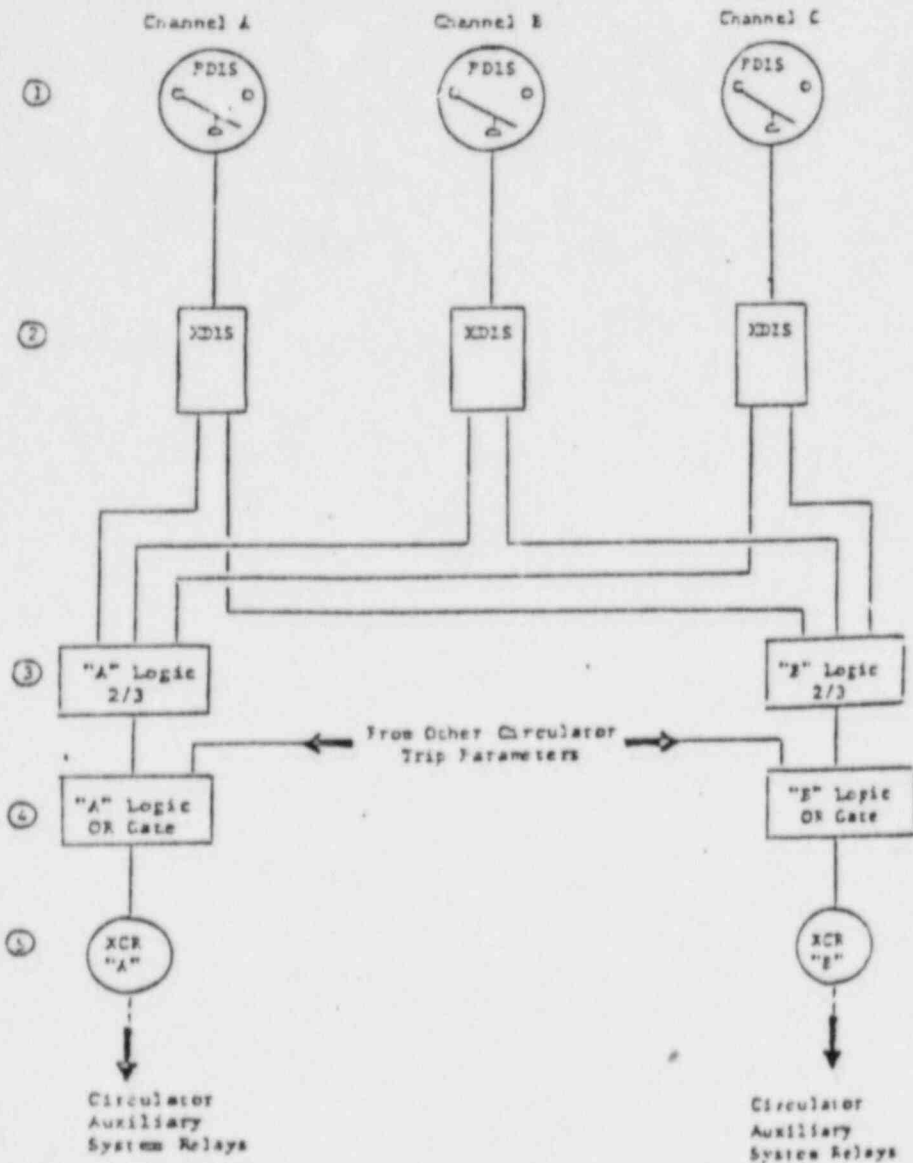
FIGURE 1

During performance of a scheduled surveillance calibration, with the plant shutdown for refueling and routine maintenance, one of three pressure differential indicating switches (PDIS-21175) was found inoperable. LCO 4.4.1, Table 4.4-3, specifies a trip setting of equal to or greater than 475 psid. The switches act to trip the circulator on sensing a pressure differential of less than 475 psid, indicating a loss of bearing water flow.

Referring to Figure 1, as the pressure differential between the water supply cavity and the main drain decreases, the pressure differential switches (PDIS) ① will individually close at their respective setpoints. This applies a voltage to the switch input modules (XDIS) ②, tripping them. Each tripped XDIS module transmits a signal to both "A" and "B" logic channels ③. When either "A" or "B" logic receives inputs from any two of the three XDIS modules they will transmit a signal to the "A" or "B" logic OR gate ④ respectively. The OR gates transmit any input signal to the respective special control relay (XCR) ⑤ to energize auxiliary relays which trip the helium circulator and initiate the following helium circulator protective actions:

Upon investigation of the instrument internals, the high alarm micro switch was found inoperable and incapable of generating a protective action signal. Failure of pressure differential indicating switch, PDIS-21175, is attributed to an accumulation of dirt and oil on the switch. Pressure differential indicating switch PDIS-21175 is manufactured by ITT Barton Model No. 288A.

The faulty micro switch was replaced and calibrated to a trip setting of 482 + 10 - 0 psig. The replacement switch was manufactured by ITT Barton, PSCo. N. Tag 14196, P.O. No. N-2834B, Switch No. 0257-0008-B.

The Public Service Company Nuclear Engineering Division has investigated the problems experienced with the ITT Barton pressure differential switches, and has recommended the replacement of the switch assemblies with electronic transmitters and bistable switches. Due to the nature of this modification, an extended shutdown will be required. Therefore, replacement of the ITT Barton switches has been scheduled to occur during the fourth refueling outage.
