LICENSEE EVENT REPORT

REPORTABLE OCCURRENCE 80-58

FORT ST. VRAIN NUCLEAR GENERATING STATION  
PUBLIC SERVICE COMPANY OF COLORADO  
16805 WELD COUNTY ROAD 19 1/2  
PLATTEVILLE, COLORADO 80651-9298

REPORT NO. 50-267/80-58/03-X-1

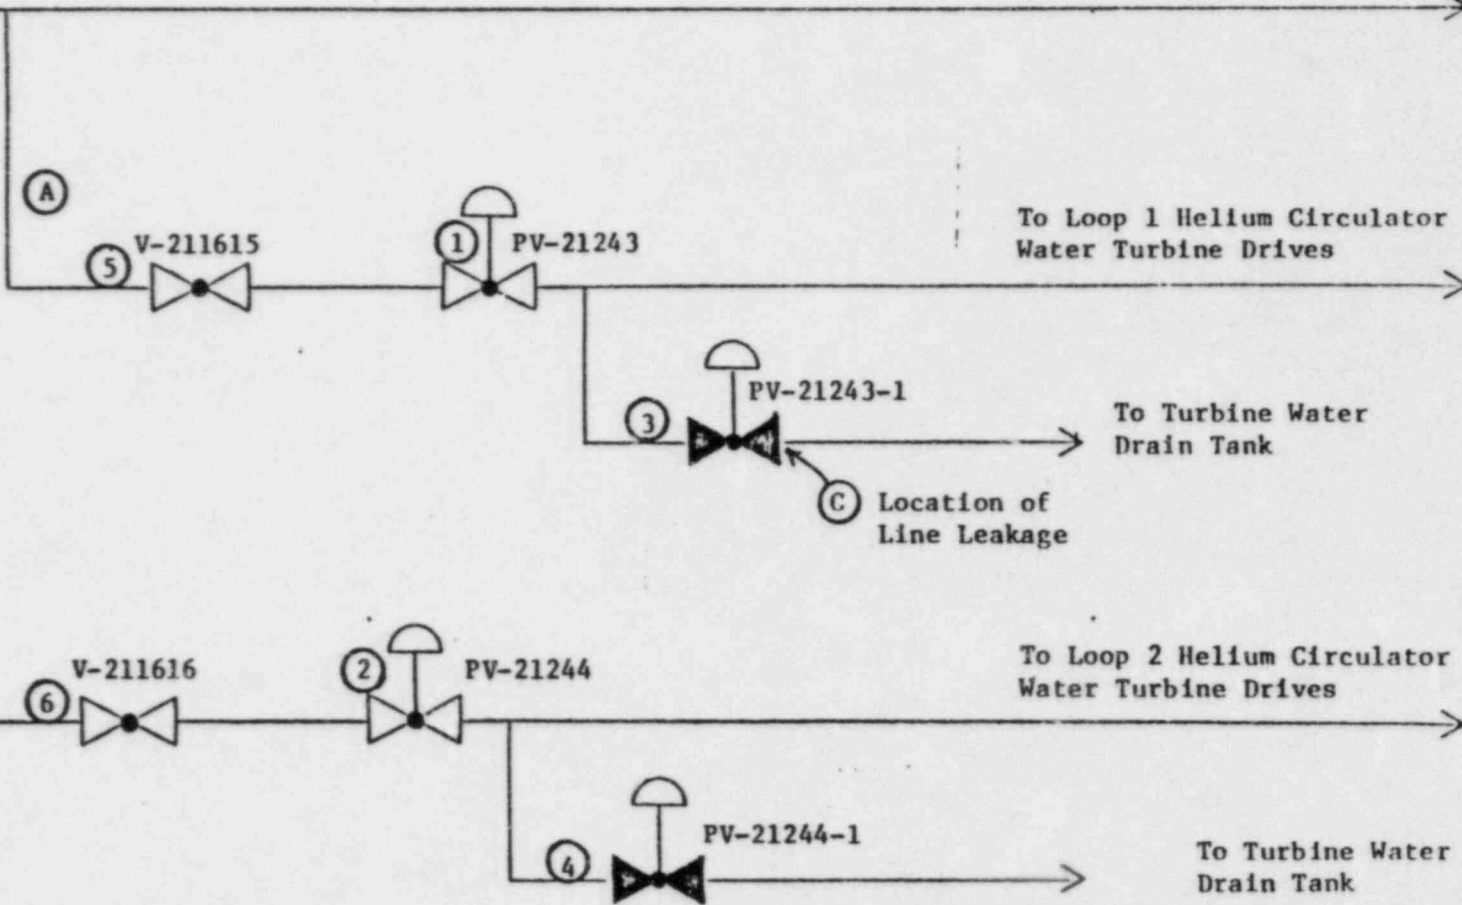
FIGURE 1

| On October 9, 1980, graveyard shift, with the plant operating at 27%
| thermal power and approximately 65 MWe, Operations personnel
| performing routine rounds observed a leak at the line between
| PV-21243-1 and the turbine water drain tank (see point C ) of
| Figure 1). The line was isolated at 0830 hours to begin repair work.

- | Component Failure.
- | The line leakage was determined to be a result of erosion caused by high pressure/temperature water.

(C) Location of Line Leakage

Separate valves ( ⑤ and ⑥ ) are provided for isolation of each loop. During isolation of the Loop 1 system, a 1/2" pipe nipple was replaced. Repairs were completed by 1830 hours, and the system returned to service within the 24 hours allowed by the LCO.

- | The emergency feedwater header to the Loop I helium circulator water turbine drives was isolated, the defective portion of piping replaced, and the system returned to service within the time allowed by LCO 4.2.2.
- | Public Service Company Change Notice No. 1421 installed bolted flanges downstream of the pressure control valves to facilitate any future valve or piping repair work.
- | Public Service Company Change Notice No. 1687 changed the valve body of PV-21243-1 and PV-21244-1, and a portion of the downstream piping from carbon steel to stainless steel, as stainless steel is much more erosion resistant.
- | No further corrective action is anticipated or required.
