U.S. NUCLEAR REGULATORY COMMISSION
REGION I

Report No. 50-443/84-12
50-444/84-06

Facility Name: Seabrook Station, Unit 1 and 2

Inspection Summary: Inspection on August 13-17 and 27-31, 1984 (Inspection Report 50-443/84-12 and 50-444/84-06)

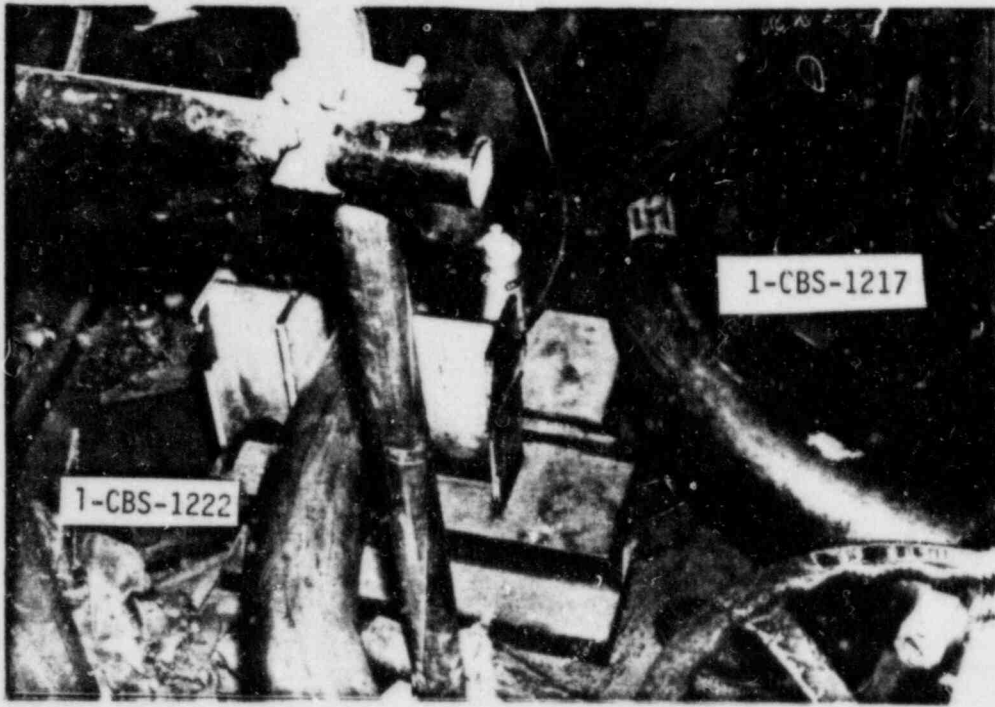
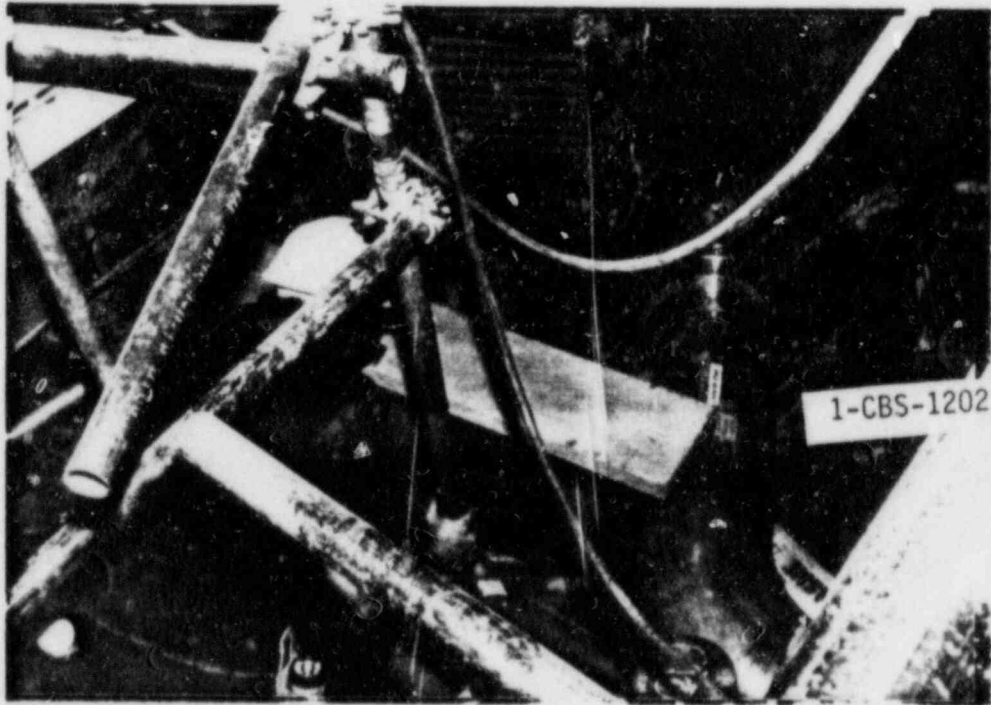
PIPE LINES CONNECTED TO RWST 1-CBS-TK8

A) TWO 4" DIAMETER PIPE LINES

B) LARGE 14" DIAMETER PIPE LINE

The staff measured the pipe bends and found them to be five (5) diameter bends as identified on the isometric drawings. The minimum, wall thickness prior to bending was in compliance with the requirements of ASME III, Table NC-3642.1(c)-1 and NC-3644 as verified by staff calculations and field measurements.

The visual inspection of these lines revealed no creases, wrinkles, flat spots or any other defects that would have been induced by improper fitup. The ovality was within specification limits and code requirement of less than 8% (NC 4223.2). At the bend area in both 4" pipes, ultrasonic measurements showed wall thinning at the outer bend radius due to the bending process. There was also slight out of round at the bend area of the two 4" lines but both were within code limits. The code recognizes that pipe wall thinning occurs and some out-of-round will result at bend areas and therefore provides a tolerance for these as specified in NC 4223.1 and Table NC 3642.1(c)-1.

The staff could not identify any defects in the as-built system to substantiate the allegor's concern related to improper fitup of 1-CBS-1222, 1-CBS-1217, or 1-CBS-1202. Independent measurements verified requirements were met for ovality and wall thickness. No evidence of cold spring was detected.

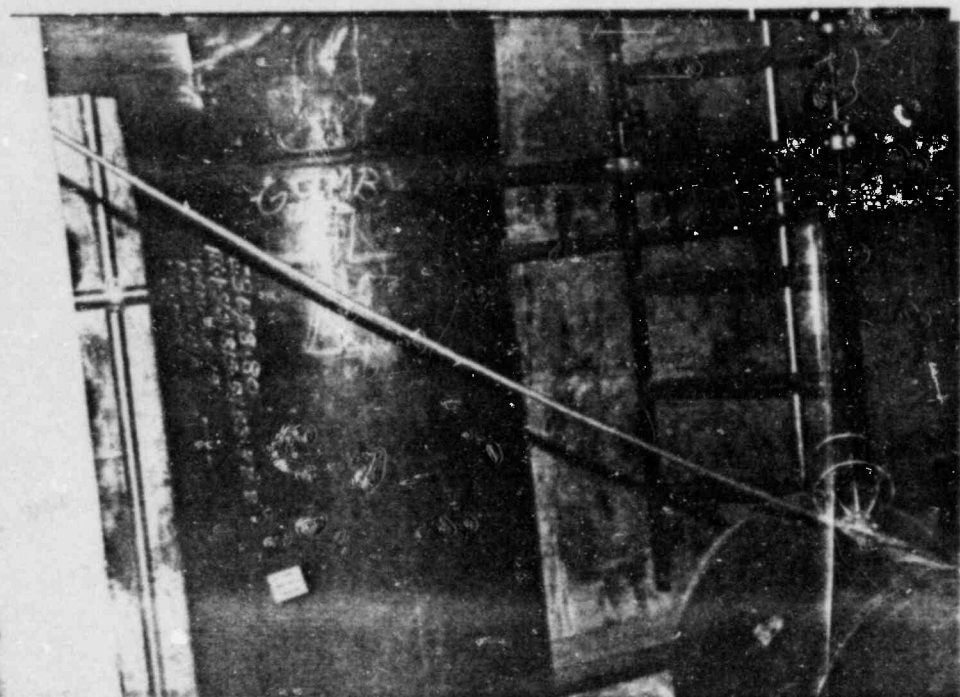
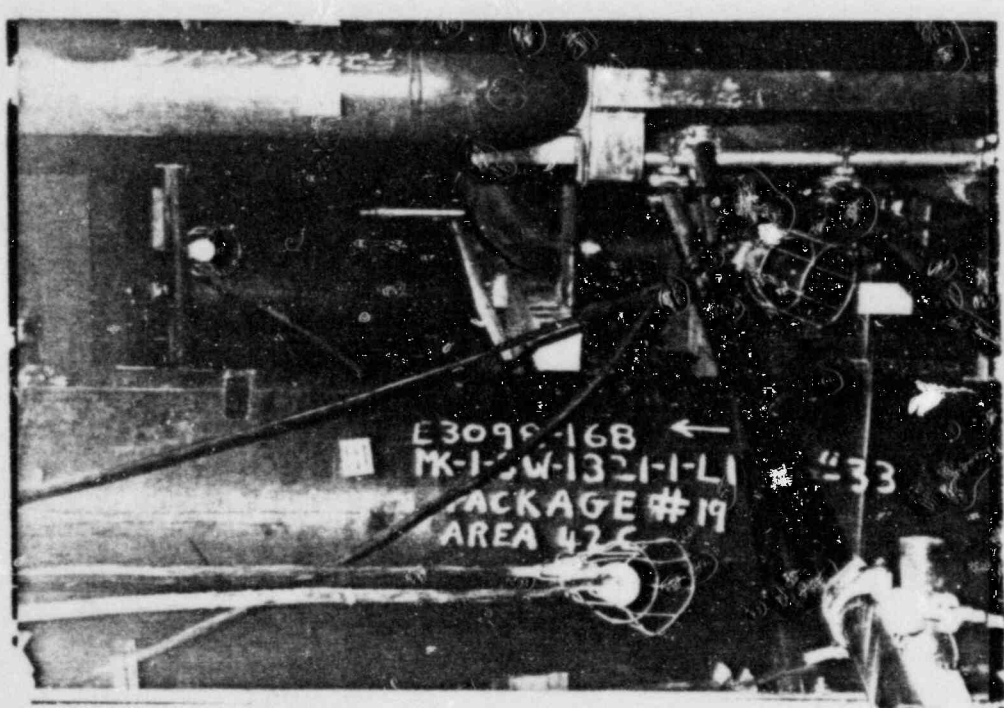
FIGURE 5-1

FERRO-CEMENT LINES-SERVICE WATER PIPE

The inspector entered the 42 inch diameter line 2-SW-1825 thru the opening for SW valve V-46 and observed the cement lining and junctions at weld seams for approximately 40 feet. The lining did contain hairline cracks although these were of width much less than the 1/32" acceptance criteria in paragraph 3.5.3.10.6 of Specification 248-2. The lining at weld joints was noted to be smooth and merged with the pipe lining.

The staff concluded that cracking of the service water pipe cement lining although unlikely could occur if excess force was applied to the pipe. In addition it is possible that cracks could occur due to mishandling during transportation.

However, the crack criteria, final internal inspections subsequent to fitup and welding, and repair criteria provide reasonable assurance that cracks exceeding the 1/32" criteria, no matter what the source, would be detected and repaired.

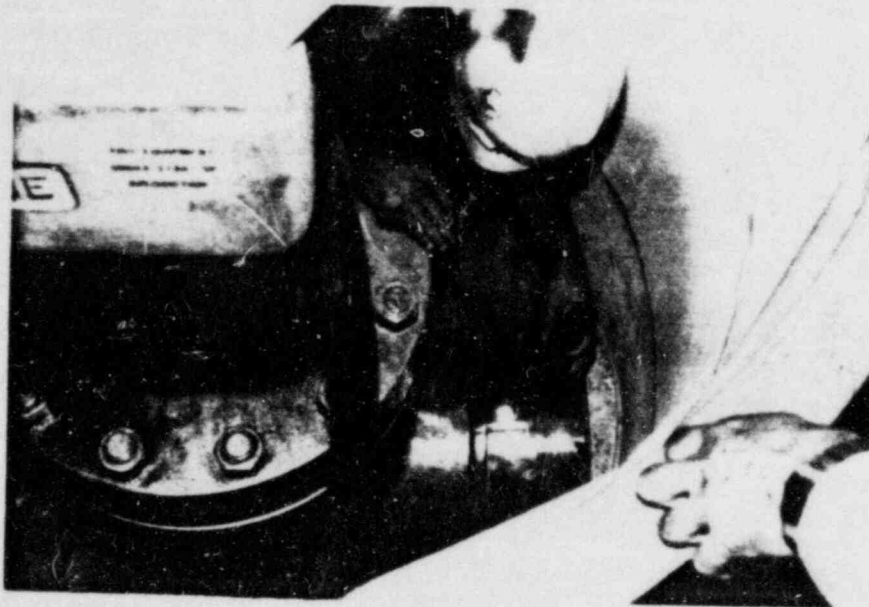
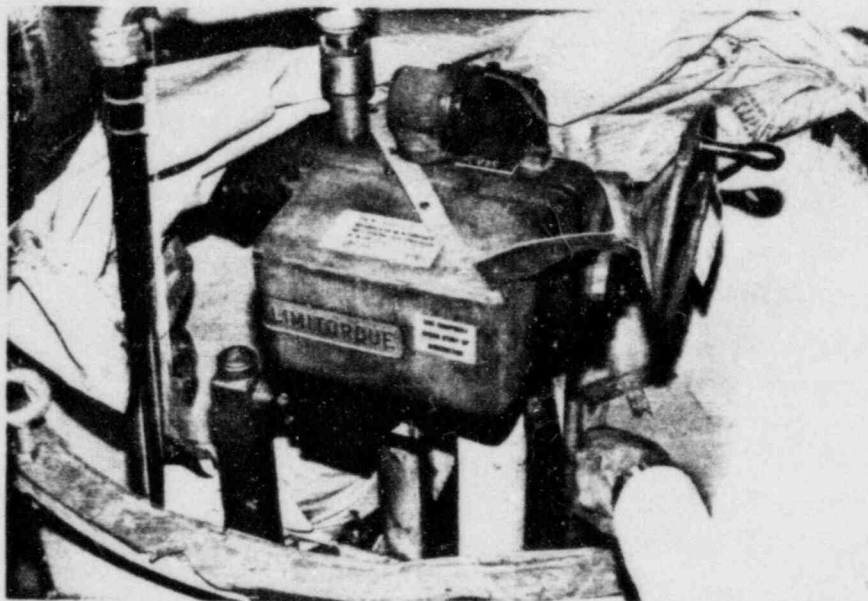
CONTAINMENT BUILDING SPRAY (CBS) LINE VALVE

The CBS-1211 and 1212 lines specified in the allegation are ASME Code Class 2 lines which are governed by the requirements of NC-4230. Visual, ultrasonic and radiographic examination of specific welds on the CBS lines did not disclose violations of the NC alignment requirements. See Figure 7-1.

Two CBS welds, F0204 and F0206, on CBS lines 1211 and 1212 respectively were radiographed and interpreted by the NRC inspection team. These welds were found to be acceptable and without evidence of excess local pipe material removal. A sample of licensee radiographs of welds in the CBS lines was reviewed by the staff and found to meet requirements.

A) NRC INSPECTING VALVE-TO-PIPE WELD ON 1-CBS-1211

B) TOP VIEW OF 1-CBS-1211 MOV SHOWING VALVE LOCATION
INSIDE ENCAPSULATION TANK

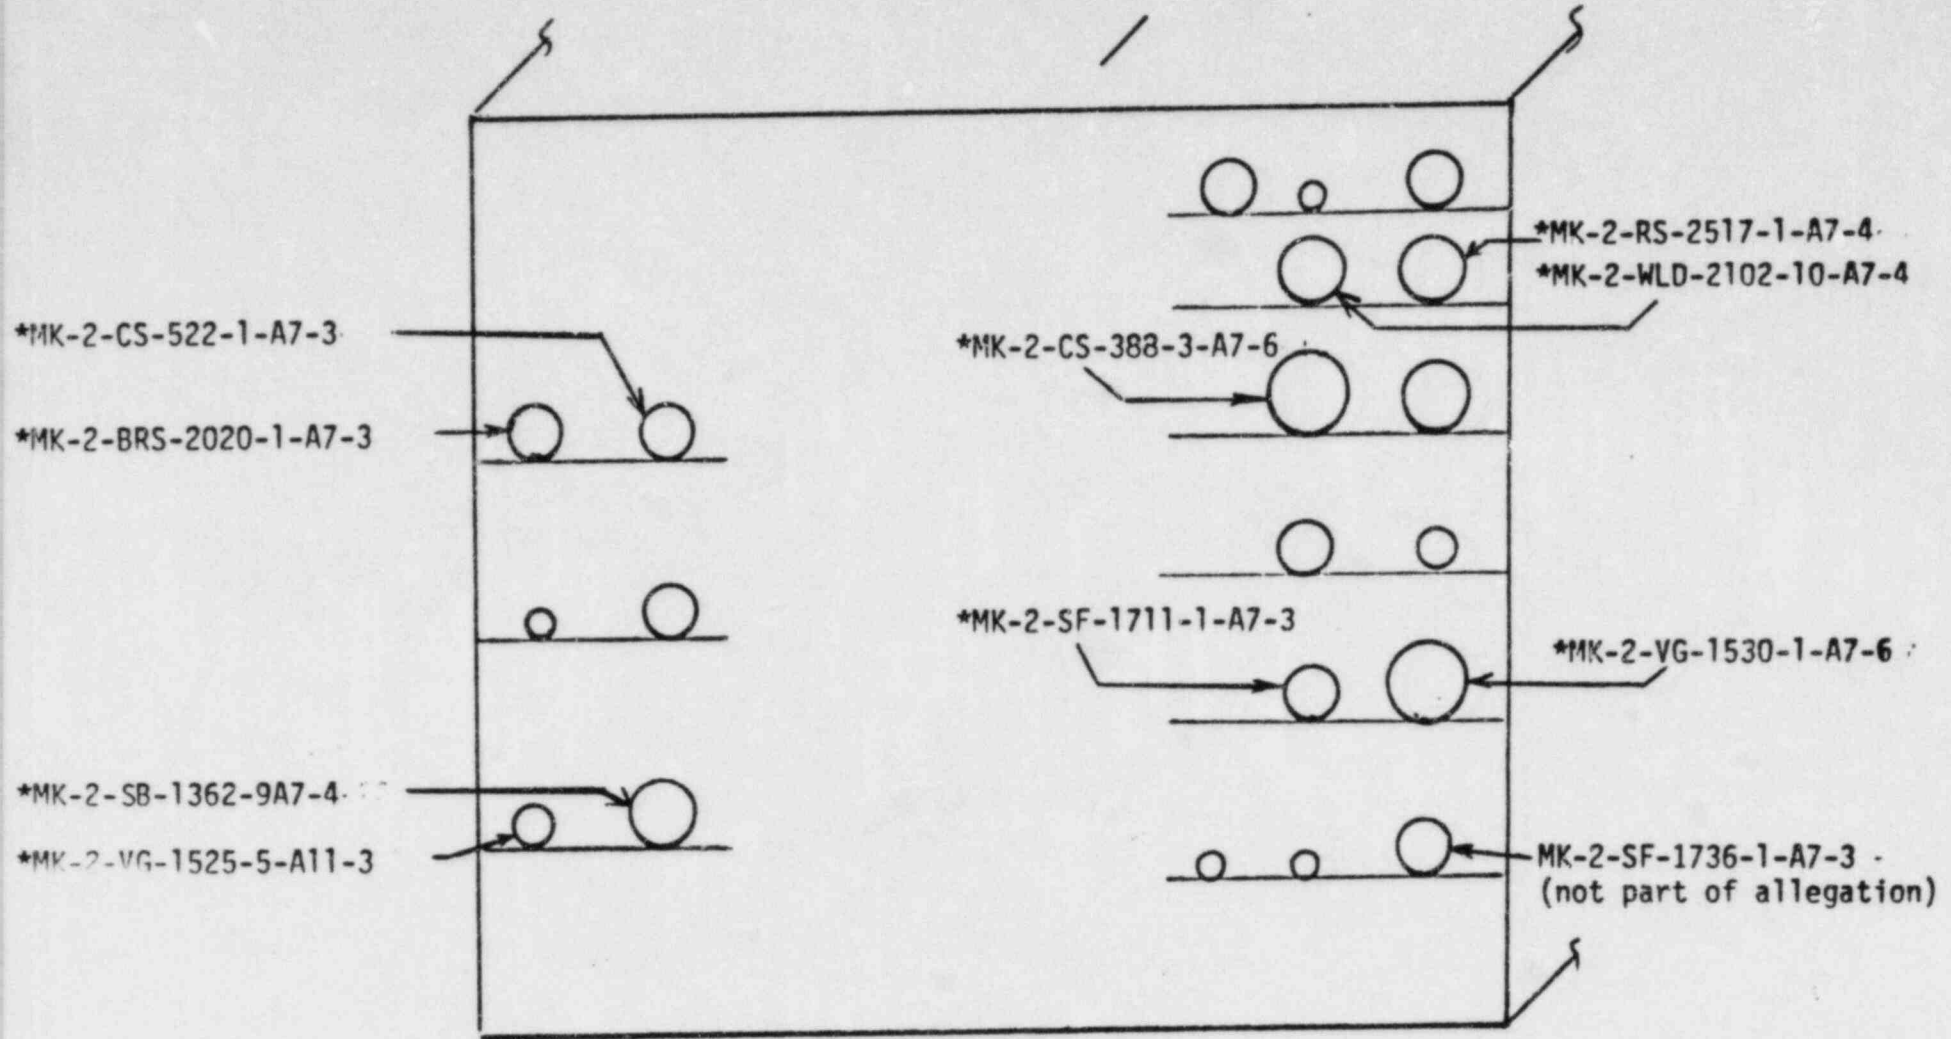
Cross Section of Tunnel Showing Pipe Runs Identified by Allegor and Inspected by NRC Staff (ALL PIPES ARE NON SAFETY RELATED)

The pipes identified with an asterisk in Figure 8-1 were inspected. The outside pipe diameters were measured by calipers, to check ovalities at the welds and 3" on either side of the welds. Visual examinations were made of the piping and welds to check for defects or nonconformance with ANSI B31.1 requirements. Weld gauges were used to measure offsets, heights and pipe alignments for concentricities on the welds. Mirrors were used to examine the internal surface of pipe welds where they were accessible from open pipe ends. Confirmatory calculations to verify compliance with code minimum wall thickness requirements were made by the staff and compared with NDE van independent measurements.

The staff did not identify any unacceptable pipe conditions. All pipes met ovality/concentricity requirements and no violations of minimum wall thickness (less than 12½% of nominal wall) were observed. Alloy analysis confirmed that stainless steel pipe met specifications.

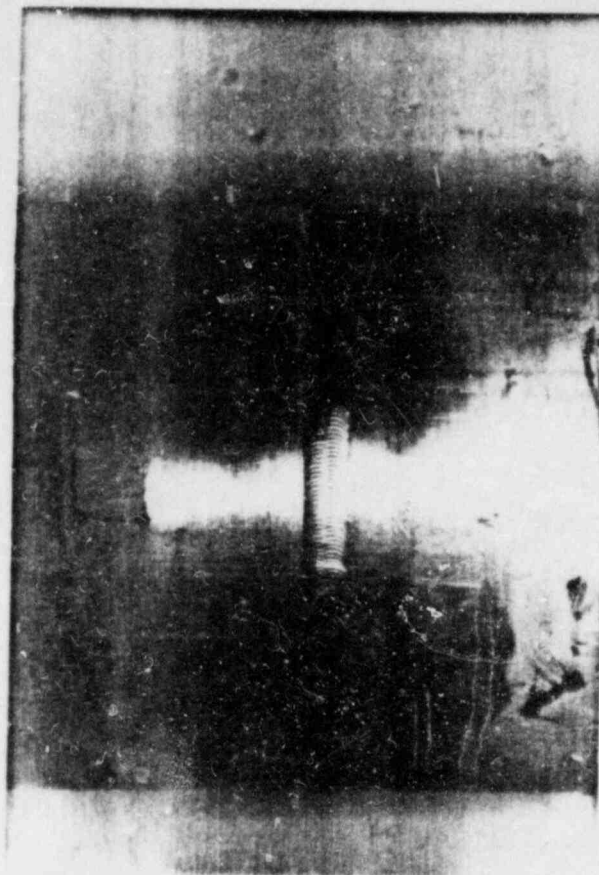
WELDS INSPECTED IN WPB PIPE TUNNEL

A typical Dimetrics weld in the WPB is shown in Figure 8-2B. The Dimetrics machine-made welds were of exceptionally high quality and uniformity (See Figure 8-2A for a comparison with a typical manual weld). Visual and liquid penetrant examinations verified acceptability. Internal examination of welds accessible from the open pipe ends by mirrors and flashlights did not reveal any unconsumed roots. Ultrasonic examination at the weld did not show any significant variation across the weld volume. Normal weld shrinkage occurred at the weld-to-pipe interface. A few welds exhibited some external discoloration but this was of no significance.

A) TYPICAL MANUAL WELD

B) TYPICAL DIMETRICS AUTOMATIC
MACHINE WELD
(Note Uniformity)

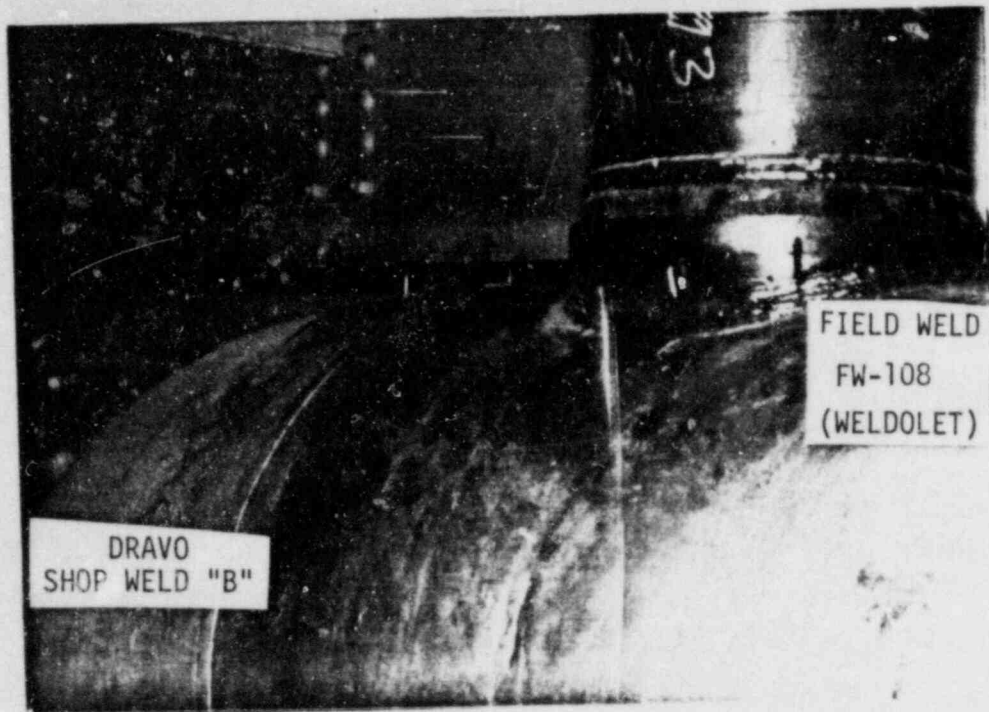
LINE NO. EX-4125-01-REV/1 --- MAIN STEAM EXTRACTION PIPE

A) CLOSE UP VIEW FROM ANGLE

B) VIEW STRAIGHT ON OF SHOP WELD "B"

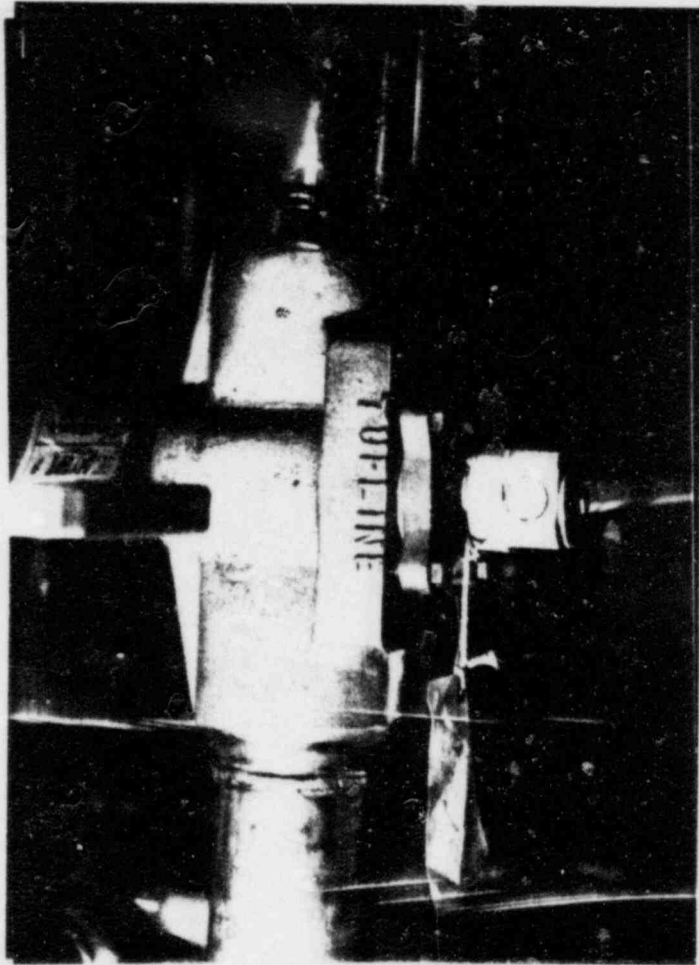
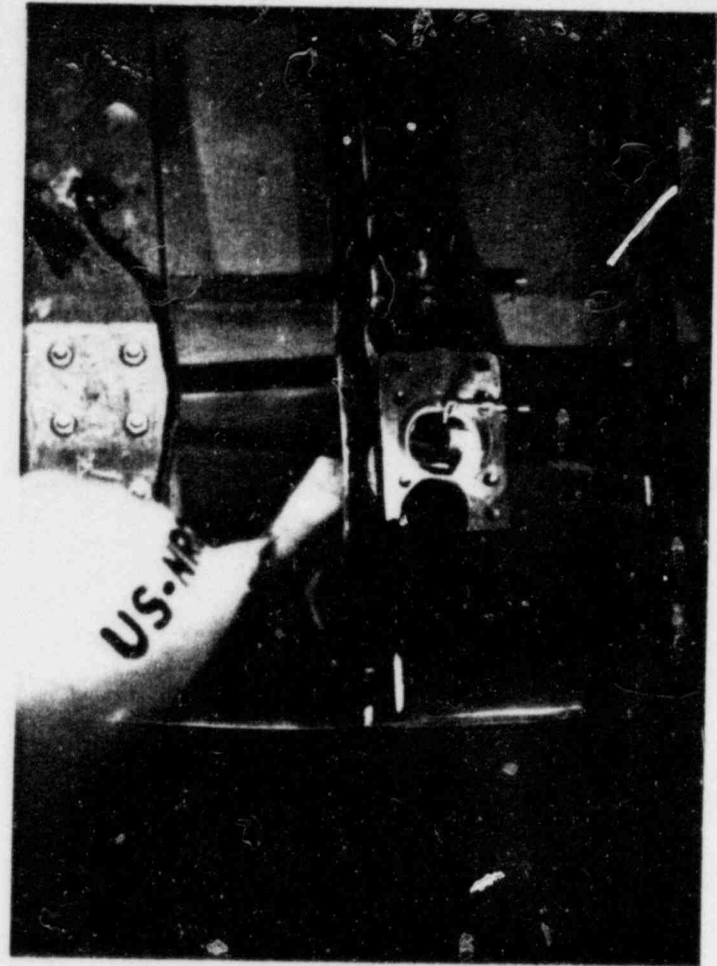
A) TYPICAL TUFLINE VALVE WITH TEFLON SLEEVE INSTALLED IN WPB AREA

B) NRC STAFF TEAR DOWN AND INSPECTION OF TUFLINE VALVE INTERNALS

Valve No.	Classification	Location	External Visual	Internal	Functional	Conclusion
2-VG-V-0085 (Vertically mounted)	Non-Safety	WPB	Fully welded slight rust at lower weld no defects observed in weld or valve	Complete Disassembly Valve Plug - No Damage Welds - Excellent	Manual Operation Completely Functional	No damage to valve internals General quality very high
2-CSV-0765 (Horizontally mounted)	Non-Safety	WPB	Fully welded Little discoloration. No defects observed in weld or valve	Complete disassembly Valve Plug - No damage Plastic sleeve - no damage Welds - Very Good	Manual Operation Completely Functional	No damage to valve
1-VG-V-0061 (Horizontally mounted)	Non-Safety	WPB	Fully welded slight rust in weld zone. No defects observed	Partial disassembly No damage to the diaphragm	Manual Operation Functionally OK	No damage to valve
BRS-2-V448 (Horizontally mounted)	Non-Safety	WPB	One end of valve welded to pipe No external defects	Access to valve from open end. No defects observed	Manual Operation Functions OK	No damage to valve

BRS-2-V548 (Horizontally mounted)	Non-Safety	WPB	One end of valve welded to pipe No external defects	Access to valve from open end No defects observed	Manual Operation Functions OK	No damage to valve

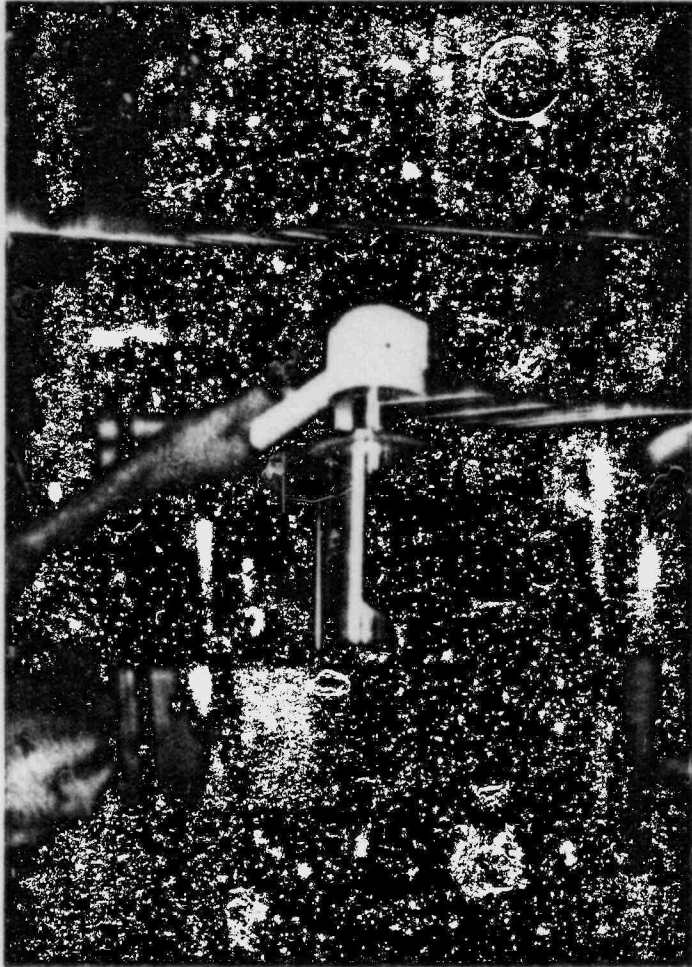
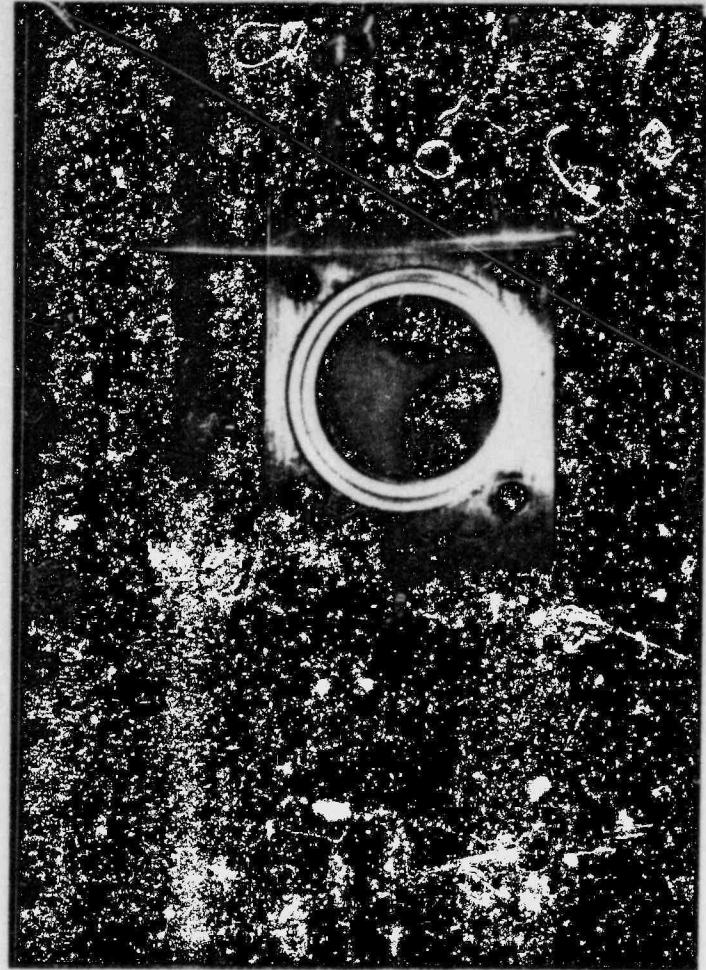
CLOSE-UP OF TUFLINE VALVE INTERNALS

A) VALVE PLUG
No Damage

B) VALVE SEAT - TEFLON SLEEVE
No Damage

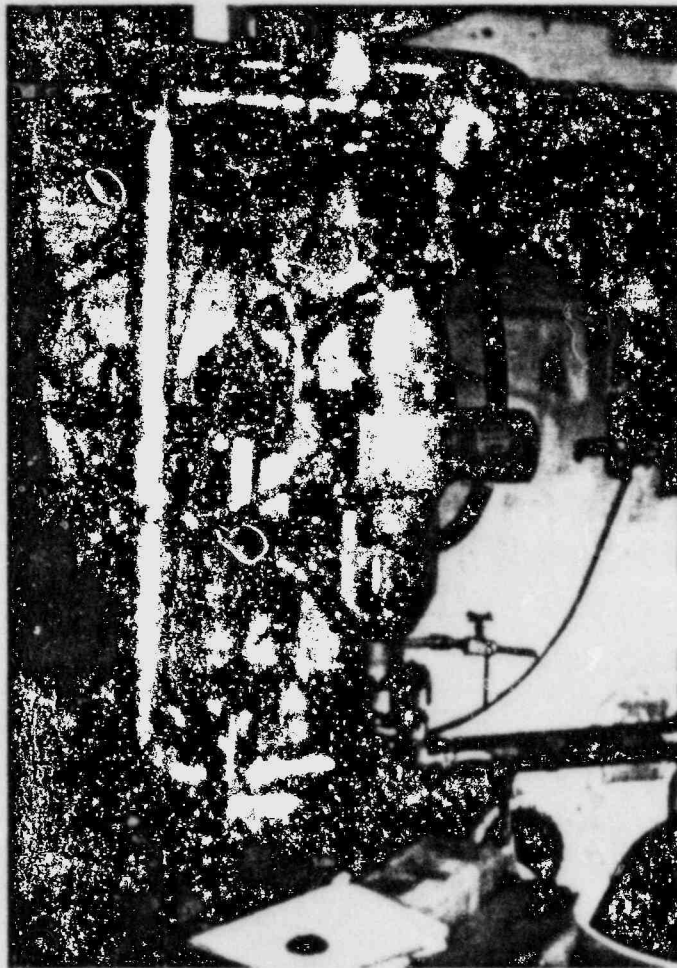
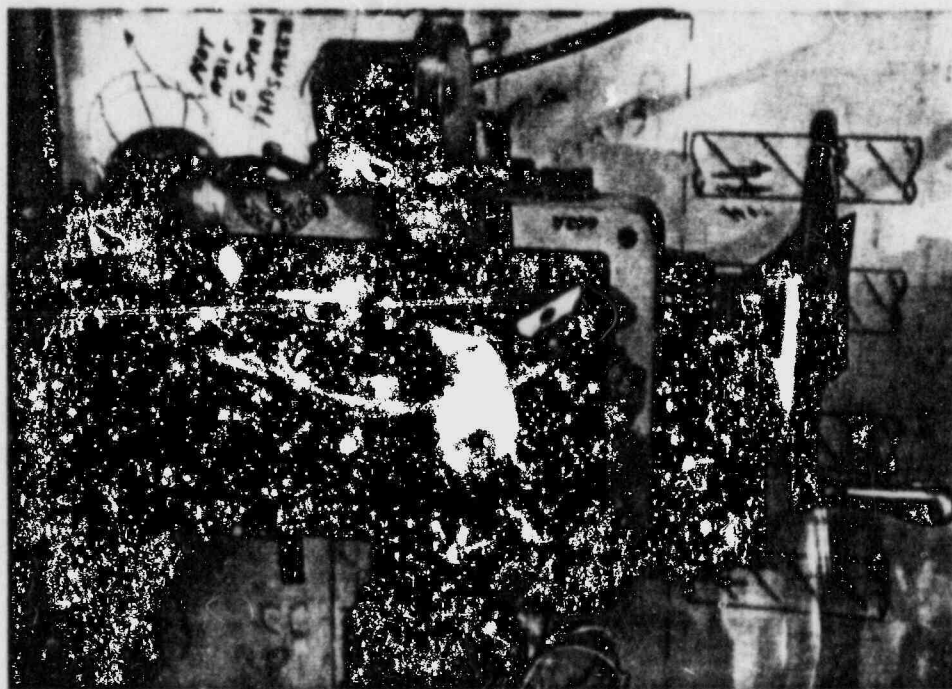
MOTOR OPERATED VALVES (MOV's)

The staff performed independent measurements on five MOVs as shown in Table 13-2. The staff did a partial tear down of the MOVs, see Figure 13-1B, to observe the condition of heaters, switch contacts, wire terminations, wire routing, gasket integrity, and a check for oil leaks. An insulation measurement (megger test) was made on two of the MOVs. The results of the NRC inspection was cross-checked with licensee data. All

A) TYPICAL MOV IN MSF AREA

B) MOV PARTIALLY DISASSEMBLED FOR NRC INSPECTION
