UNITED STATES
NUCLEAR REGULATORY COMMISSION

FACILITY: Three Mile Island Nuclear Station, Unit 1 (TMI-1)

SUBJECT: SUMMARY OF OCTOBER 12, 1995, MEETING WITH GPU NUCLEAR CORPORATION
REGARDING FUEL CLADDING DISTINCTIVE CRUD PATTERNS AT THREE MILE
ISLAND NUCLEAR STATION, UNIT 1 (TMI-1)

**TMI-1 Fuel Assembly Degradation
NRC/GPUN/BWFC Meeting - October 12, 1995**

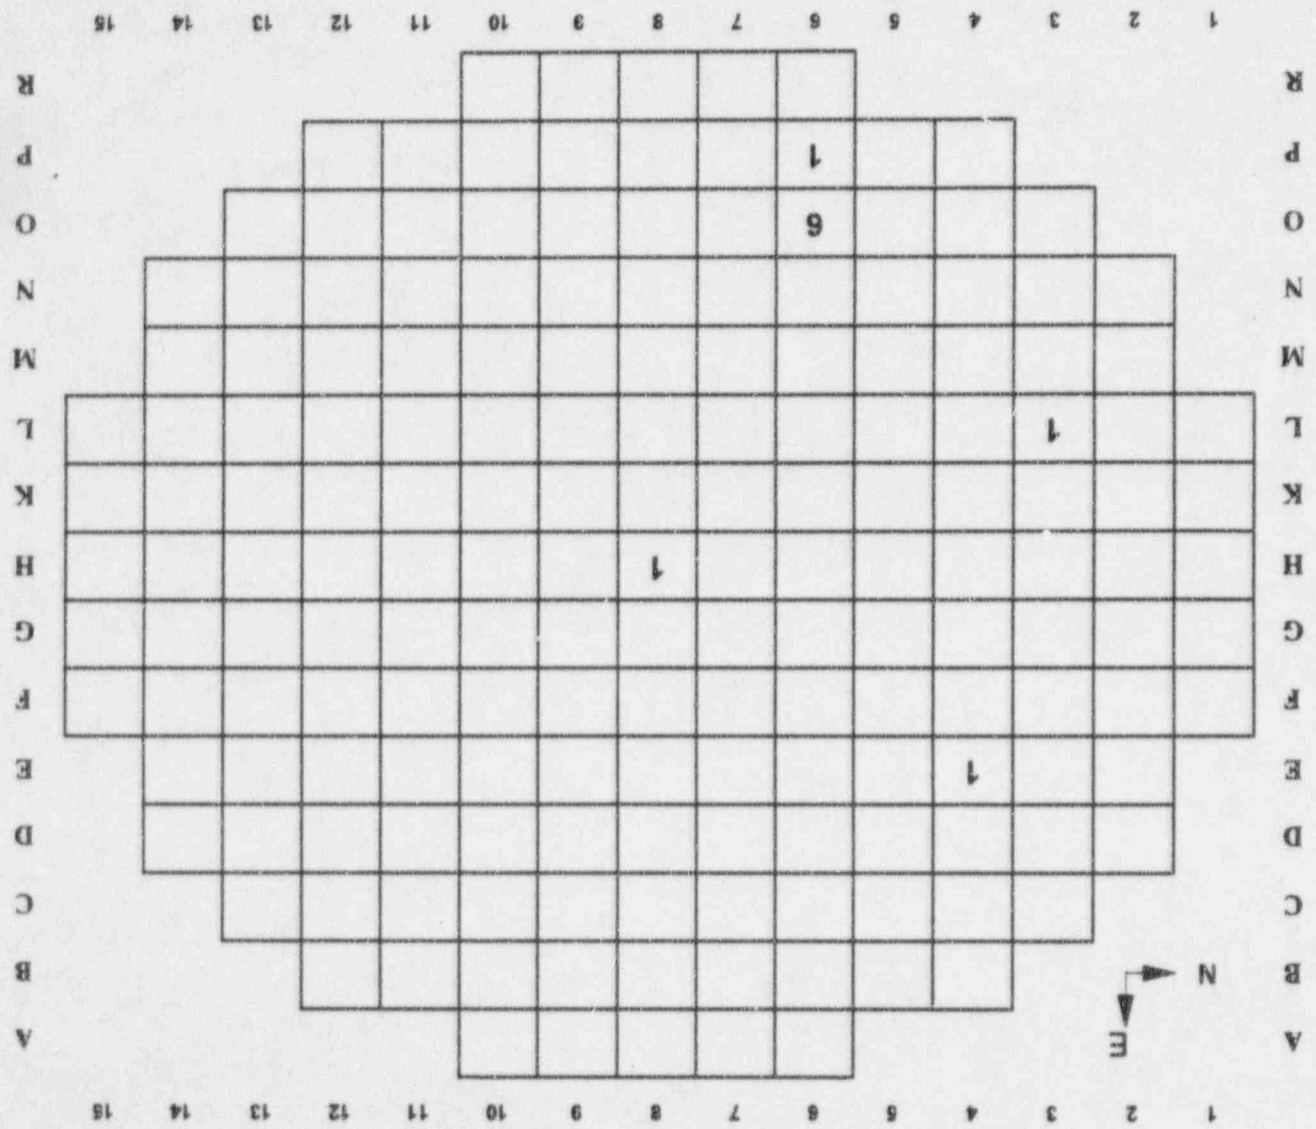
Pin Failure by Core Location

- Ultrasonic Test of 177 Fuel Assemblies
- 9 UT Failed Pins and 1 ECT Not Identified by UT
- 21 Assemblies Reconstituted with Rod ECTs
- 266 Pins EC Tested
- 94 Pins with Positive EC Indications
- Pin ECT Included 34 Internal Pins w/o Crud Pattern
- Visual Inspection of All Reinserted Fuel
- Two Highest Power Assemblies from Cycle 9 Inspected

- 19 Cycle 11 Assemblies Repaired with 87 Dummy SS Pins
- 8 New Assemblies Substituted for Cycle 11
- 4 Previously Discharged Assemblies Substituted

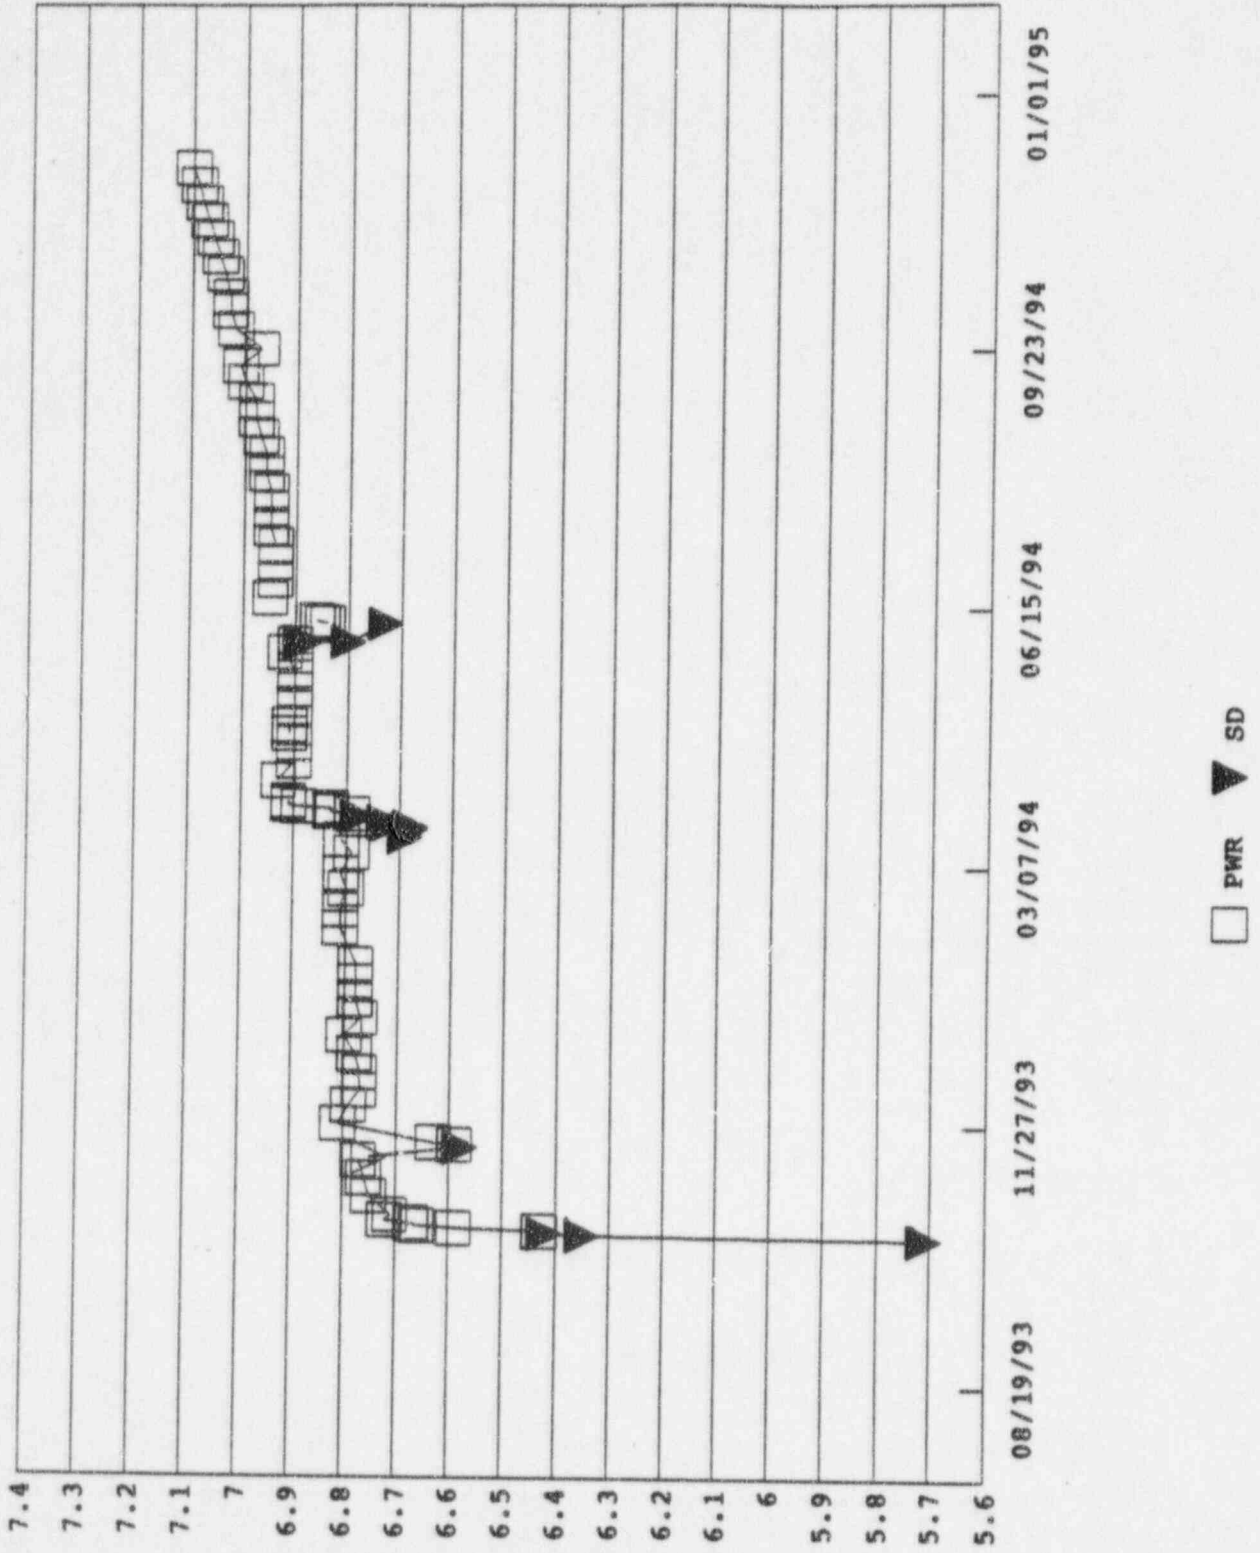
CYCLE 10 PH
AT 305 C

Low pH due to high boron and low lithium concentrations caused unusual crud deposits in high temperature regions of the core where localized boiling in adjacent hot channels occurred.

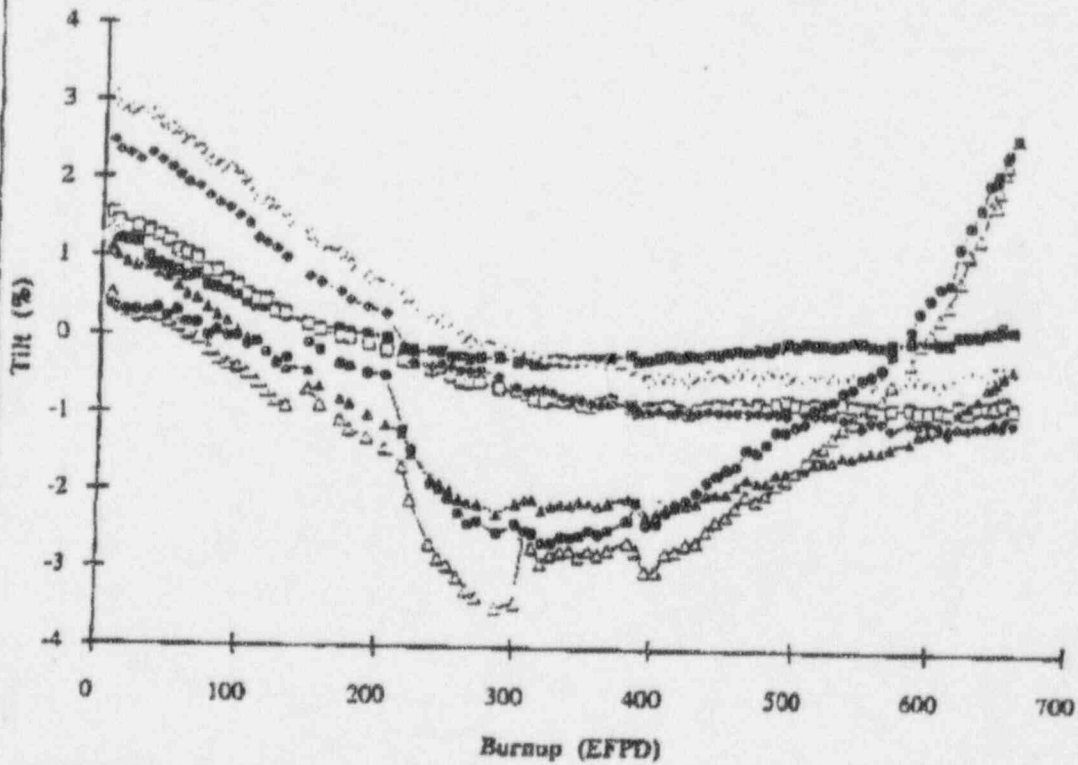
TMI-1 Cycle 10
Z-W Quadrant Power Tilt-by-Level

- Cycle 10 Design - Core Physics
 - ▶ BOC Boron, Max Enrichment, Use of Gd
 - ▶ Power in Fresh Assemblies Near Periphery Slightly Higher than in Other Cycles
- Cycle 10 Design - Core Thermal-Hydraulics
 - ▶ Consistent with Other Cores
- Startup Testing Results
 - ▶ All Zero Power Tests Within Expected Ranges
 - ▶ Initial Power Distributions Showed Good Agreement
- Operating Data Assessment
 - ▶ Radial Power Distribution Agrees with Predictions
 - ▶ Quadrant Tilt Not Excessive but Upper Level Detectors in Outer Ring Show Unusual Behavior with Burnup

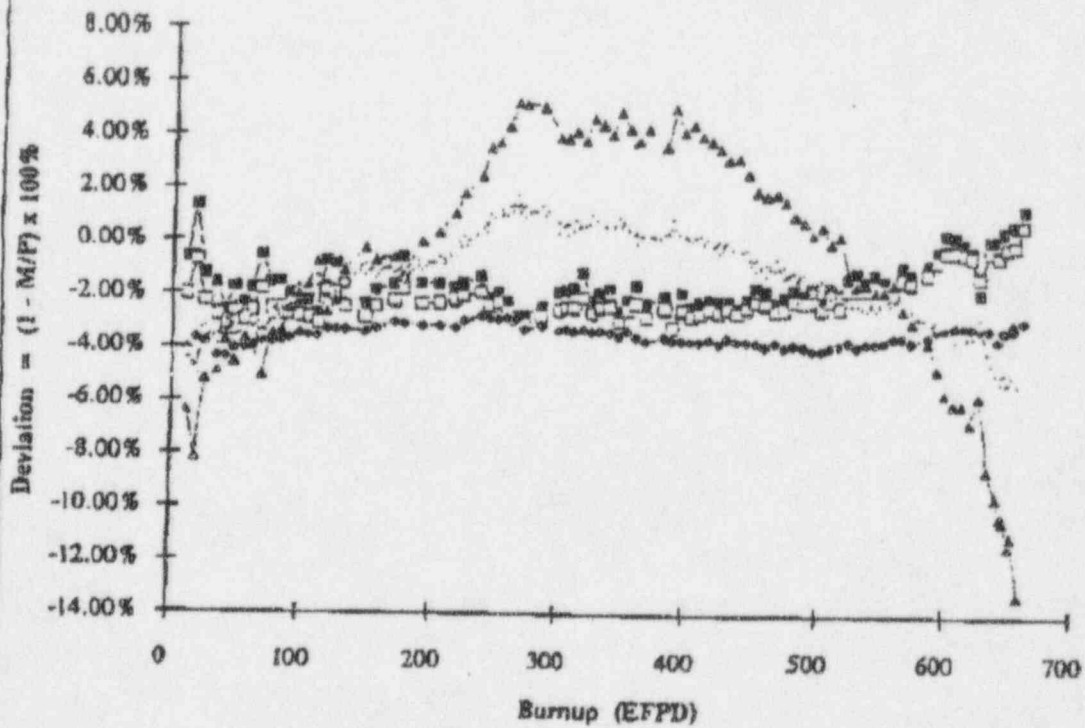
TMI-1 Cycle 10
Segment Peaking Comparisons
Eighth-core Location L-14

- Quadrant Tilt Not Particularly High (~ 2% @BOC in Z-W Quadrant)
- Level Dependent Quadrant Tilt Behavior Unusual (top 2 spans) in Z-W Quadrant
- Measured Maximum Radial Power Distribution Agrees with Predictions Throughout Cycle (within 2%)
- Measured Maximum Total Segment Power Agreement Diverged Reaching 3% @ 300 EFPD
- Measured Power Imbalance Deviates From Predictions in Mid-cycle Period (between 150 to 575 EFPD; maximum difference ~ 3% @ 300 EFPD)
- Upper Segment Peaking Shows Unusual Behavior (top 2 spans) in Fresh Fuel with Observed DCP

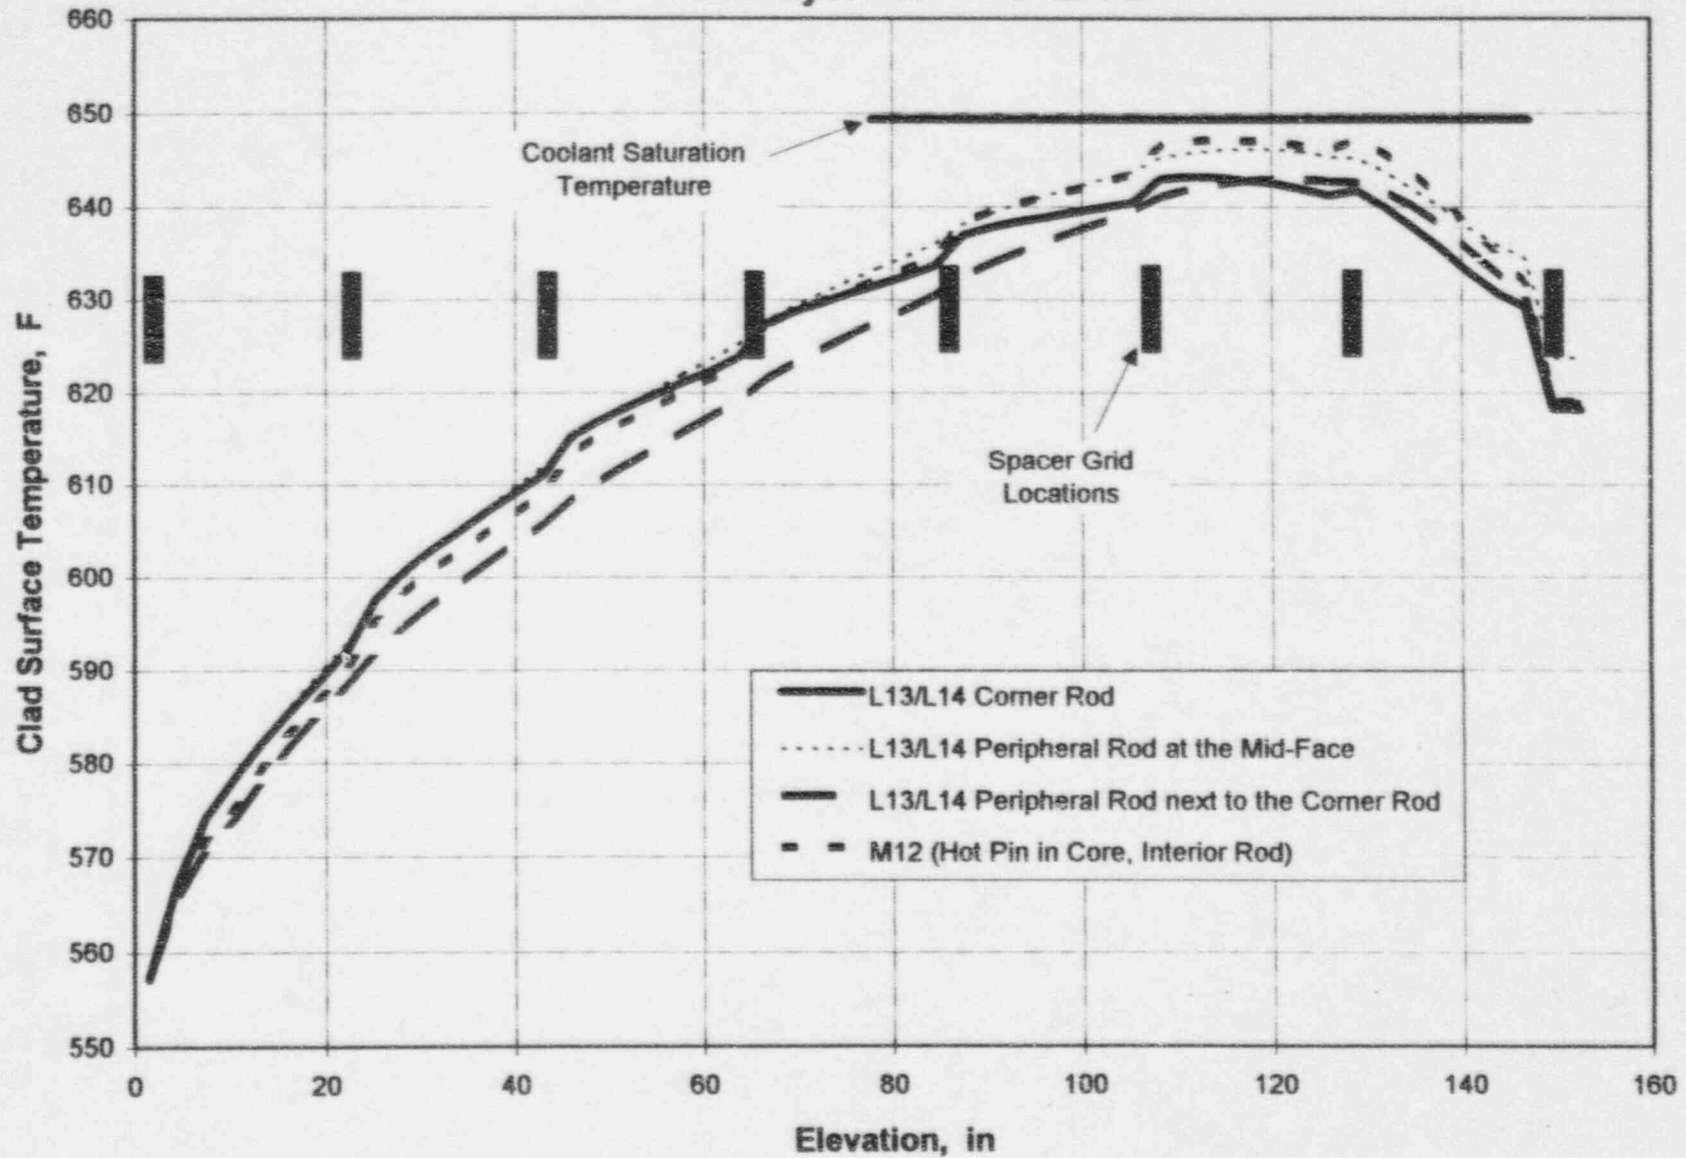
Clad Surface Temperature versus Elevation

- Thermal-Hydraulic Evaluation
 - ▶ Core-Wide Analysis Shows Temperatures Slightly Higher in Outer Ring Fresh Fuel Locations
 - ▶ Local Conditions Analyses Show Clad Surface Temperatures Among Highest in Core; Local Velocities Lower in Peripheral Channels than in Bundle Interior
 - ▶ Both Core-Wide and Local Conditions are Similar to or Bounded by Those in Other Similar Cores
- Correlates to High Temperature, Low Velocities but These Conditions Would Not in Themselves Lead to Fuel Degradation
