UNITED STATES OF AMERICA
NUCLEAR REGULATORY COMMISSION

In the Matter of)
)
LONG ISLAND LIGHTING COMPANY)
)
(Shoreham Nuclear Power Station,)
Unit 1))

SUPPLEMENTAL TESTIMONY OF DR. ROBERT N. ANDERSON,
PROFESSOR STANLEY CHRISTENSEN, G. DENNIS ELEY,
AND RICHARD B. HUBBARD
REGARDING SUFFOLK COUNTY'S EMERGENCY DIESEL
GENERATOR CONTENTION CONCERNING CYLINDER BLOCKS

SUFFOLK COUNTY
October 18, 1984

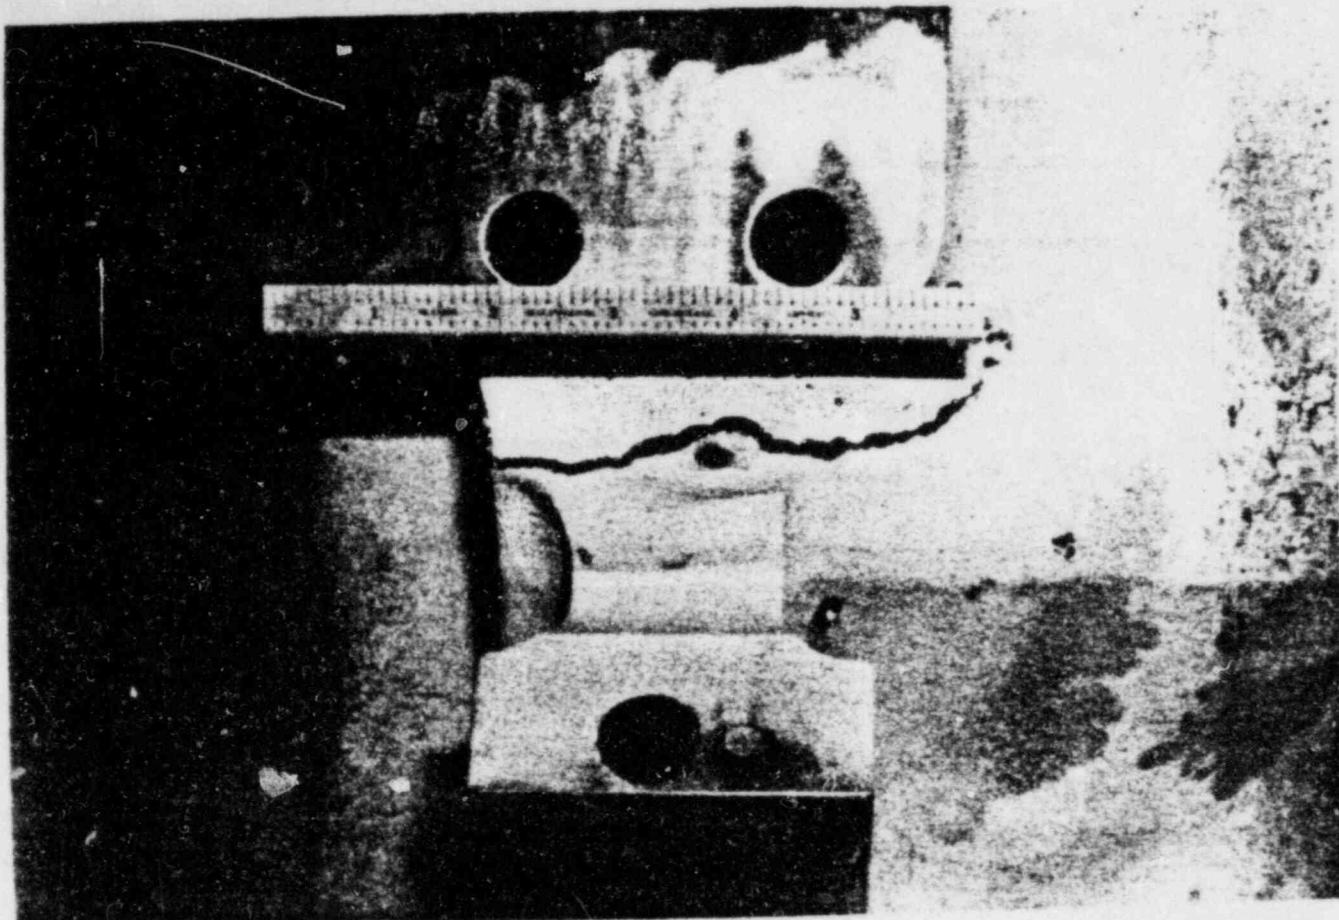
inches.^{2/} Some of these cracks were measured by FaAA after sectioning and found to be from 0.5 inch to 0.906 inch deep in a block wall only 1.25 inches thick.^{3/} FaAA found that all of these cracks had been ground and welded. Some representative photographs of these cracks are shown in Exhibit S-3.

ORIGINAL BLOCK - EDG 103
CAM GALLERY BEARING SADDLE #5
FaAA PHOTO - 8/24/84 - Rool 05125

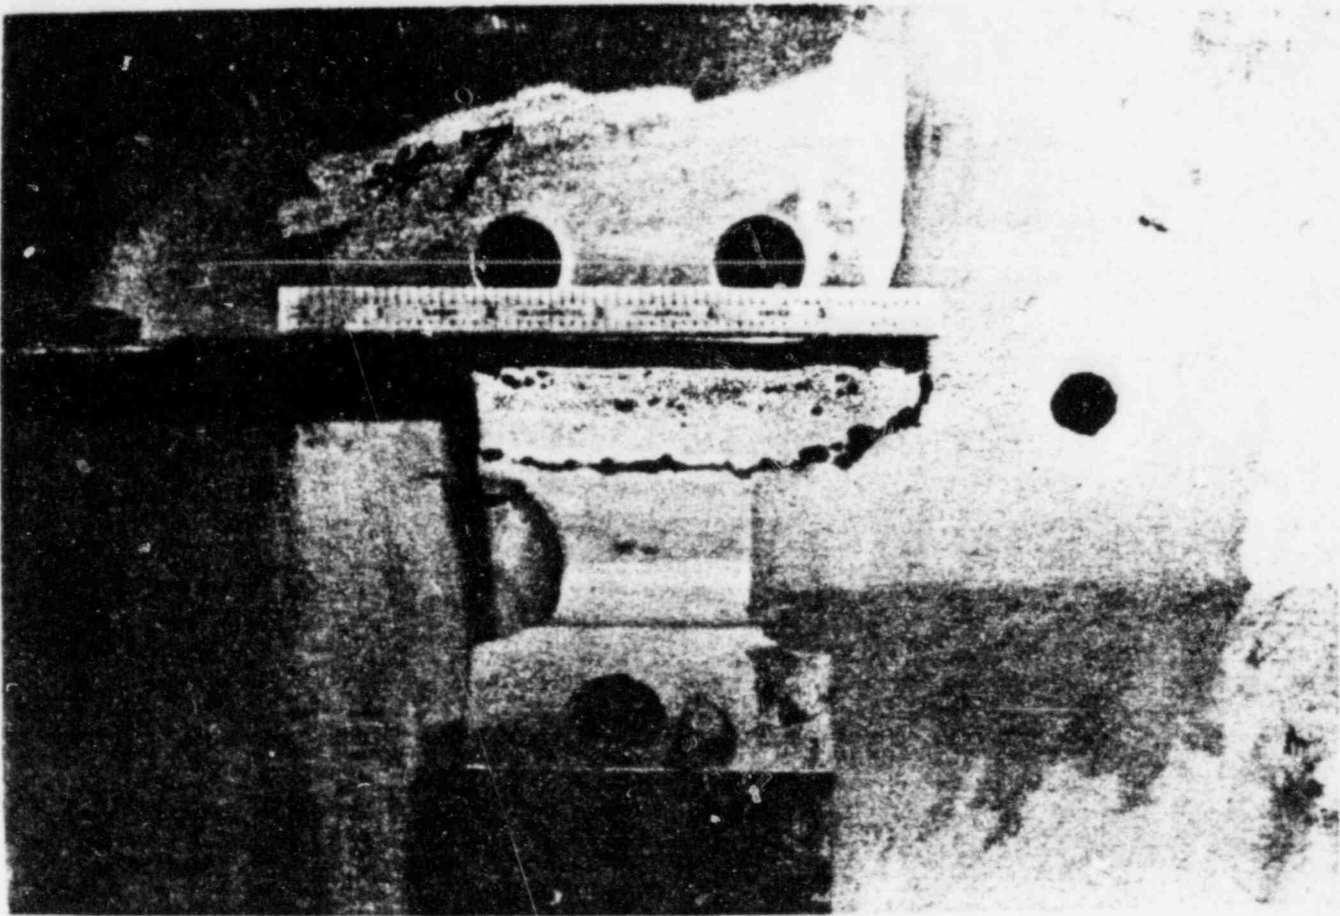
A. (Anderson). No. That conclusion is based upon FaAA's erroneous interpretations of a "dark oxide" on the surface of a crack sectioned from cam gallery No. 7, the presence of high concentrations of calcium on the surface of that crack, the absence of a "rust-colored oxide," and the appearance of the crack surface.

ORIGINAL BLOCK - EDG 103

CAM GALLERY BEARING SADDLE #7

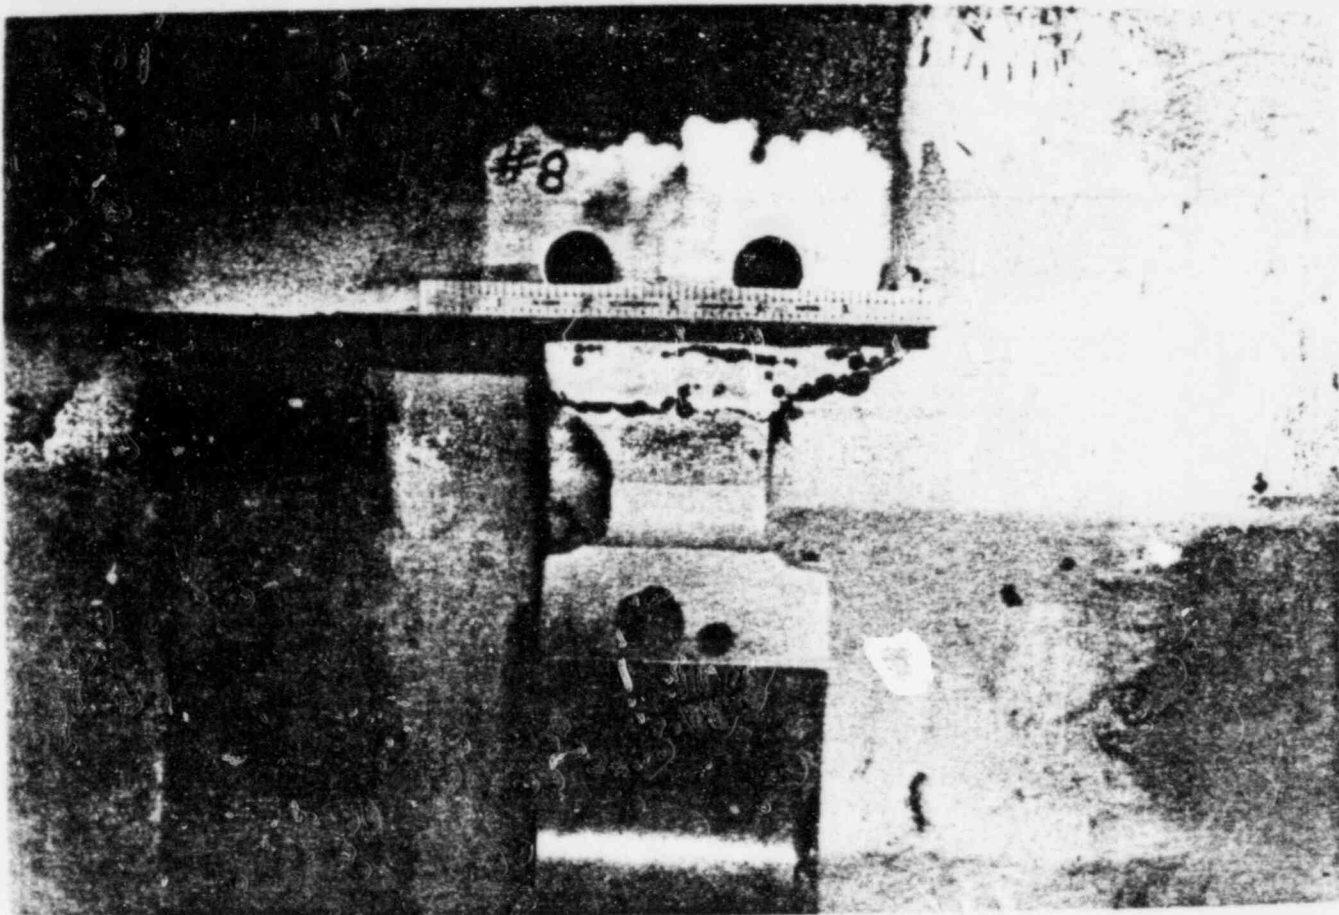
ORIGINAL BLOCK - EDG 103

CAM GALLERY BEARING SADDLE #8

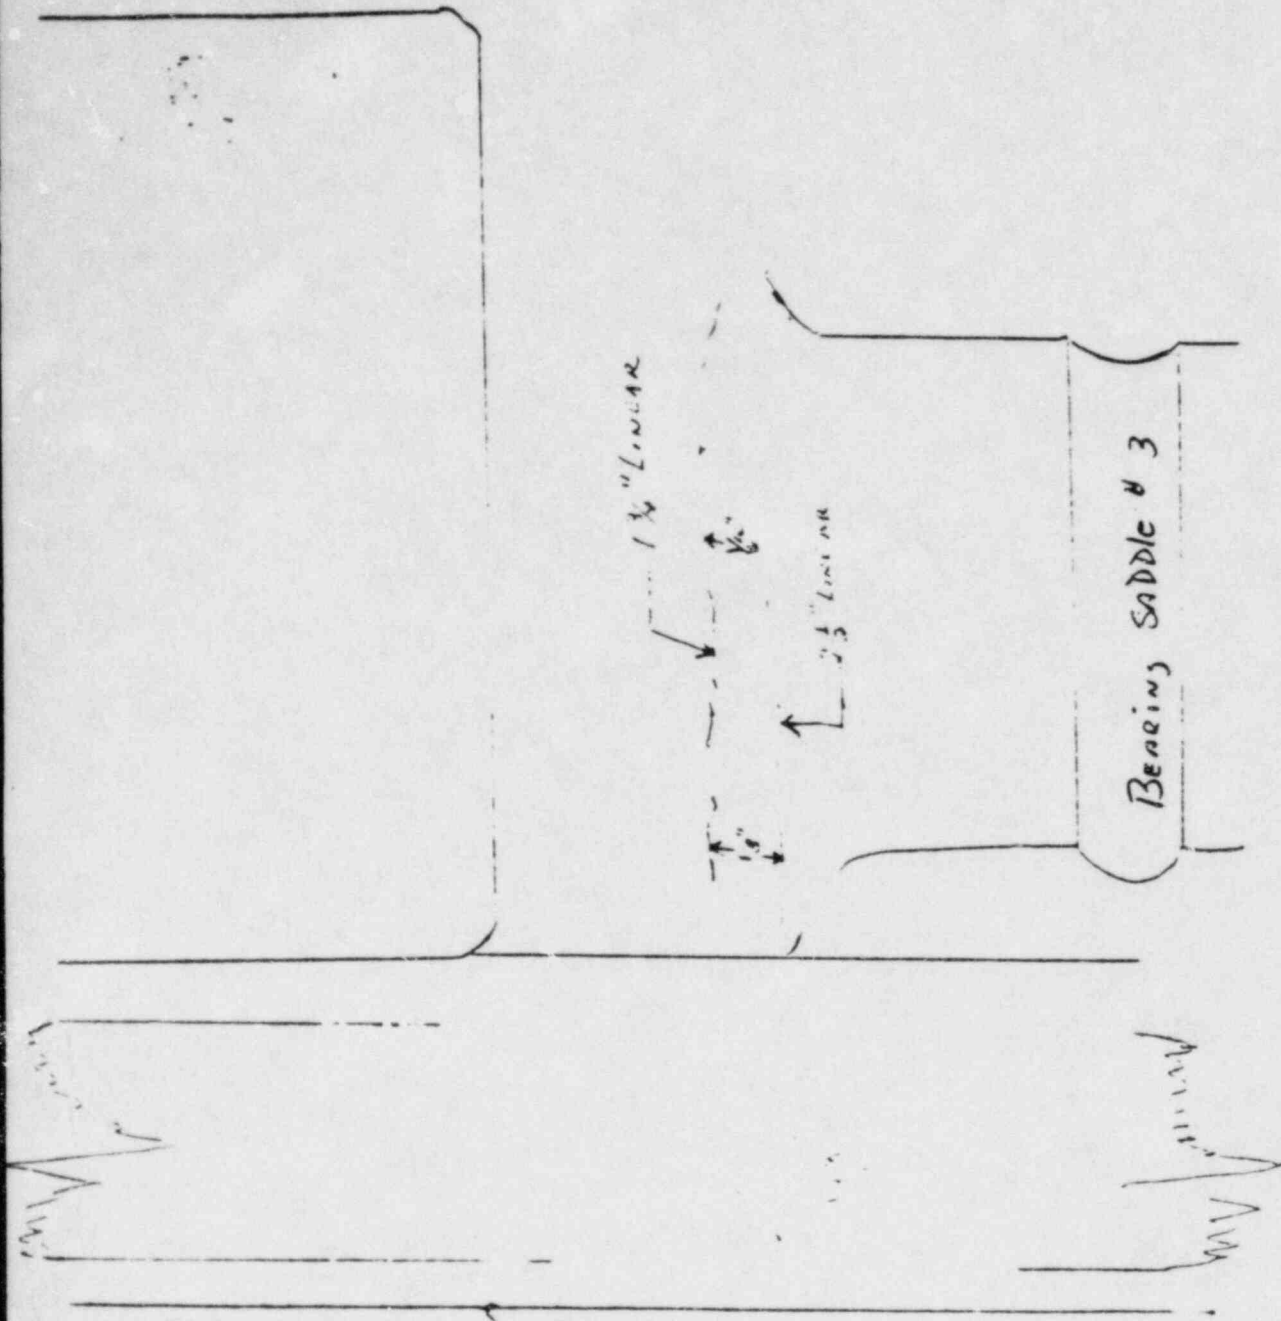
Inspector Date
 Victor C. [Signature] 11/20/51
 MAGNETIC PARTICLE INSPECTION RESULTS OF 1R43#EDG. 101, CAM GALLERY AREA #2 CYLINDER AREA
 MPE PARTICLE used: WET METHOD (FLUORESCENT) EQUIPMENT: Yoke

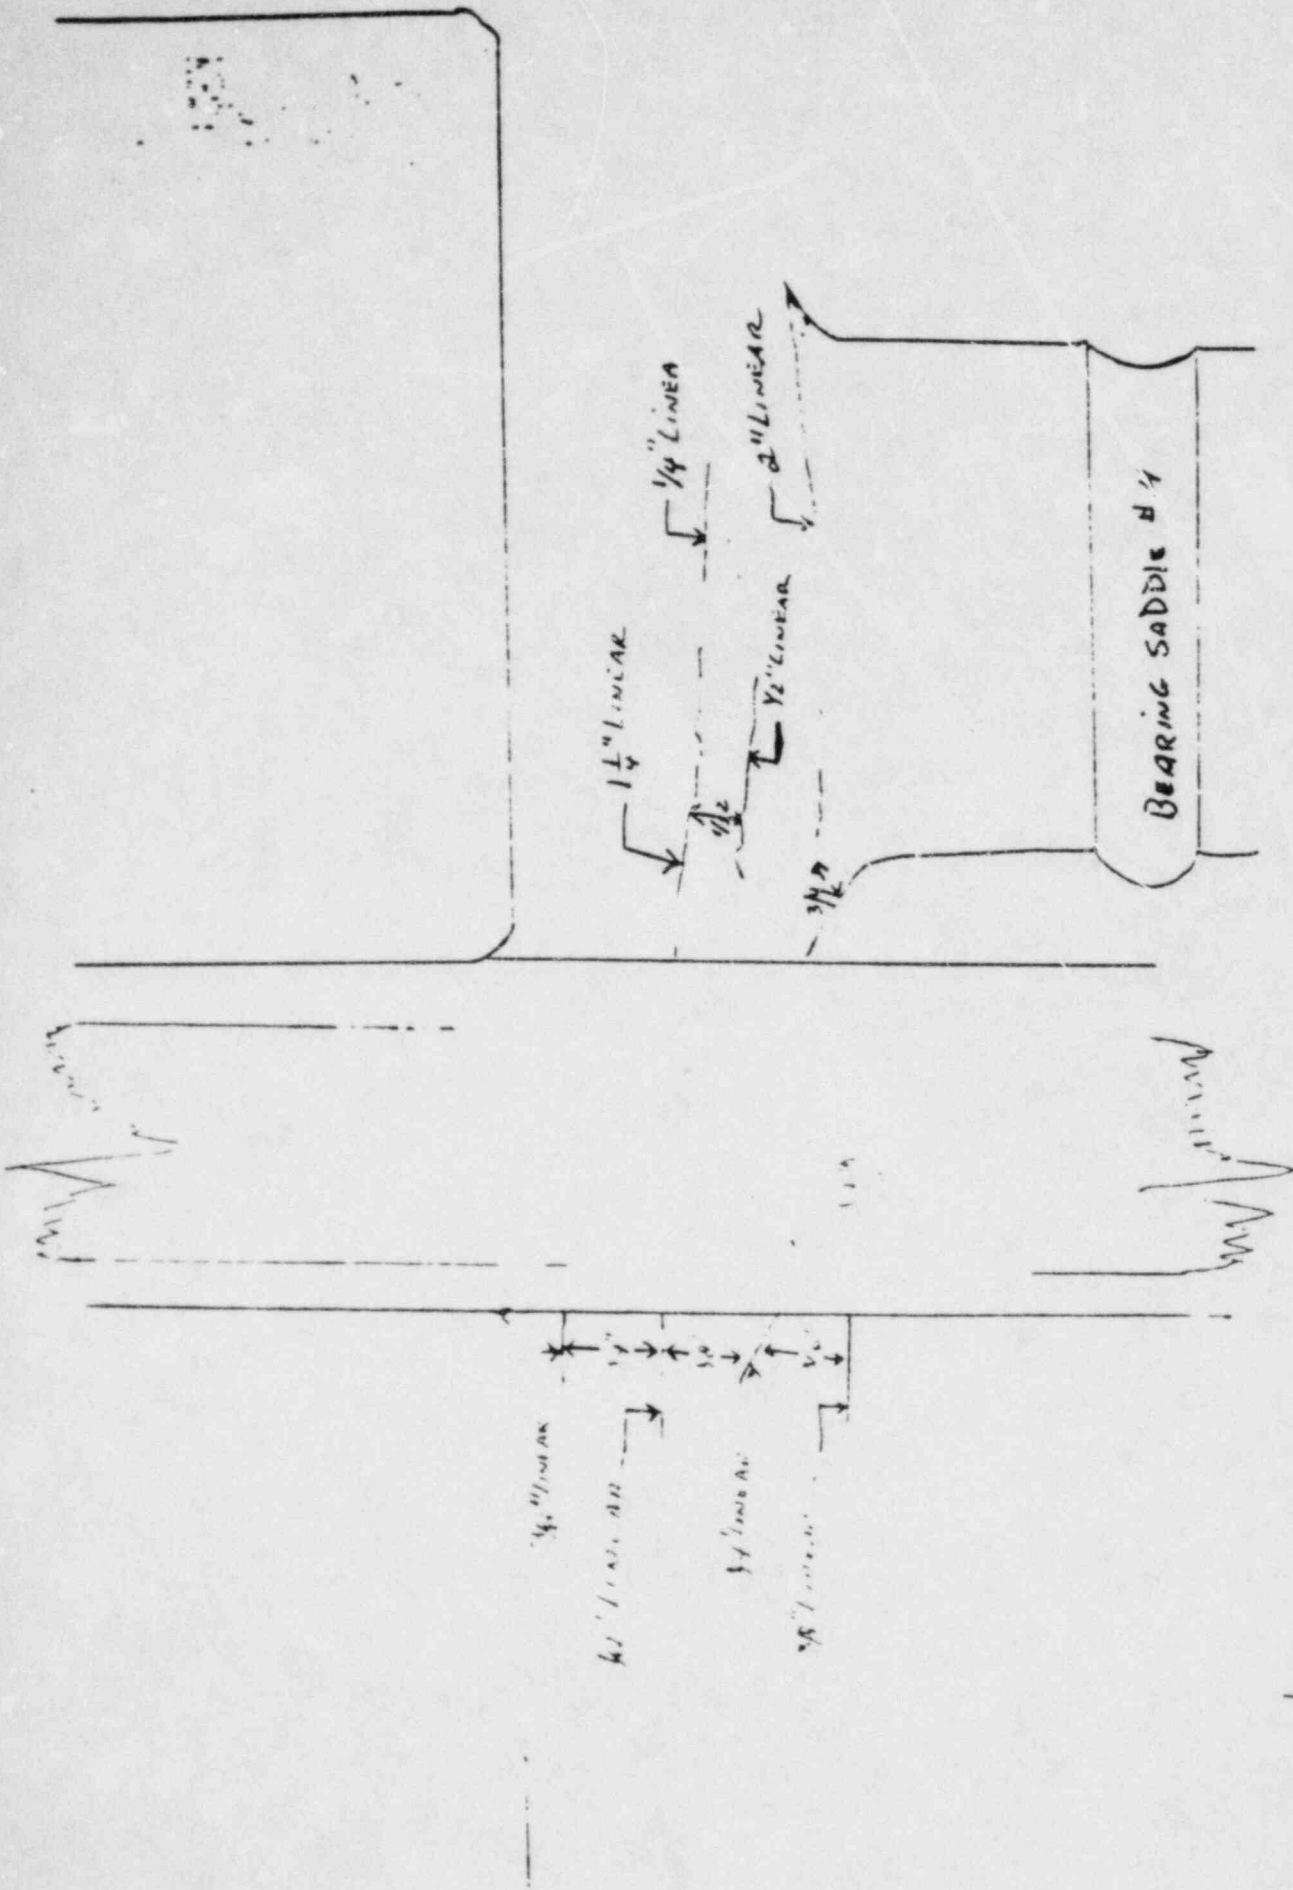
Inspector's Note
 The Bore - 1.0000 ±
 IGATE Particle Inspection Results of 1R43 EDG-108 CAM GALLEY AREA #3 CYLINDER AREA
 IPE Particle: WFT Method (Fluorescent) EQUIPMENT: YOKO

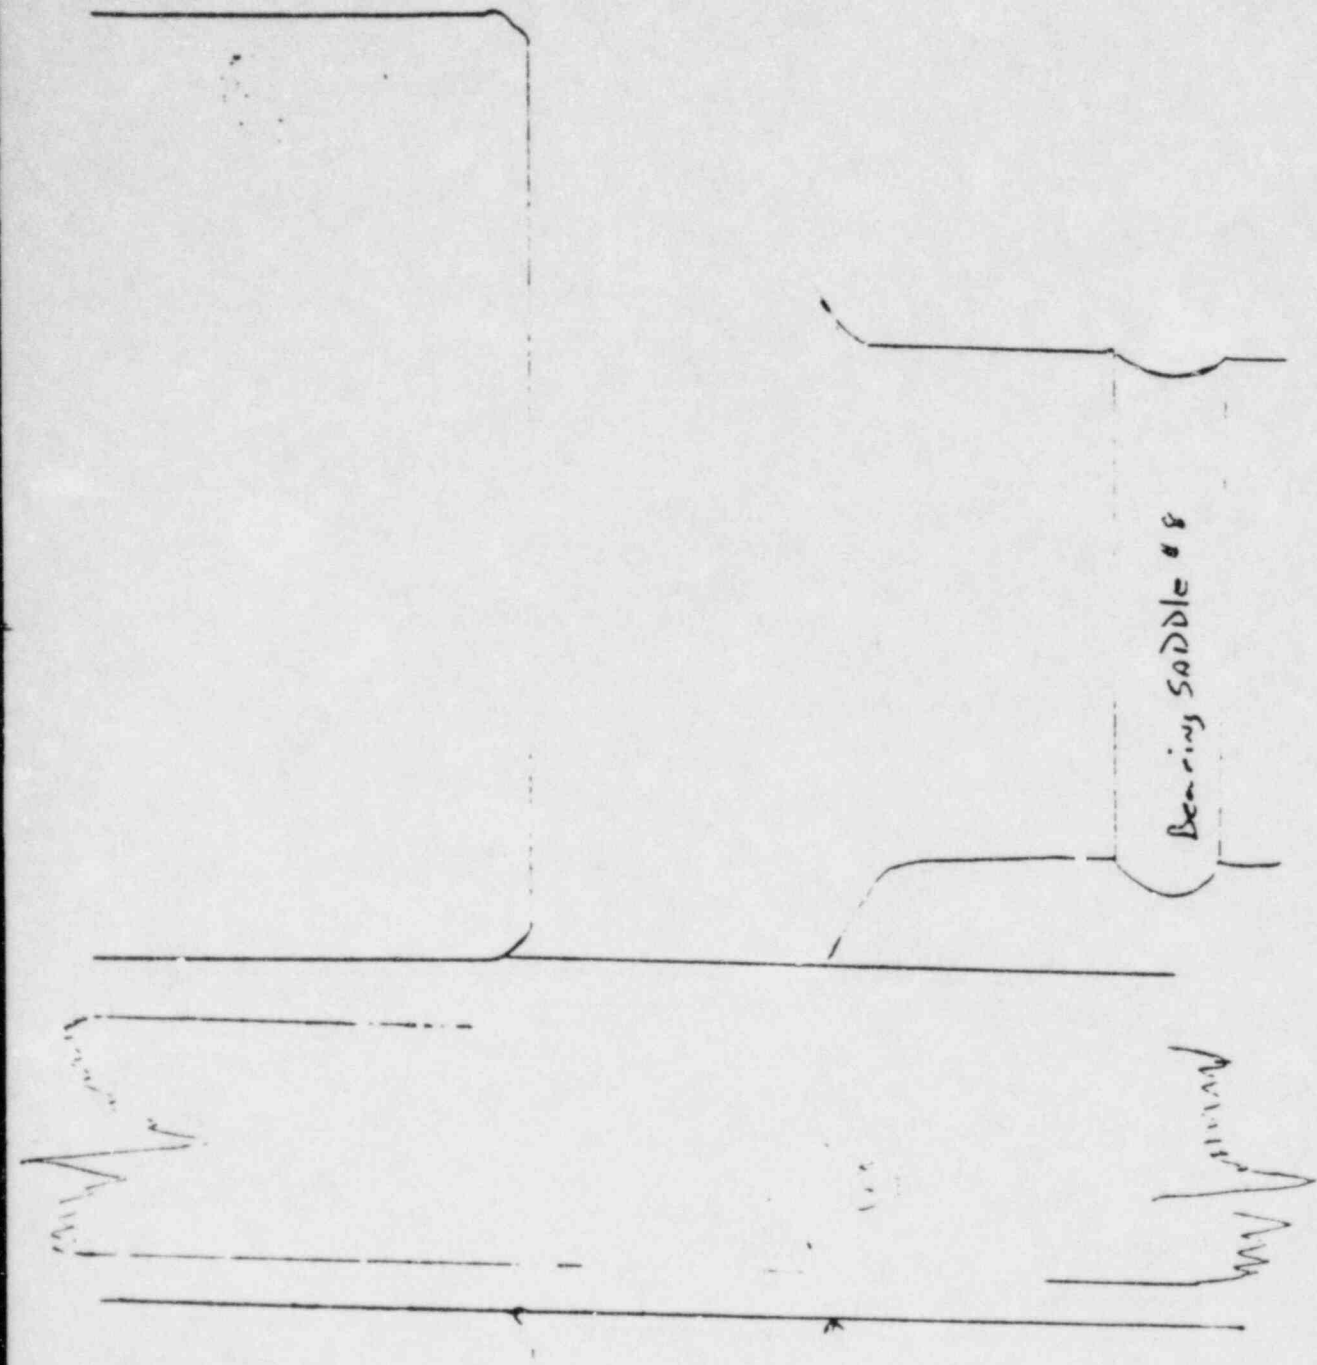
Inspection Date 9/20/84
 MAGNETIC PARTICLE INSPECTION RESULTS OF BEARING SADDLE # 8
 TYPE PARTICLE USED: WET METHOD (FLUORESCENT)
 Equipment: Yoke

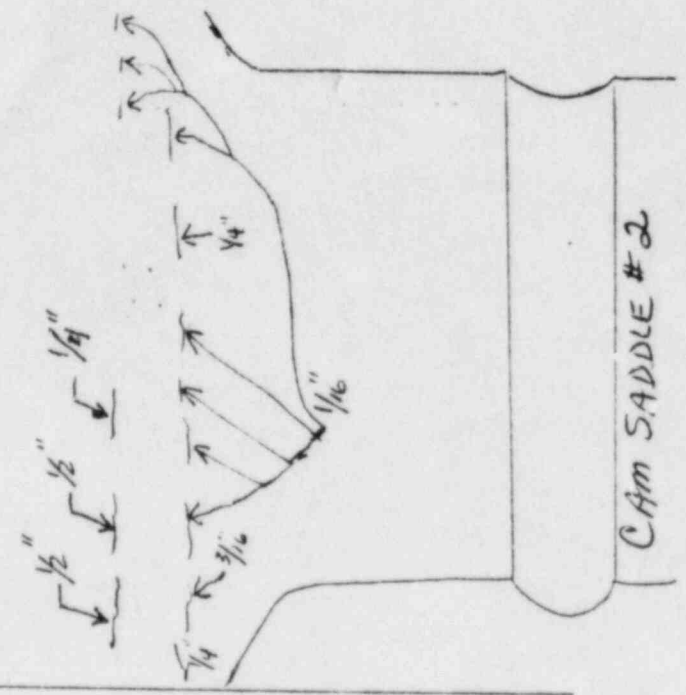
CAM SADDLE # 2

IR43* EDG 103
MT EXAMINATION INDICATIONS

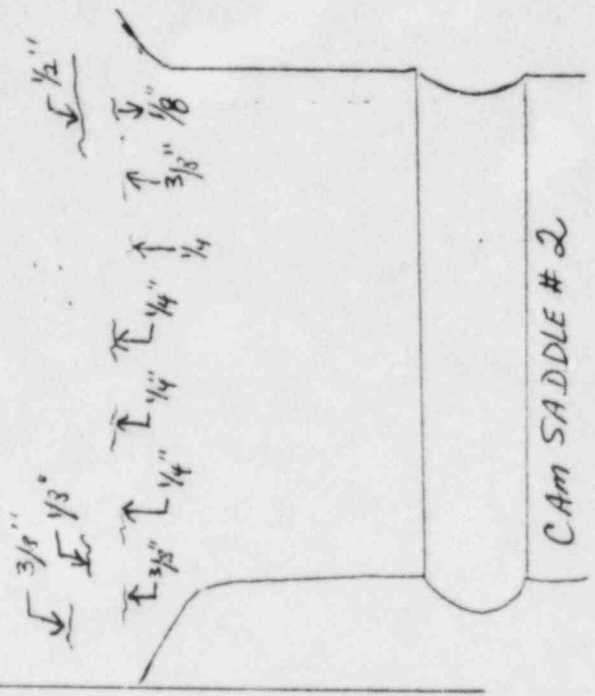
CAM SADDLE #2

IR43 * EDG-103
LP EXAMINATION INDICATIONS
PENETRANT DWELL TIME - 10 MIN.
DEVELOPER DWELL TIME - 7 MIN
MATZ. Temp. - 82°F
