U.S. NUCLEAR REGULATORY COMMISSION
REGION I

Report No. 50-289/84-22

Facility Name: Three Mile Island Nuclear Station, Unit 1

Inspection Conducted: July 23 - 27, 1984

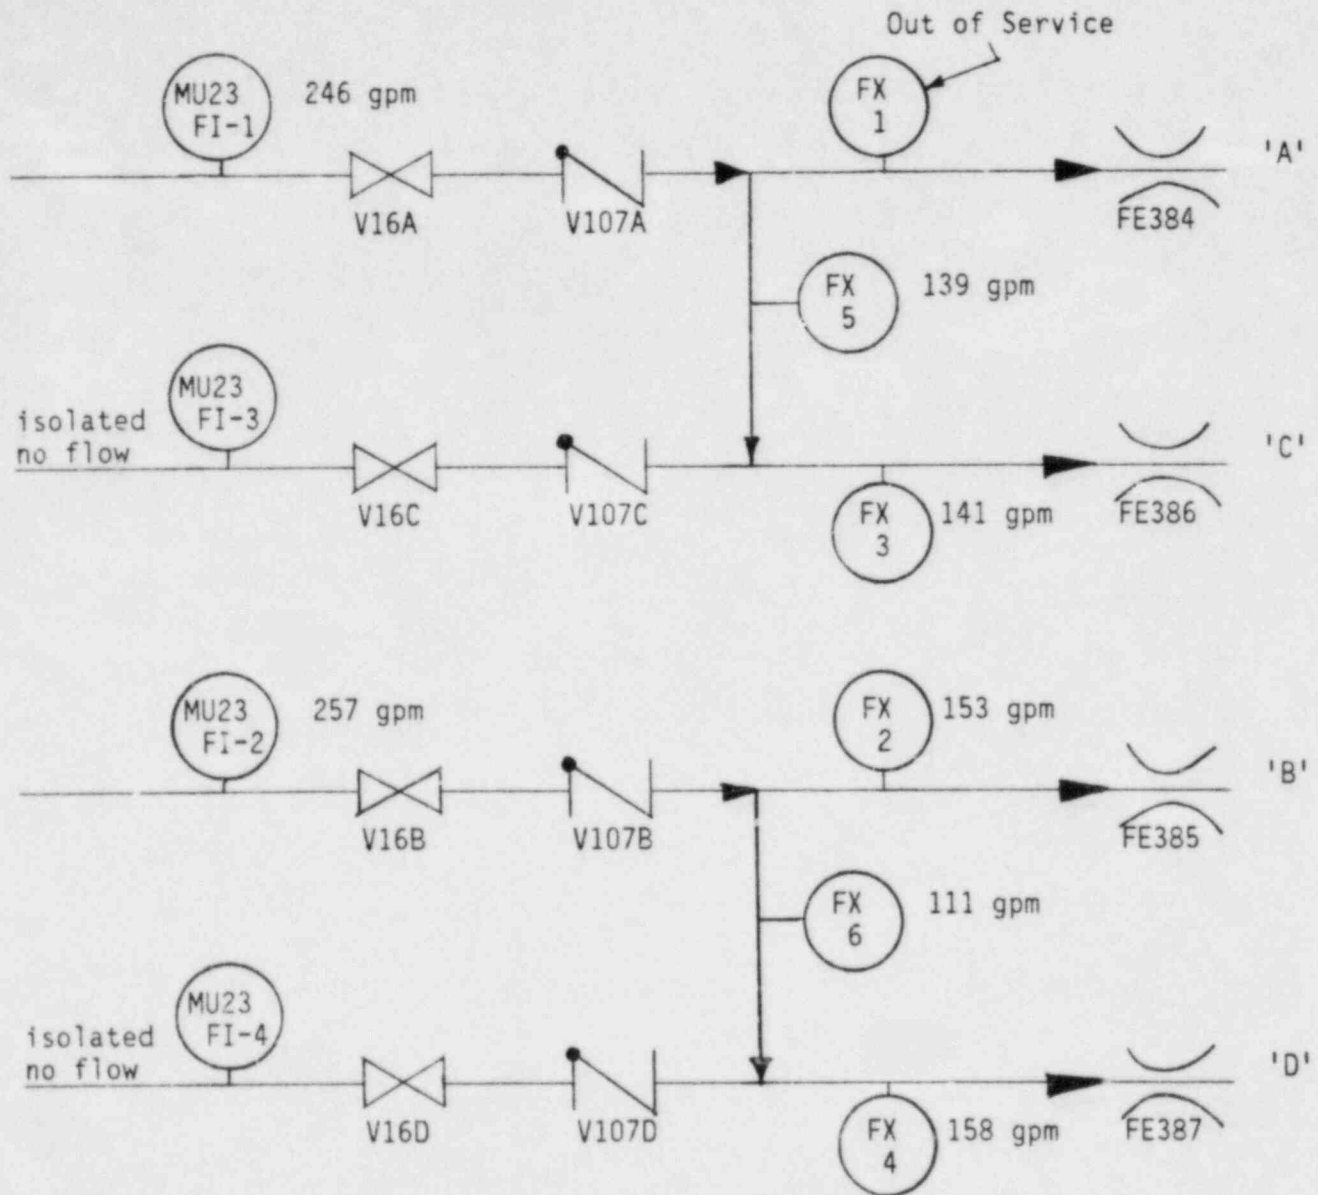
Attachment 1 May 22, 1984 HPI TEST RESULTS

Case 1: RCS Pressure = 1200 psig, MU-P-1A Running. The measured flow is depicted in the Attachment 1.

The total measured injection flow through the three lowest flow legs exceeded the required flow of 306 gpm. However, the flow readings from the temporary Controlatron external flow measuring instruments were not consistent, as evidenced from the large deviation between FX6 and FX4. Furthermore, reading from MU23 FI2 did not agree with FX2 and FX4. These readings failed to demonstrate the fluid continuity. The licensee's Technical Functions group are currently assessing these problems.

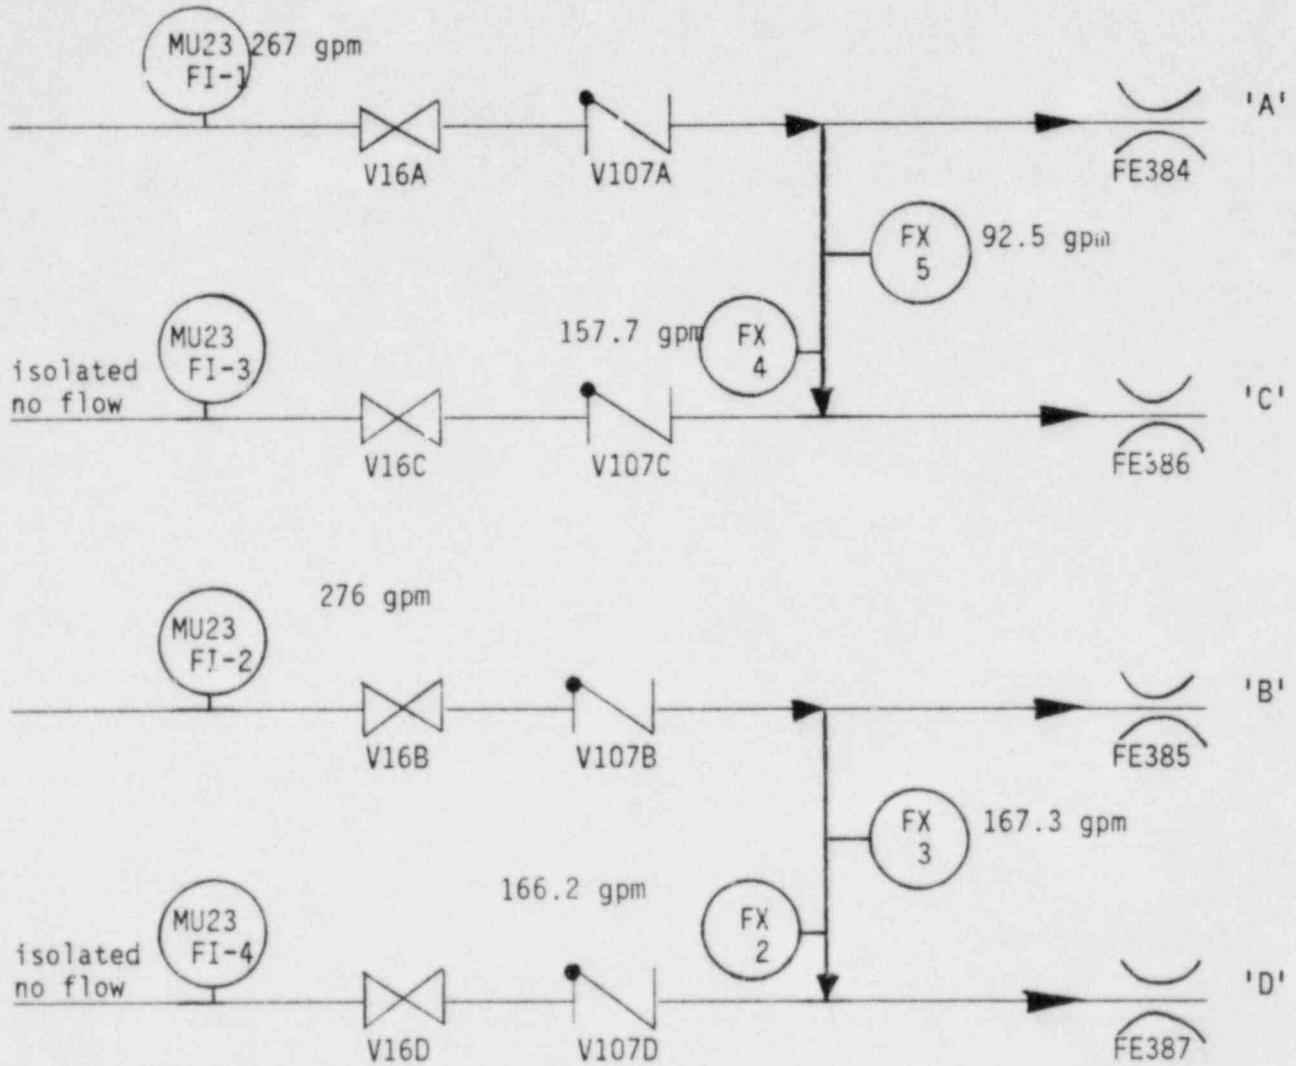
Case 1 : MU-P1A Running

The large variation in the response of the Controlatron flow instruments was attributed to the improper locations of these instruments. The presence of sonic wave obstacles such as cavitating venturis and pipe bends in the instrument nearby, caused the Controlatron reading to be less reliable. The test was repeated on May 26, 1984 with modifications on the Controlatron location. Two Controlatrons were located on each cross leg and the remaining injection line Controlatrons were removed. The test was performed twice at RCS pressure of 800 psig with MU-P1A and MU-P1B running, respectively. The test results are summarized in the Attachment 2.

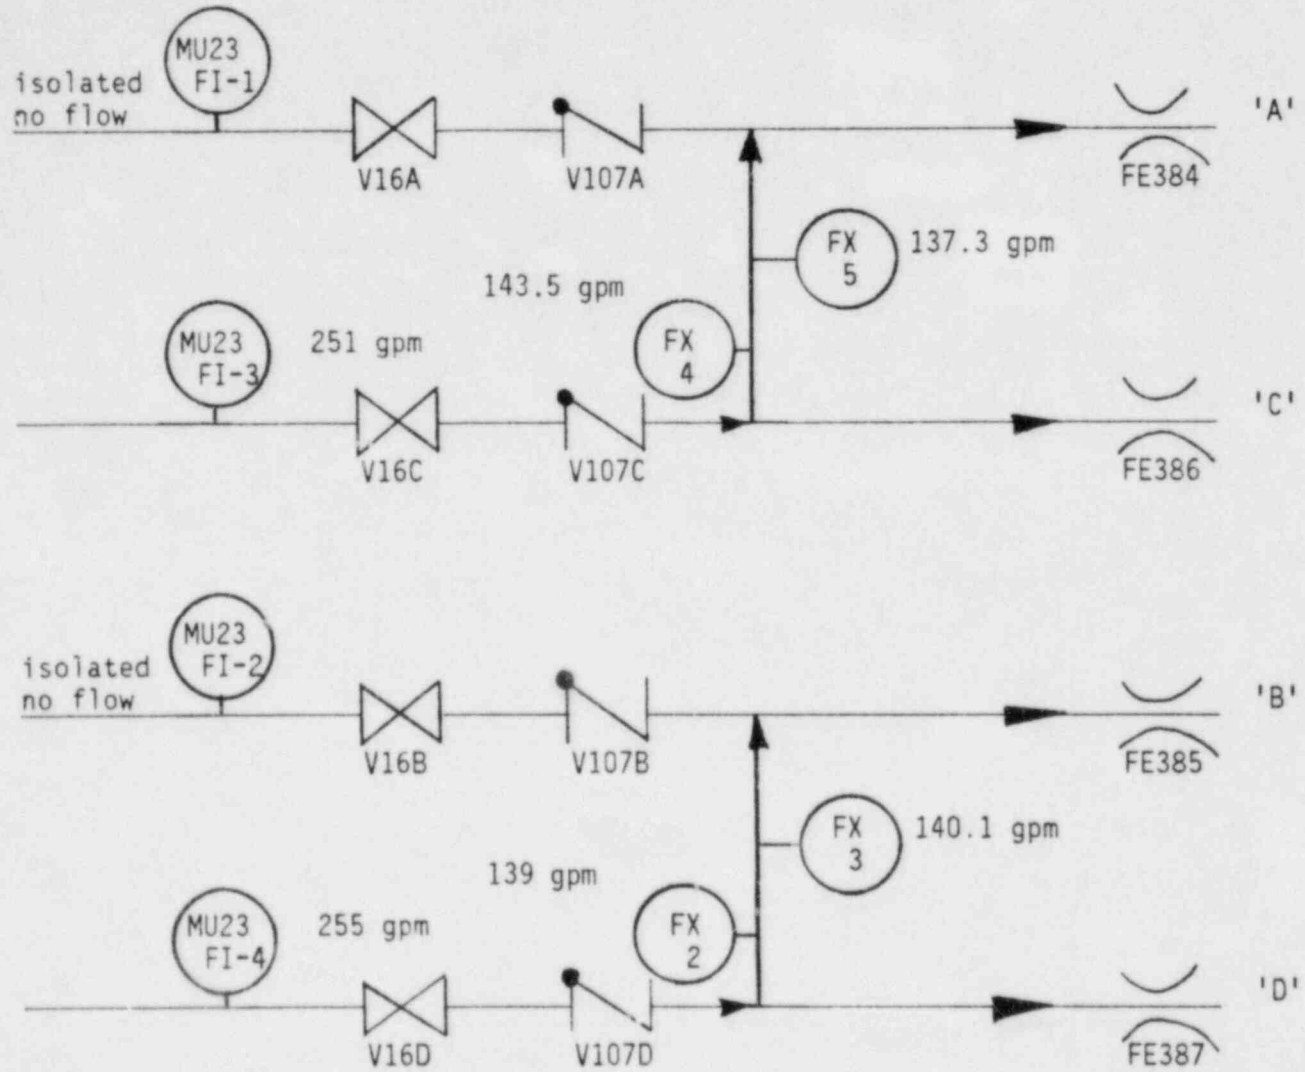
Case 2 : MU-P1B Running

Only the MU-P1B running case showed consistent readings of Controlatrons. The split flow derived from this set of test data met test acceptance criteria.
