GULF STATES UTILITIES COMPANY

River Bend Station - Unit 1
Docket No. 50-458

Enclosed for your review are Gulf States Utilities Company (GSU) revised program plan for evaluating and testing the Division I & II standby diesel generators and also data on the inspections and testing performed to date. This letter supplements docketed correspondence from J. E. Booker to H. R. Denton dated July 19, 1984 (RBG-18,244).

RIVER BEND TRANSAMERICA DELAVAL DIESEL 1A INSPECTION REPORT

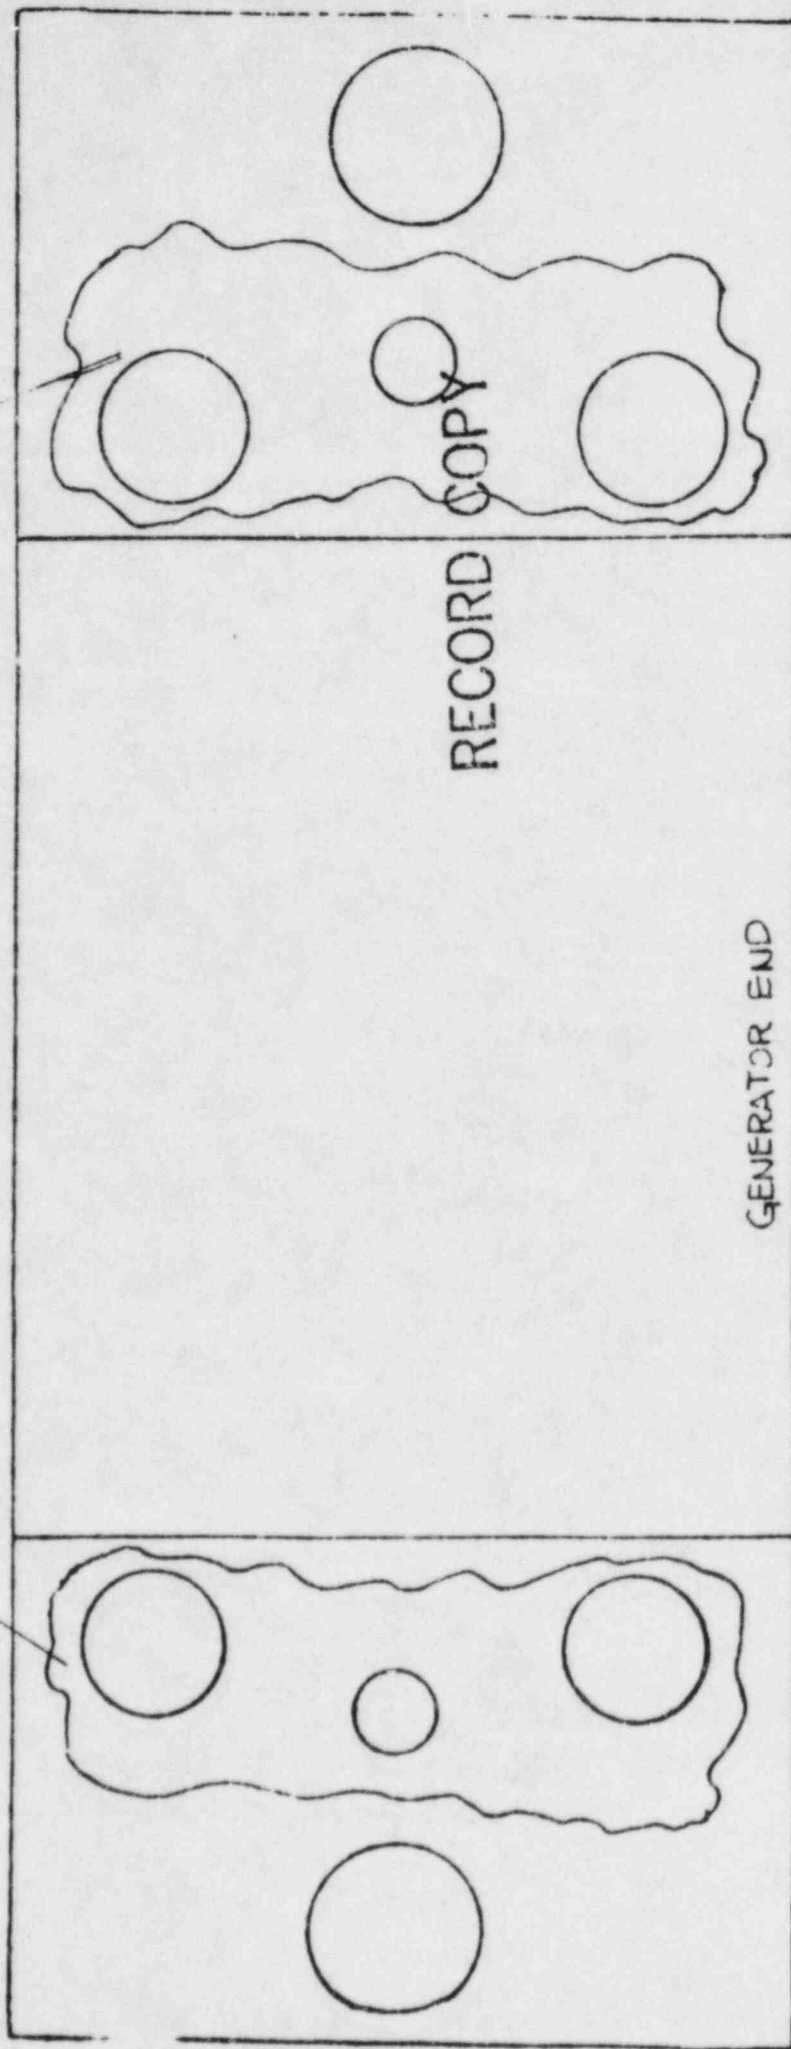
MAIN SADDLE BEARING NOS

1. No indication of excessive wear, fretting, erosion or corrosion was observed in the main bearing saddle area (Satisfactory).
2. No indication of fretting was observed in the cap mating surfaces (Satisfactory).

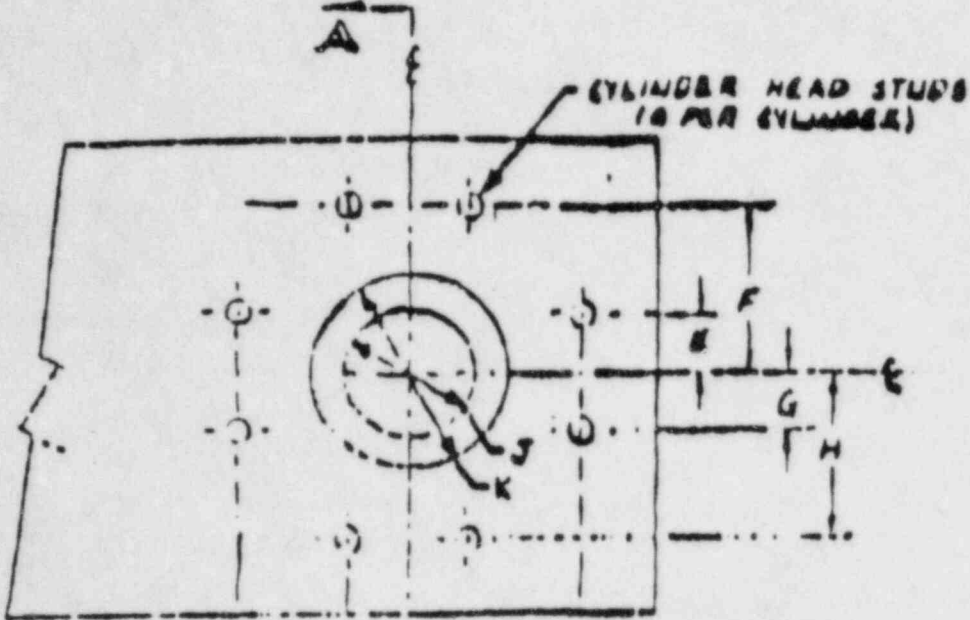
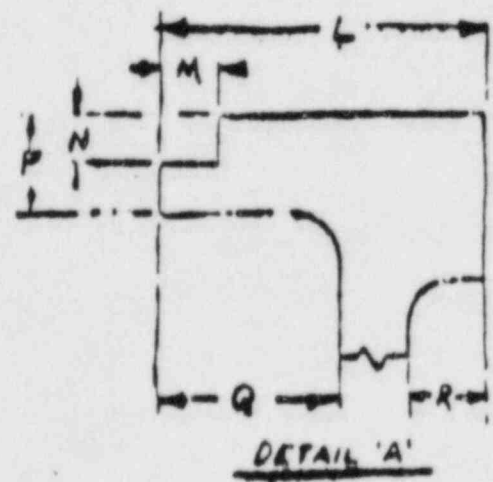
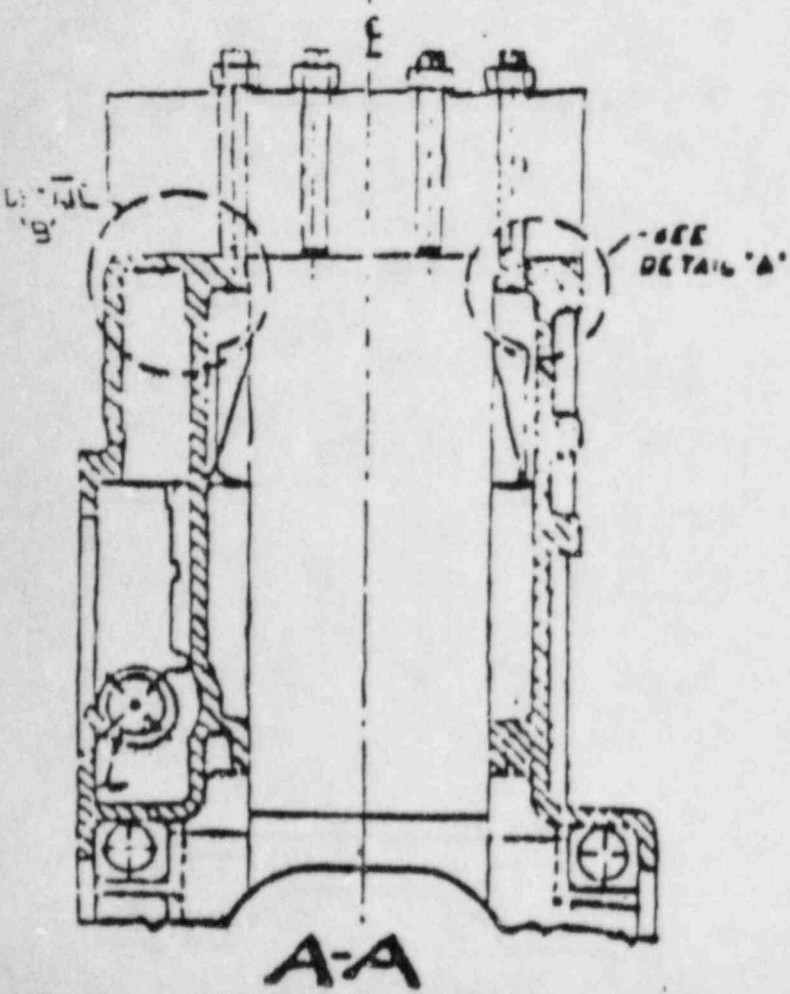
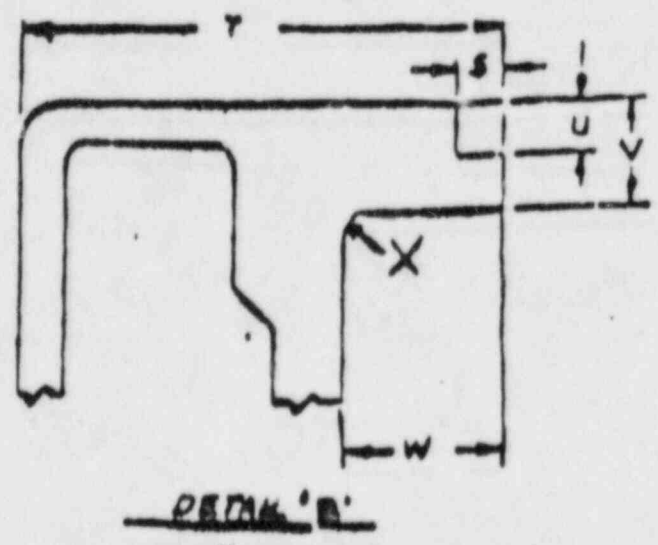
20F410

1. Dimensional inspection of cylinder block was performed and preliminary information is satisfactory. Awaiting final disposition from TDI Owners Group.
2. Completed LP inspection of the cylinder block liner landing. No indications evident (Satisfactory).
3. Completed MT of the engine block top. No indications observed (Satisfactory).
