LICENSEE EVENT REPORT (LER)

FACILITY NAME (1) Calvert Cliffs Unit 1	DOCKET NUMBER (2) 0 5 0 0 0 3 1 7	PAGE (3) 1 OF 013
--	--------------------------------------	----------------------

TITLE (4)  
Loss of Circulating Water Caused by Sea Nettle Impingement

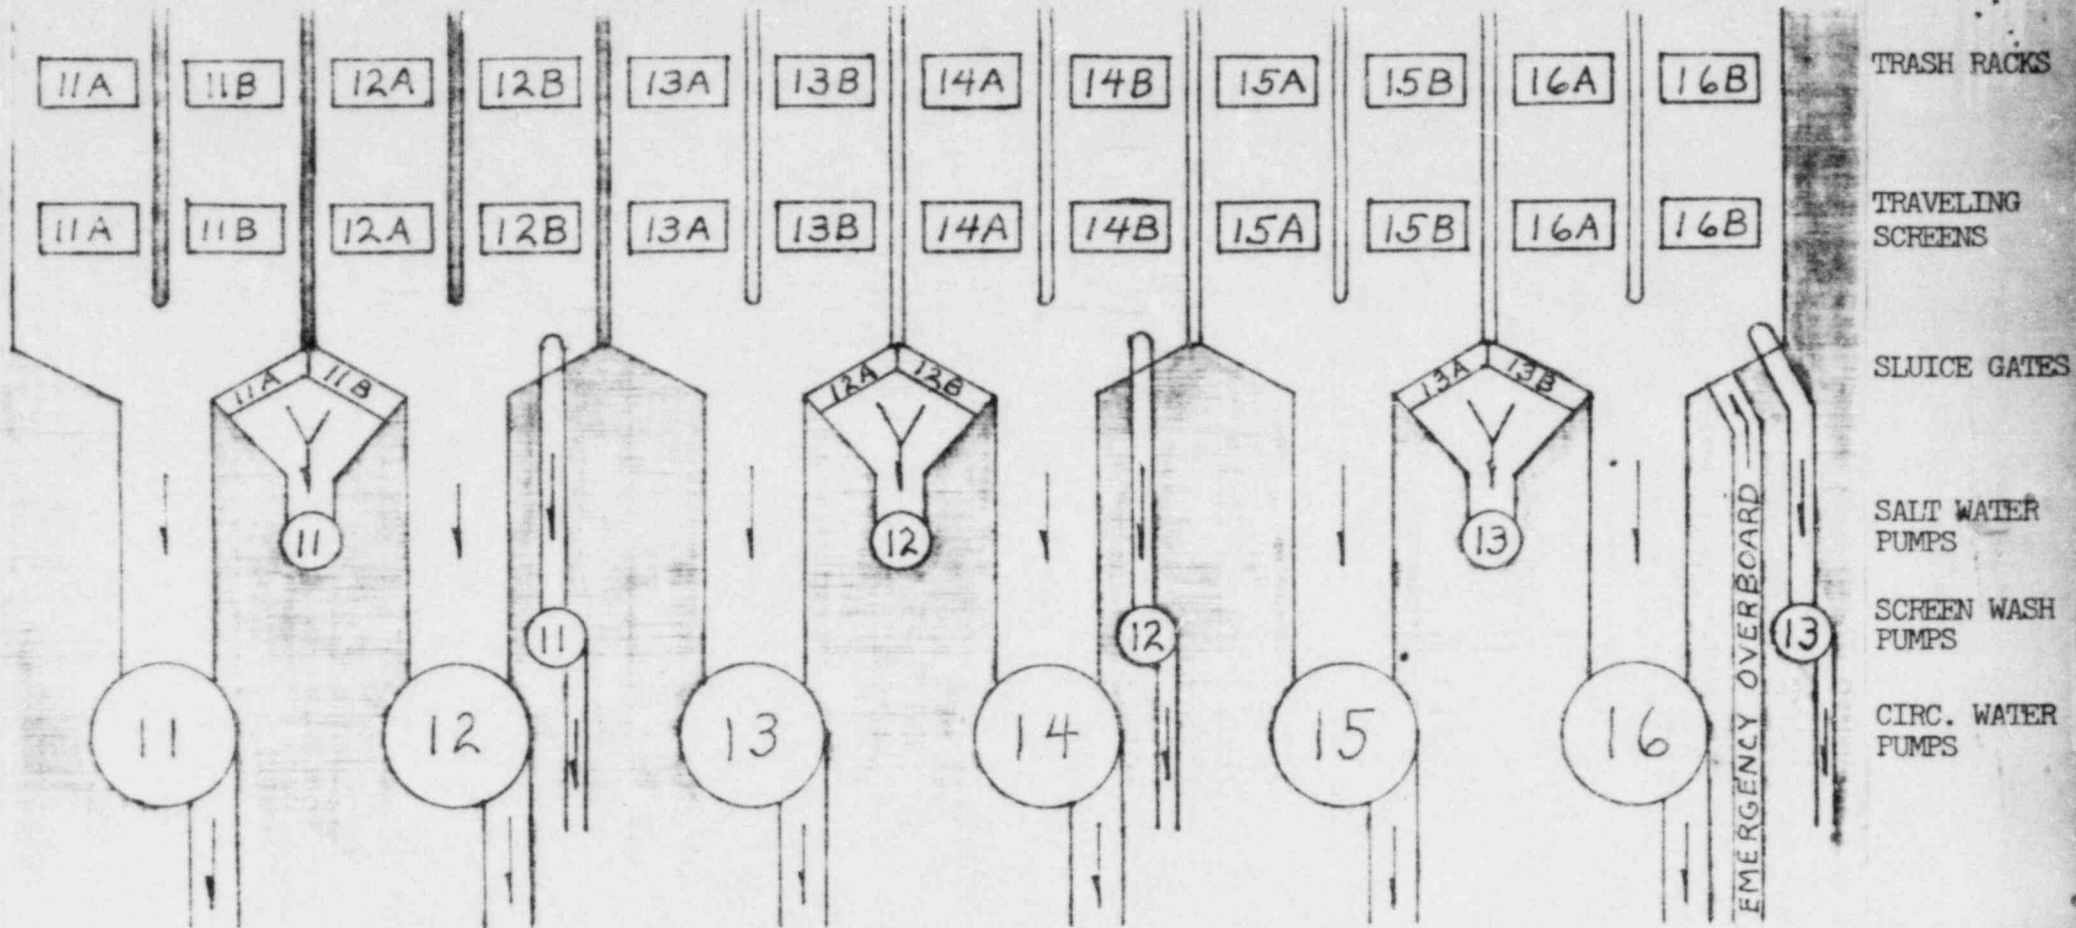
UNIT 1 WATERFRONT

Attachment 1 is provided as a description of the Unit 1 intake structure. Each salt water pump takes suction on either of two adjacent circulating water pump wells. There are three salt water pumps, six circulating water pumps, and twelve traveling water screens for each unit.
