U.S. NUCLEAR REGULATORY COMMISSION  
REGION I

Report No. 50-247/84-13

Facility Name: Indian Point Nuclear Generating Station, Unit 2

Inspection Summary: Inspection on June 12-15, and July 5-6, 1984 (Report No. 50-247/84-13)

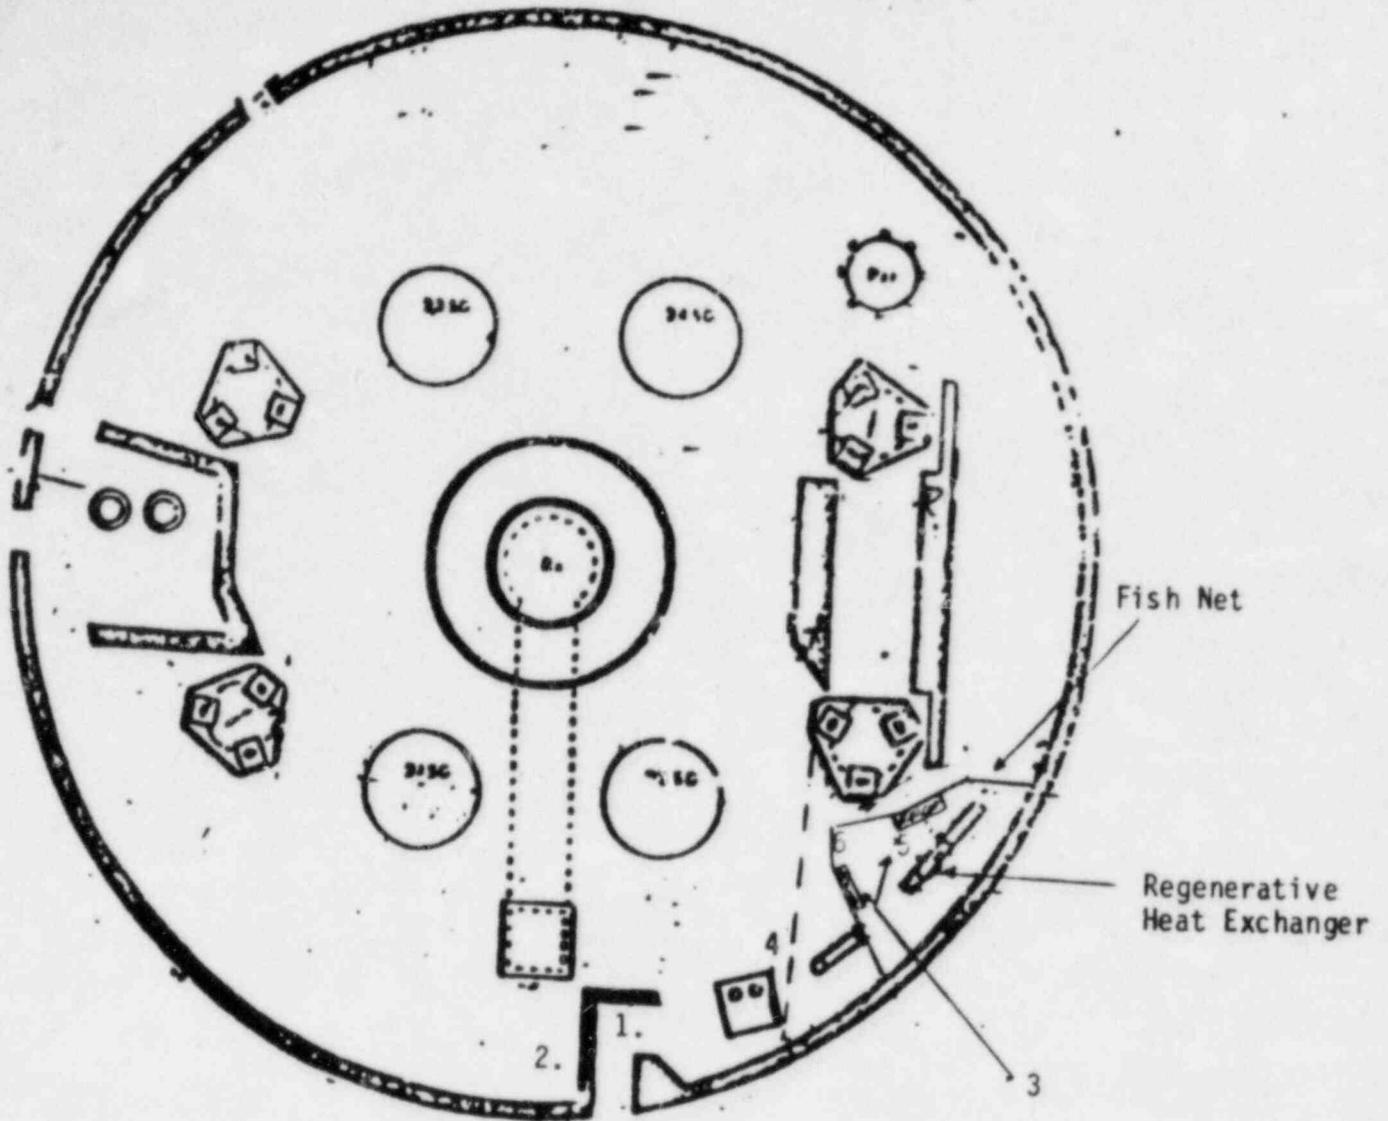
46' Elevation of Primary Containment  
(Inside Crane Wall)

On June 19, 1984 at about 3:00 p.m. three Contractor workers were suited up at the 95 foot elevation access point in preparation for work on the number 21 steam generator. The suiting up included placement of multiple dosimeters on the workers. The workers were then led to the 46 foot elevation of the primary containment south access control point by a licensee Radiation Protection Supervisor. Believing that the workers were to be needed at the work area shortly, the Radiation Protection Supervisor directed a Junior Radiation Protection Technician at the Control Point to send the three workers inside the crane wall to wait in a low dose rate area until they were called. The workers donned their head-sets and air-supplied hoods and were directed to wait at the labyrinth area (See Figure 1).

The workers entered the temporary shield cubicle of the Regenerative Heat Exchanger (see Figure 1) and proceeded to wait in the area until called. Unbeknown to the workers, the area was a High Radiation Area with radiation dose rate between 2000 millirem/hour and 4000 millirem/hour. The

to work. Due to insufficient instructions to the workers, the workers entered and waited in a high radiation area next to the Regeneration Heat Exchanger. 10 CFR 19.12, "Instructions to Worker", require that workers be instructed in precautions and procedures to minimize exposure. This appears to be an apparent violation of 10 CFR 19.12, "Instruction to Workers" (50-247/84-13-08).

- On June 19, 1984 the entrances to the Regenerative Heat Exchanger Area, an area exhibiting general area radiation dose rates between 2000 millirem/hour and 4,000 millirem/hour was not locked or otherwise controlled in any manner to preclude unauthorized entrance thereto. Technical Specification 6.12.1.b requires, in part, that the access to high radiation areas greater than 1000 millirem/hour be controlled. This appears to be an apparent violation of Technical Specification 6.12.1.b, "High Radiation Area" (50-247/84-13-09).

1. Labyrinth Area
2. Low Background area behind shield wall
3. Shield wall believed by workers B and C to be proper shield wall
4. Approximate location of rope barrier and posting
5. Area where workers waited
6. Entry point
