MIDLAND

1) NRC Question:

What is the condition of the soils under all other plant areas of the site?

1. The Detroit District hereby submits this letter report with regard to completion of subtask No. 1 of the subject Interagency Agreement concerning the Midland Nuclear Plant, Units 1 and 2. The purpose of this report is to identify unresolved issues and make recommendations on a course of action and/or cite additional information necessary to settle these matters prior to preparation of the Safety Evaluation Report.

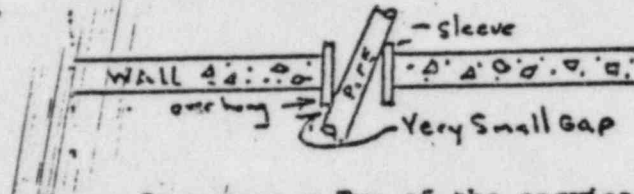
West Borated Water Tank - in the valve pit attached to the base of the structure, a large diameter steel pipe extended through a steel sleeve placed in the wall. Because the sleeve was not cut flush with the wall, clearance between the sleeve and the pipe was very small.

Service Water Structure - Two of the service water pipes penetrating the northwest wall of the service water structure had settled differentially with respect to the structure and were resting on slightly squashed short pieces of 2 x 4 placed in the bottom of the penetration. From the inclination of the pipe, there is a suggestion that the portions of the pipe further back in the wall opening (which was not visible) were actually bearing on the invert of the opening. The bottom surface of one of the steel pipes had small surface irregularities around the edges of the area in contact with the 2 x 4. Whether these irregularities are normal manufacturing irregularities or the result of concentration of load on this temporary support caused by the settlement of the fill, was not known.

These instances are sufficient to warrant an examination of those penetrations where Category I pipe derives support from plant fill on one or both sides of a penetration. In view of the above facts, the following information is required.

(2) Identify all those locations where a Category I pipe deriving support from plant fill penetrates an exterior concrete wall. Determine and report the vertical and horizontal rattle space presently available and the minimum required at each location and describe remedial actions planned as a result of conditions uncovered in the inspection. It is anticipated that the answer to Question (1) can be obtained without any significant additional excavation. If this is not the case, the decision regarding the necessity to obtain information at those locations requiring major excavation should be deferred until the data from the other locations have been examined.
