U.S. NUCLEAR REGULATORY COMMISSION  
REGION IV

Inspection Report: 50-313/95-24  
50-368/95-24

Facility Name: Arkansas Nuclear One, Units 1 and 2

Areas Inspected (Unit 2): Special, announced inspection of a licensee identified Unit 2 design deficiency where a single failure of a direct current electrical bus could affect both trains of the emergency feedwater system.

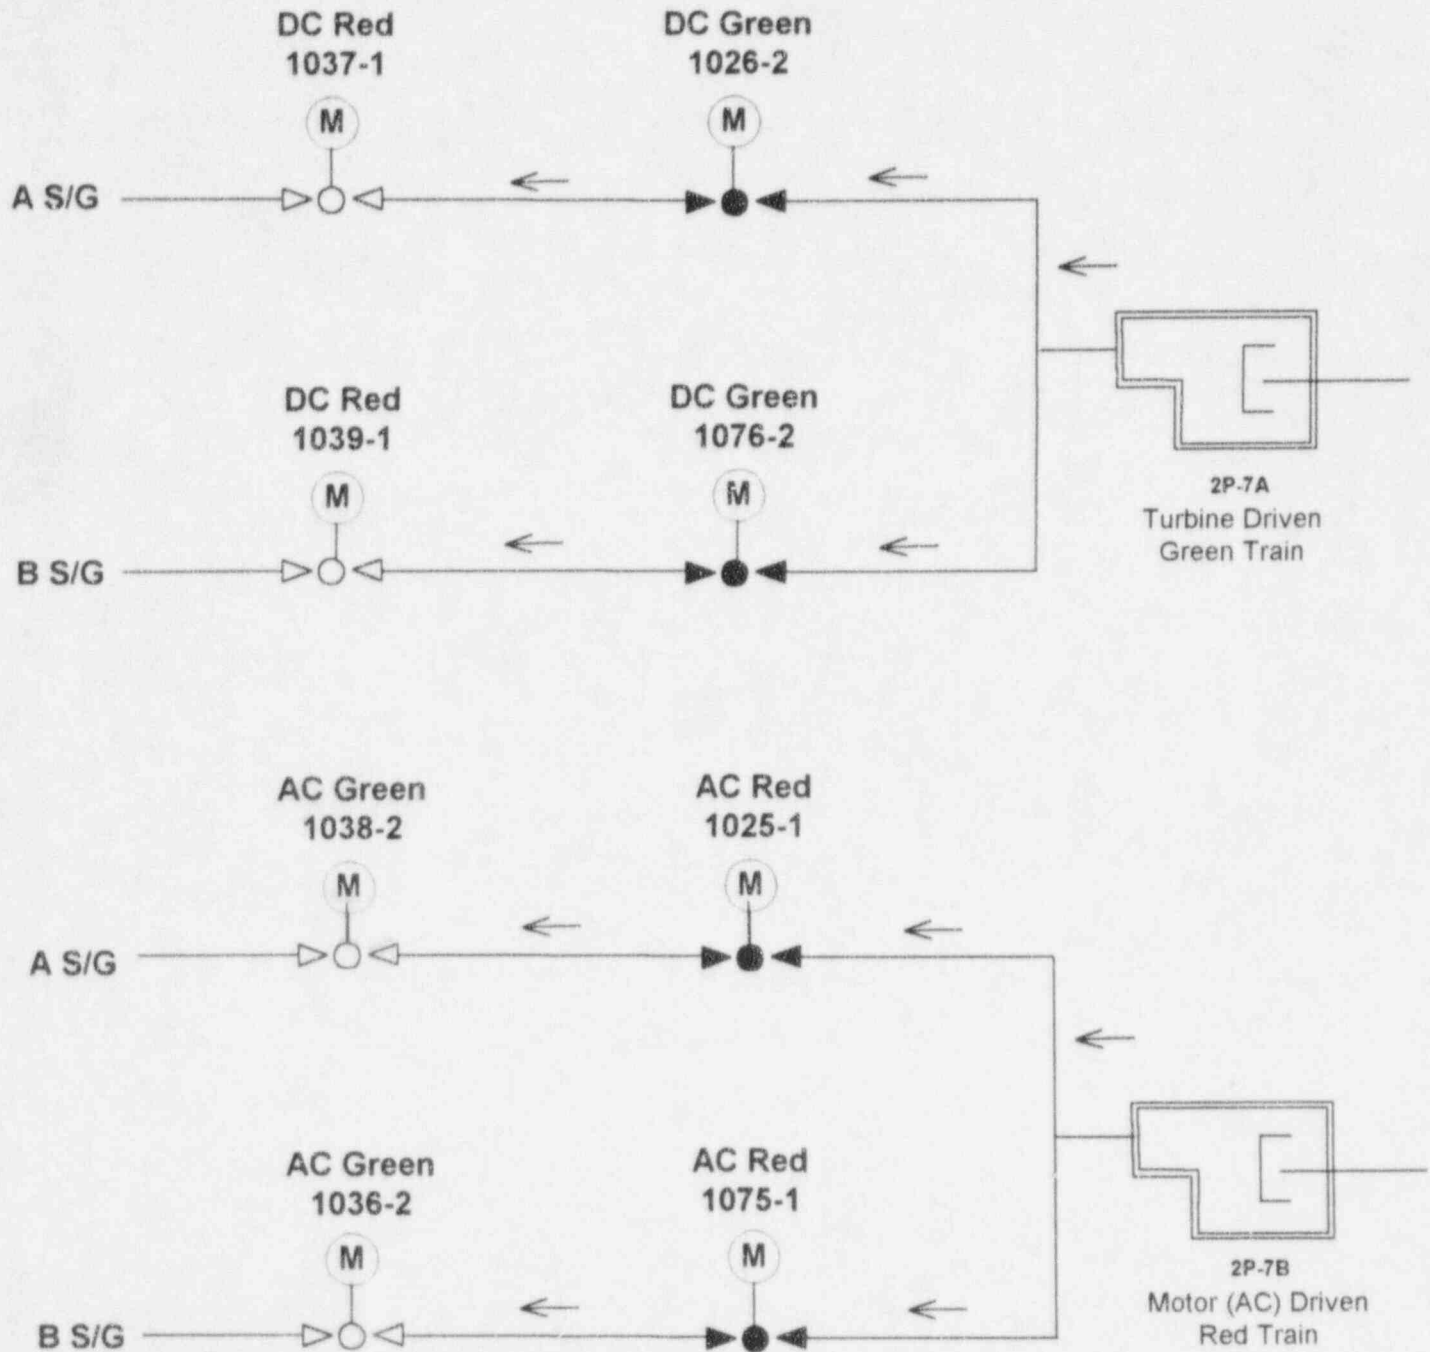
## ANO UNIT 2 Emergency Feedwater Simplified Diagram

A simplified diagram of the configuration is shown in Attachment 2. Each train has four valves, two for each steam generator. Each of the four lines has two valves, one from each train, in series.

The green train has a turbine-driven pump and uses green train dc power to operate the pump controls. There are four dc motor-operated valves downstream of the pump, with the normally closed green train dc valves nearest the pump and the normally open red train dc valves nearest the steam generators. The red train valves in the green train are normally open and assumed to fail as is (open).

The red train uses a motor-driven pump with red train ac power. There are four motor-operated valves downstream of this pump, with dc power used in the valve control circuit and ac power used to operate these valves. The green train valves in the red train are normally open and were assumed to fail as is (open). Each green train valve uses an energized dc relay in the valve control circuit to keep the valve open and the valve closes when the relay is deenergized.

This sequence is an unanticipated effect of a postulated loss of the green train vital dc bus on the red train of the EFW. This postulated event occurs because the control power and the motive power for these valves were different, and the failure of the control power did not immediately remove the motive power to these valves. The design intention was that motive power would not be available and, therefore, the green train valves would fail-as-is (open) and a flow path from the red train pump to the steam generator would remain available. The designer of the configuration failed to consider the effect that coastdown of the main generator would have on the ac powered valves.

On July 25, the licensee modified the green train valves in the red train EFW control power closing circuitry using Plant Change 95-8057, which removed the single failure concern. This change added a relay into the control circuit, which ensures that, if the green train dc bus fails, the valve will fail-as-is (open). The inspector reviewed the plant change and found it acceptable.
