Florida Power

CORPORATION
Crystal River Unit 3
Docket No. 80-002

October 23, 1995
3F1095-06

Subject: Fifth Tendon Surveillance Exempted Tendons

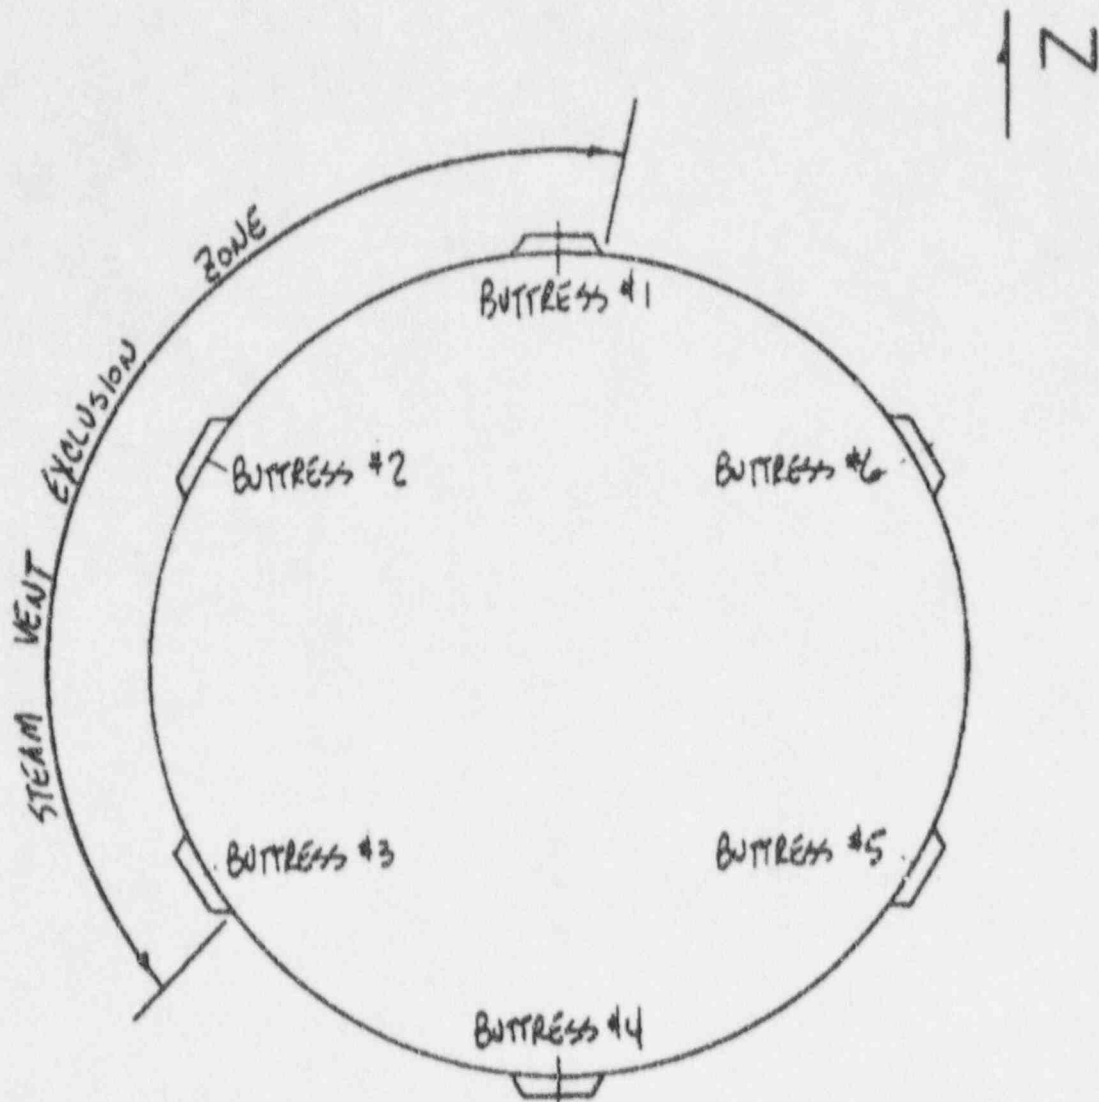
PLAN VIEW : REACTOR BLDG.

The attached sketch (page 3) depicts the Steam Vent Exclusion Zone with regard to tendon surveillances. The Reactor Building contains six (6) external buttresses spaced at sixty degree intervals. The exclusion zone encompasses buttresses #1, #2, and #3. Because of the potential for activation of the steam vents while on line, the following tendon groups are excluded from selection when performing an on-line surveillance:

- 1) Dome Tendons: Eighty five of the 123 dome tendons have at least one end (i.e., tendon cap) falling within the exclusion zone.
- 2) Hoop Tendons: These tendons each encompass three buttresses from end to end (i.e., three hoop tendons make up the circumference of the Reactor Building). There are six groups of hoop tendons: 1-3, 2-4, 3-5, 4-6, 5-1, and 6-2. Tendons above the roof line in the following groups would be excluded: 1-3, 2-4, 3-5, 5-1, and 6-2. This leaves only the 4-6 grouping as accessible while on line. One Hundred Forty (140) of the 282 total hoop tendons fall within the exclusion zone (i.e., are above the roof line and have at least one end on buttresses #1, #2, or #3). Hoop tendons below the roof line are not in the Steam Vent Exclusion Area.
- 3) Vertical Tendons: One third (i.e., 48) of the 144 vertical tendons fall within the exclusion zone.

Of the 549 total tendons, 273 (almost 50%) fall within the steam vent zone and can not be inspected while the plant is on-line.
