TECHNICAL SERVICES BUSINESS
GE Nuclear Energy
175 Curtner Avenue, San Jose, CA 95125

GENE-523-A110-1095
DRF # 137-0010-8
October 1995

**A STRUCTURAL MARGIN
EVALUATION FOR HATCH 2
INTERNAL CORE SPRAY LINES**

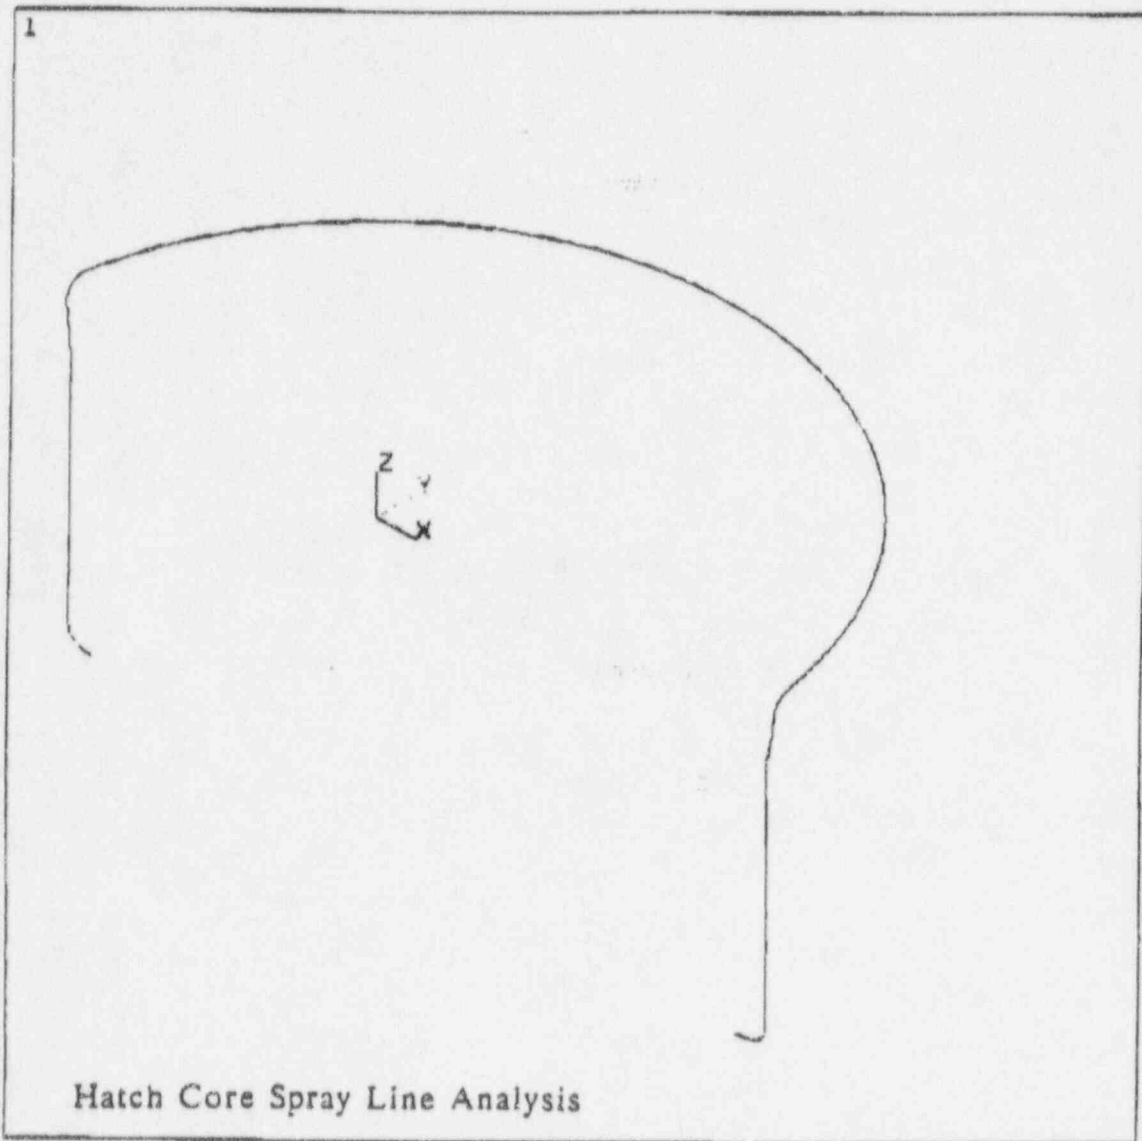
Figure 1 Finite Element Model of Core Spray System

A finite element model was constructed using the geometry of a core spray line very similar to that of Hatch 2. Figure 1 shows the geometry of the model. The stress analysis was conducted using ANSYS computer code (Reference 3). Loads due to the weight of the pipe (including captured water in the pipe) were applied to the model along with vertical and horizontal seismic loads and reactor vessel downcomer flow impingement loads. The largest resulting stresses were used from the finite element model results. These stresses were then combined with the stresses due to pressure and core spray flow loads. The resulting total stresses are shown in Table 1 on the next page as noted above, the loads due to thermal mismatch of the core spray line and reactor vessel need not be included as they are secondary in nature.

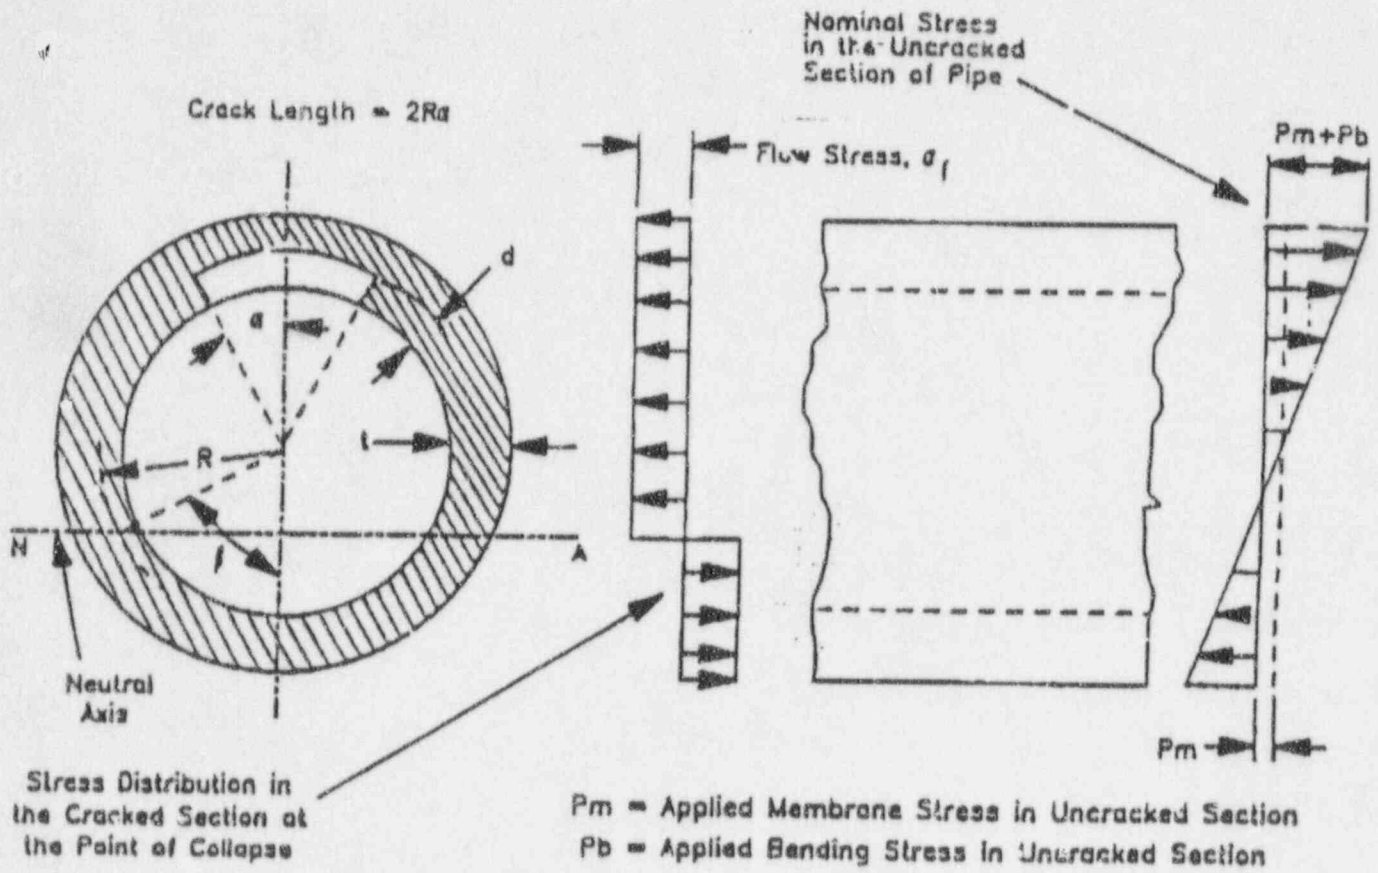
Figure 2 Stress Distribution in a Cracked Pipe at the Point of Collapse

Consider a circumferential crack of length, $l = 2R\alpha$, and constant depth, d , located as shown in Figure 2. In order to determine the point at which collapse occurs, it is necessary to apply the equations of equilibrium assuming that the cracked section behaves like a hinge. For this condition, the assumed stress state at the cracked section is as shown in Figure 2 where the maximum stress is the flow stress of the material, σ_f . Equilibrium of longitudinal forces and moments about the axis gives the following equations:

Using the stresses of Table 1 and a d/t ratio of 1.0 (through-wall flaw), the allowable through-wall crack for which failure by collapse might occur is 263°.
