LICENSEE EVENT REPORT (LER)

FACILITY NAME (1) CRYSTAL RIVER UNIT 3	DOCKET NUMBER (2) 0 5 0 0 0 3 0 2	PAGE (3) 1 OF 0 3
---	--------------------------------------	----------------------

TITLE (4)
AUXILIARY BUILDING EXHAUST FANS OUT OF SERVICE FOR MAINTENANCE

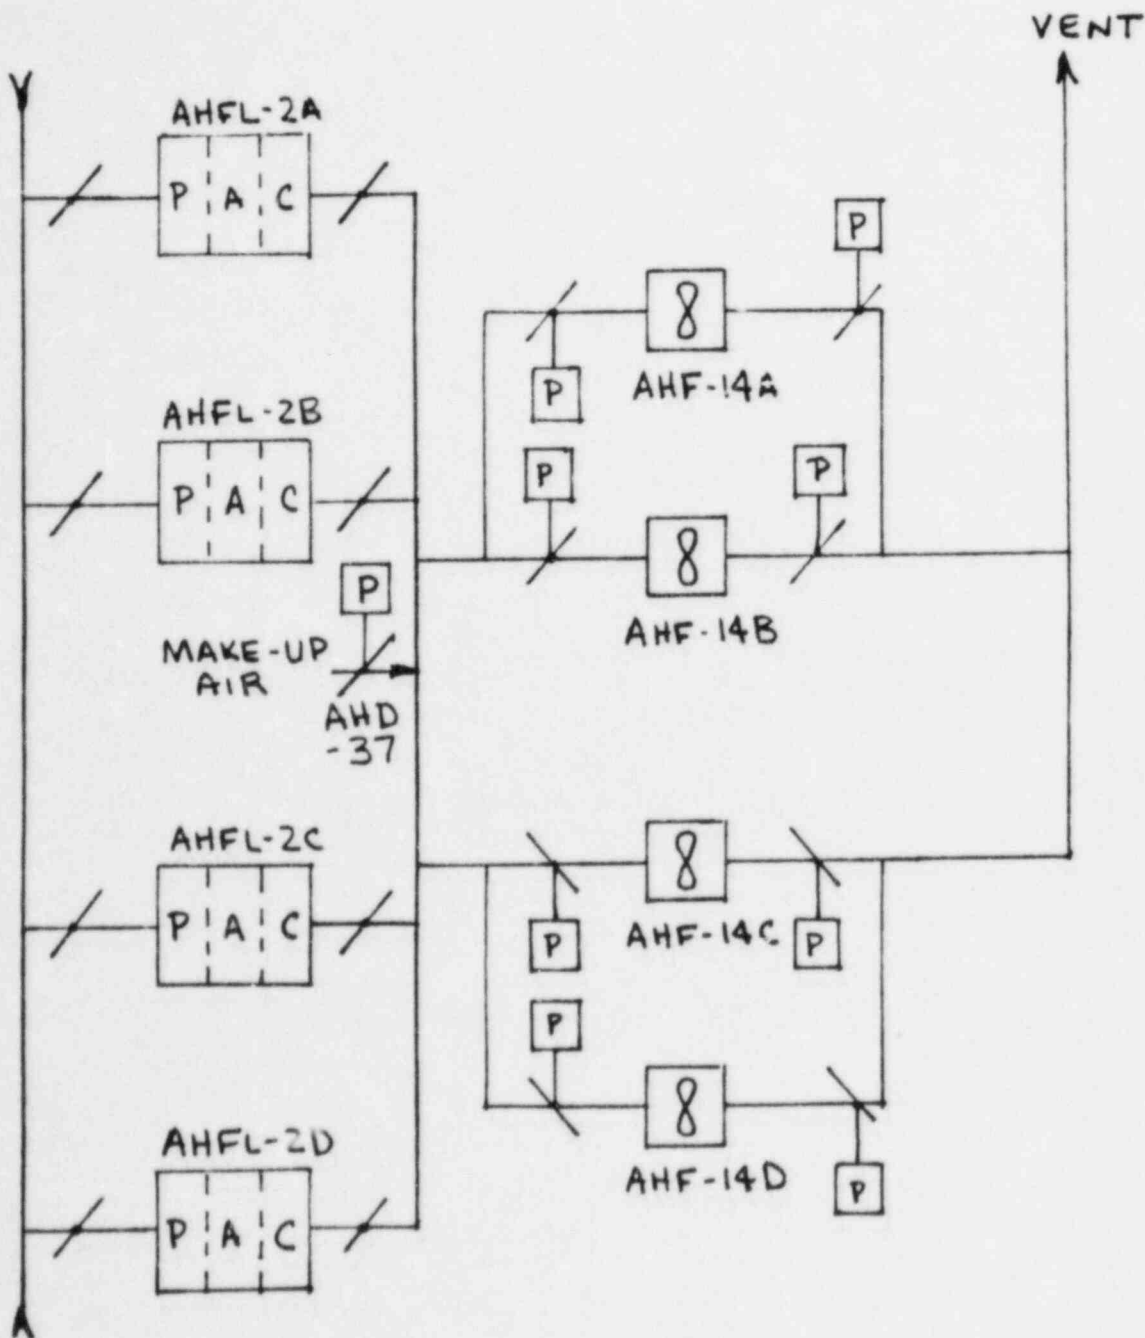
FIGURE 1

1. On March 22, 1984, during a planned shutdown, at 0330 the Auxiliary Building Exhaust Fans (AHF-14 A, B, C, D) (VF, FAN) were taken out of service in order to install a blank-off plate (FB) on makeup air damper AHD-37 (VF, DMP) (Figure 1). The purpose of the blank-off plate was to allow the ventilation system to be operated while damper AHD-37 was replaced. The blank-off plate was installed, and a pair of exhaust fans restarted at 0550 on 3/22/84.
2. On June 25, 1984, at 0445 the Auxiliary Building Exhaust Fans were taken out of service in order to install a blank-off plate on the exhaust duct for filter bank AHFL-2B (VF, FLT). The purpose of the blank-off plate was to allow the exhaust damper for the filter bank to be replaced. The blank-off plate was installed and the exhaust fans restarted at 0530 on 6/25/84.
