NYN-95 084

October 25, 1995

Subject: Supplement to Relief Request From ASME Code Section XI Requirements and Results of Augmented Inspections

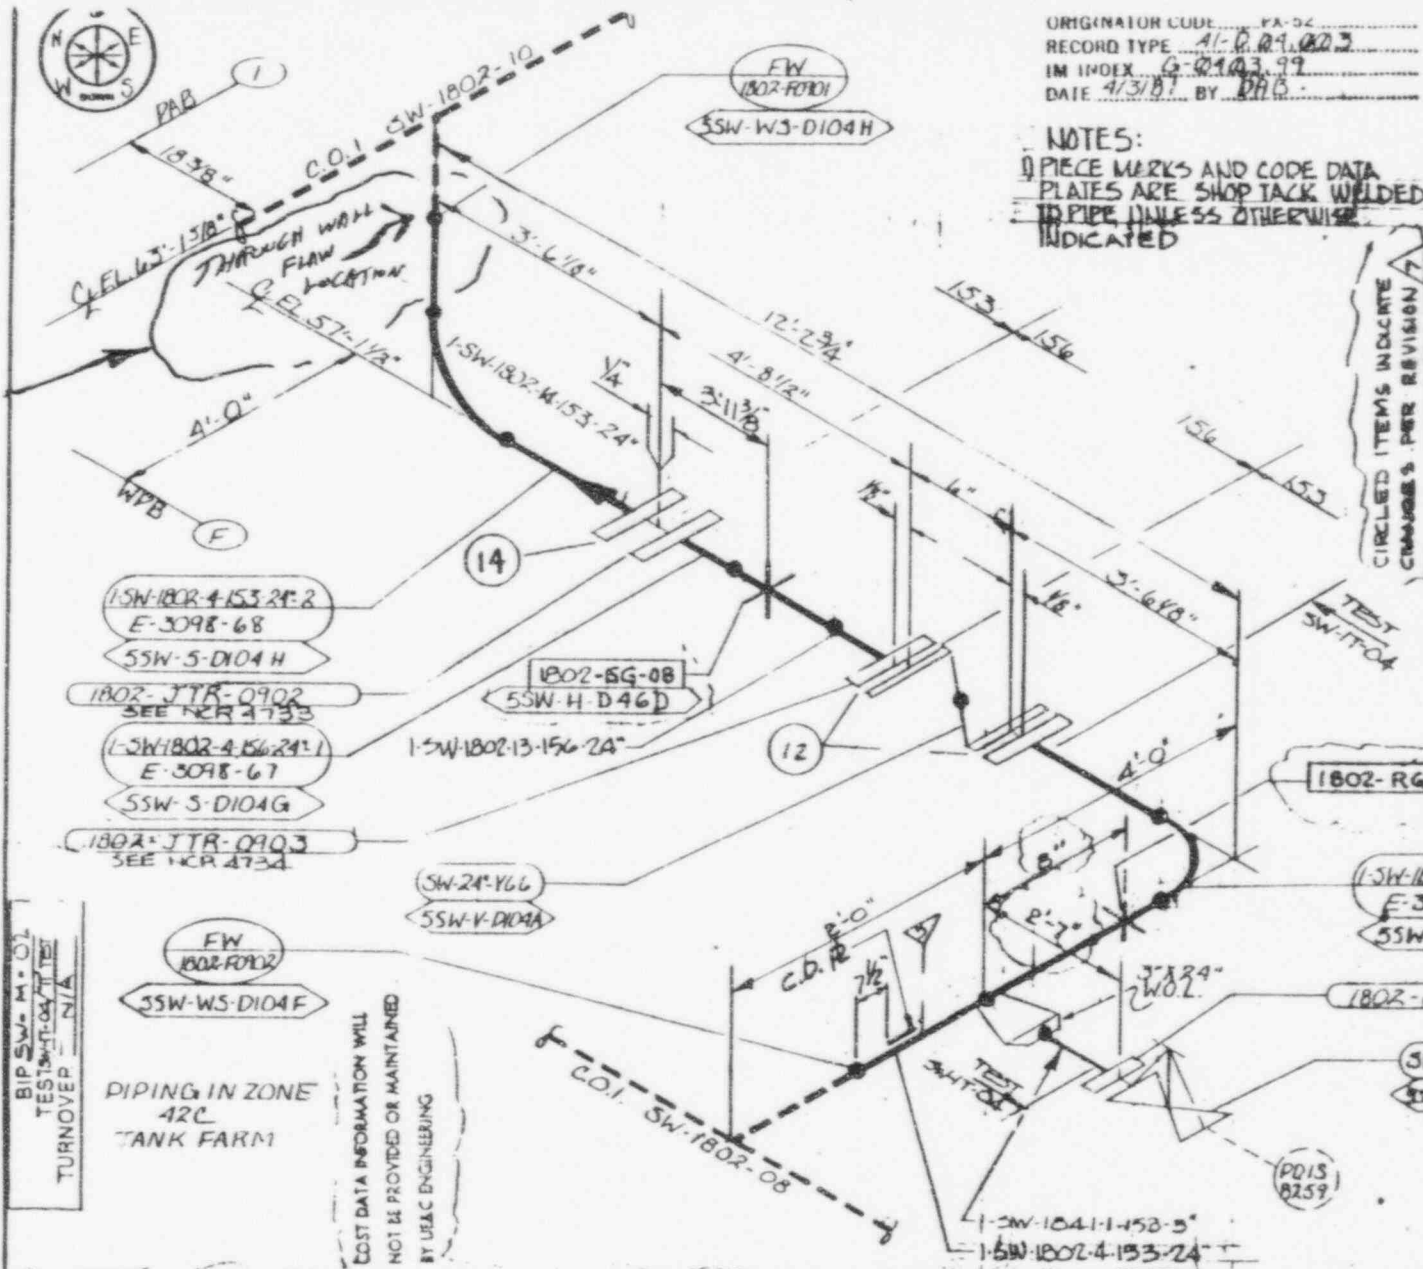
ATTACHMENT # 1

There are two through wall flaws causing leakage from Field Weld SW-1802-F0901 on line 1802-14-153-24". One flaw has leakage at two locations approximately 1/4" apart. This field weld connects line 1802-14 to line 1802-5-153-24" and is downstream of the normally closed "B" train strainer bypass valve SW-V66. (Refer to Attachment 1)

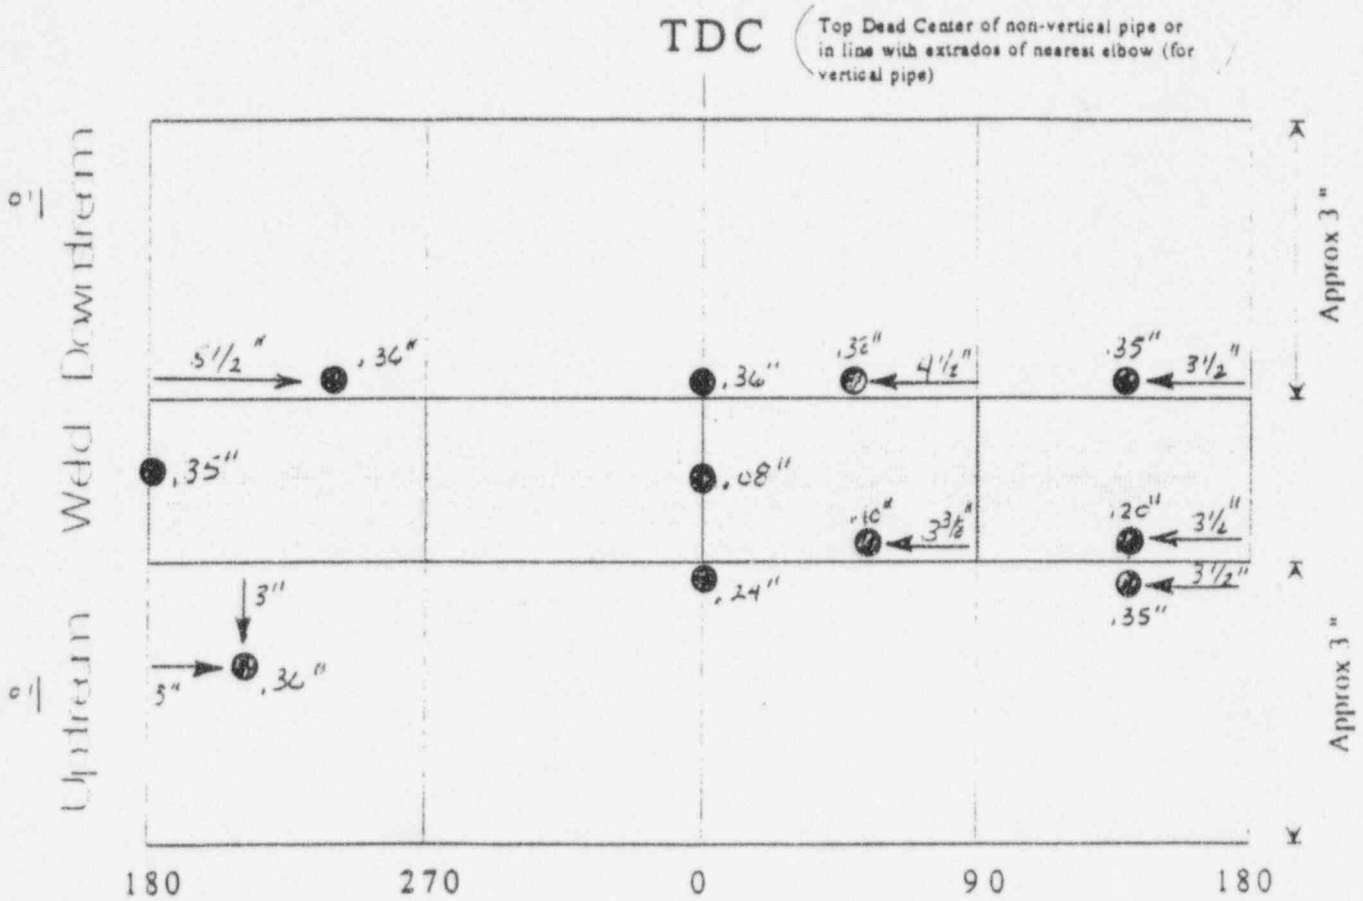
Line 1802 Weld No. F0901 Date 10-18-95

Localized long term degradation or improper application of X-Pando or Sikadur Low-Mod-Gel joint compound permitted sea water to come in contact with the carbon steel piping substrate/weld. Pitting corrosion then caused accelerated local attack at this unprotected field weld.

The flaws are localized. The first flaw (75° location on the UT coordinate system) has two pinhole leakage points approximately 1/4" apart. The flaw is elliptical in shape and shown in detail in the attached UT Examination Report per Attachment 3, page 5. The second flaw (0° location on the UT coordinate system) has a single leakage location and is shown in detail on Attachment 3, page 4.

NOTE: WELD CROWN NOT SCANNED FROM 1" CW OF 0° TO 6" CCW OF 90° DUE TO AS-WELDED CONDITION.

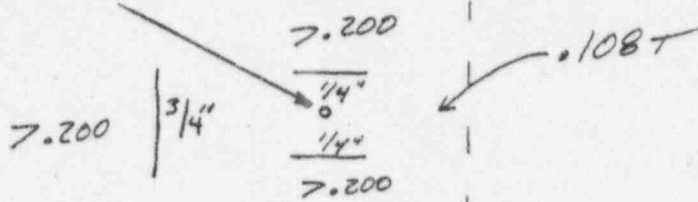
2nd LEAK LOCATION
.08

0° → AS-Welded
1" No
SCAN

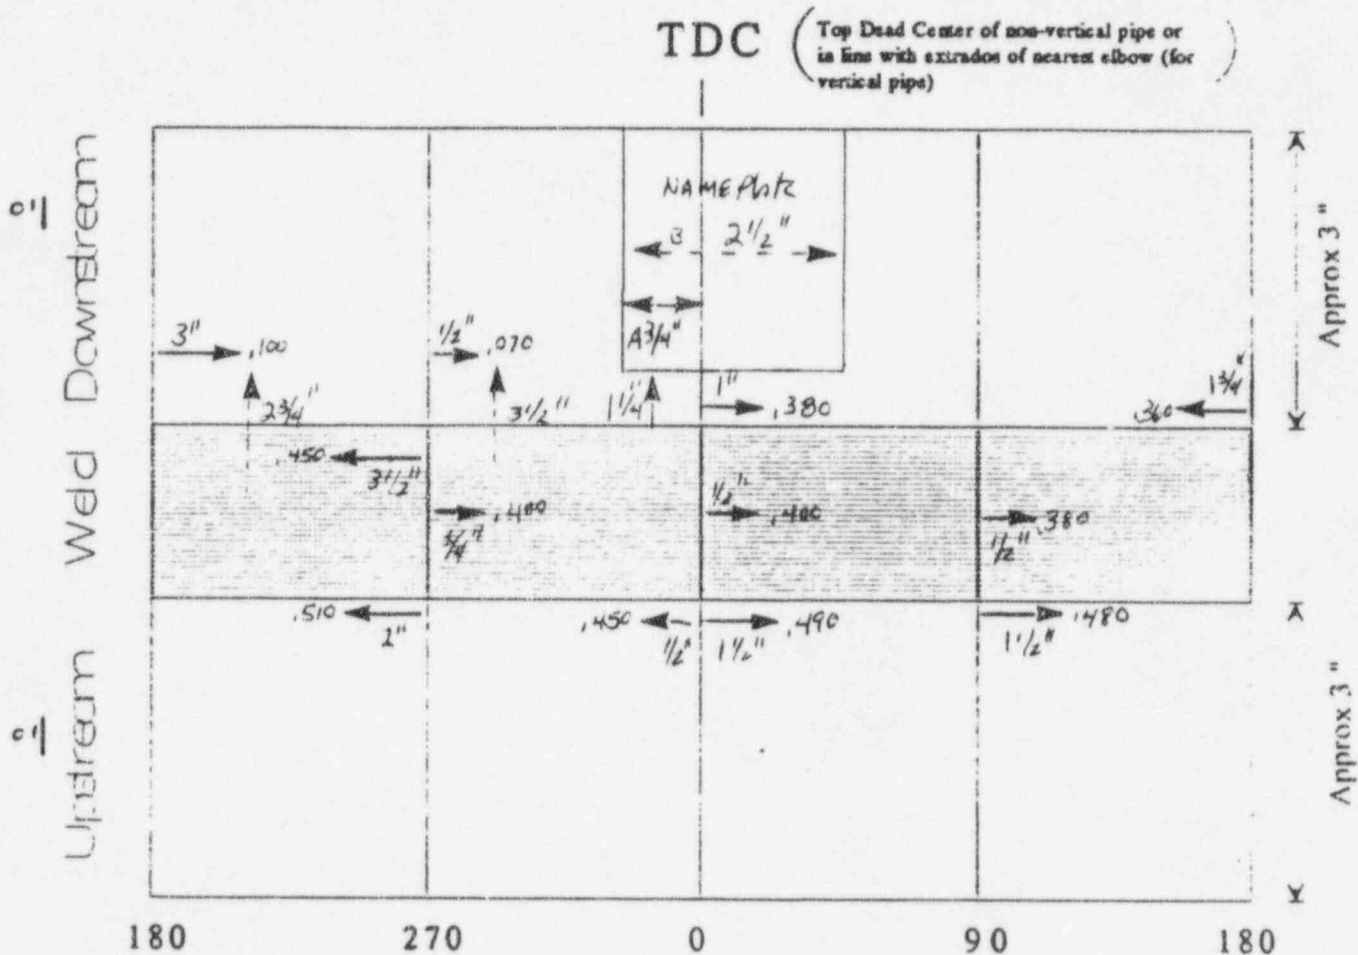
Line 1802 Weld No. F1001 Date 10-20-95

It should be noted that one other field weld, SW-1802-F1001, initially exhibited two locations of wall thinning of less than minimum wall thickness. These readings were taken on the pipe wall outside of the weld area. Subsequent evaluation determined that these readings were caused by inclusions in the base metal during manufacturing and were not the result of corrosion. These inclusions are acceptable per the code and they do not adversely affect system operability nor require repair.
