Docket No. 50-346

Toledo Edison Company
ATTN: Mr. Donald Shelton
Vice President
Nuclear
Edison Plaza
300 Madison Avenue
Toledo, OH 43652

SUBJECT: ADDITIONAL PROTECTION FOR LIGHTNING STRIKES AT NUCLEAR POWER
GENERATING STATIONS

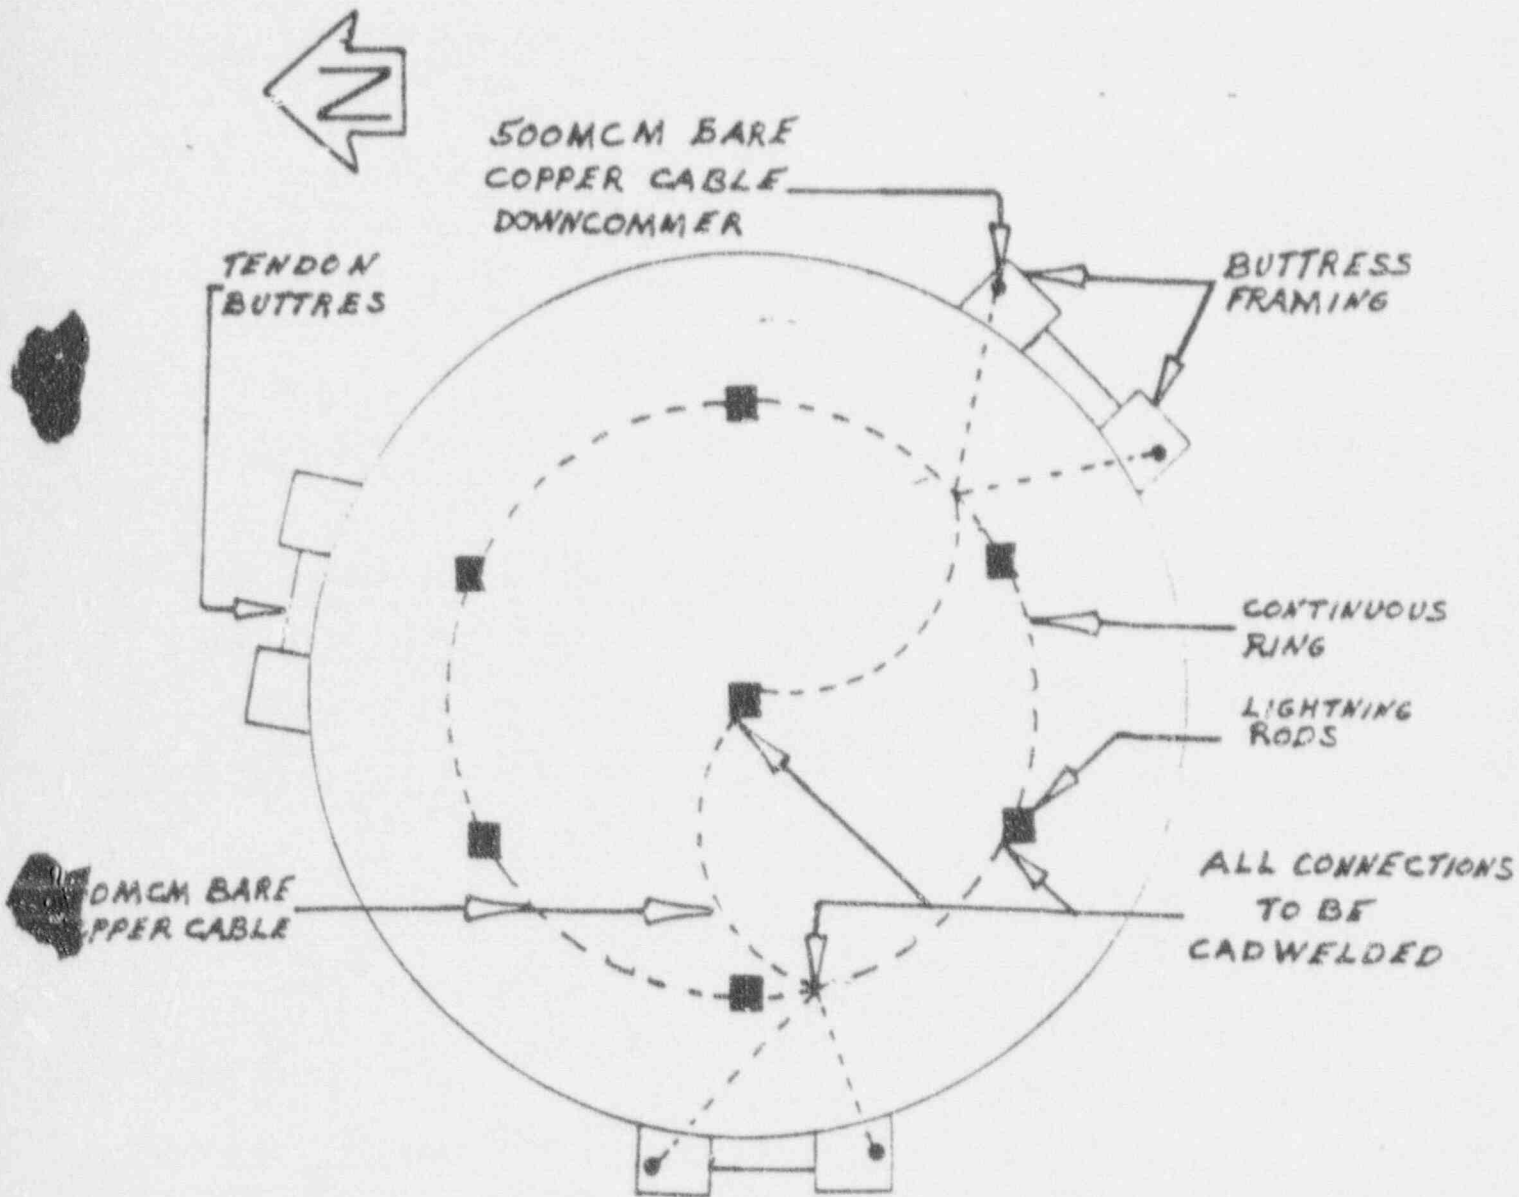
CONTAINMENT BL'DG DOME
LIGHTNING ROD AND GROUND
CABLE ARRANGEMENT

To prevent equipment damage due to similar lightning strikes, the containment lightning protection system was modified. This modification was installed prior to start-up after the lightning strike. The primary objective of the modification was to minimize the effect of lightning strikes on plant equipment. This objective was satisfied by isolating the containment lightning protection grid from structural steel and routing new conductors from the grid to the station ground mat. This approach will ensure that lightning strikes are carried to ground external to the containment structure.

NOTE: INSTALL BONDING JUMPER FROM EACH DOWNCOMMER TO EACH LADDER SECTION AND TO BUTTRESS FRAMING AT 10' INTERVALS.

INSTALL BONDING JUMPER FROM EACH DOWNCOMMER TO EXISTING GROUND MAT AND/OR TO 10' GROUND RODS.
