Florida Power

CORPORATION
Crystal River Unit 3
Docket No. 95-302

Subject: Licensee Event Report (LER) 95-019-00

TITLE (4)
Service Water System Review Discovers Leak Instrumentation Unable to Perform its Function Resulting in Operation Outside the Design Basis of thte Plant.

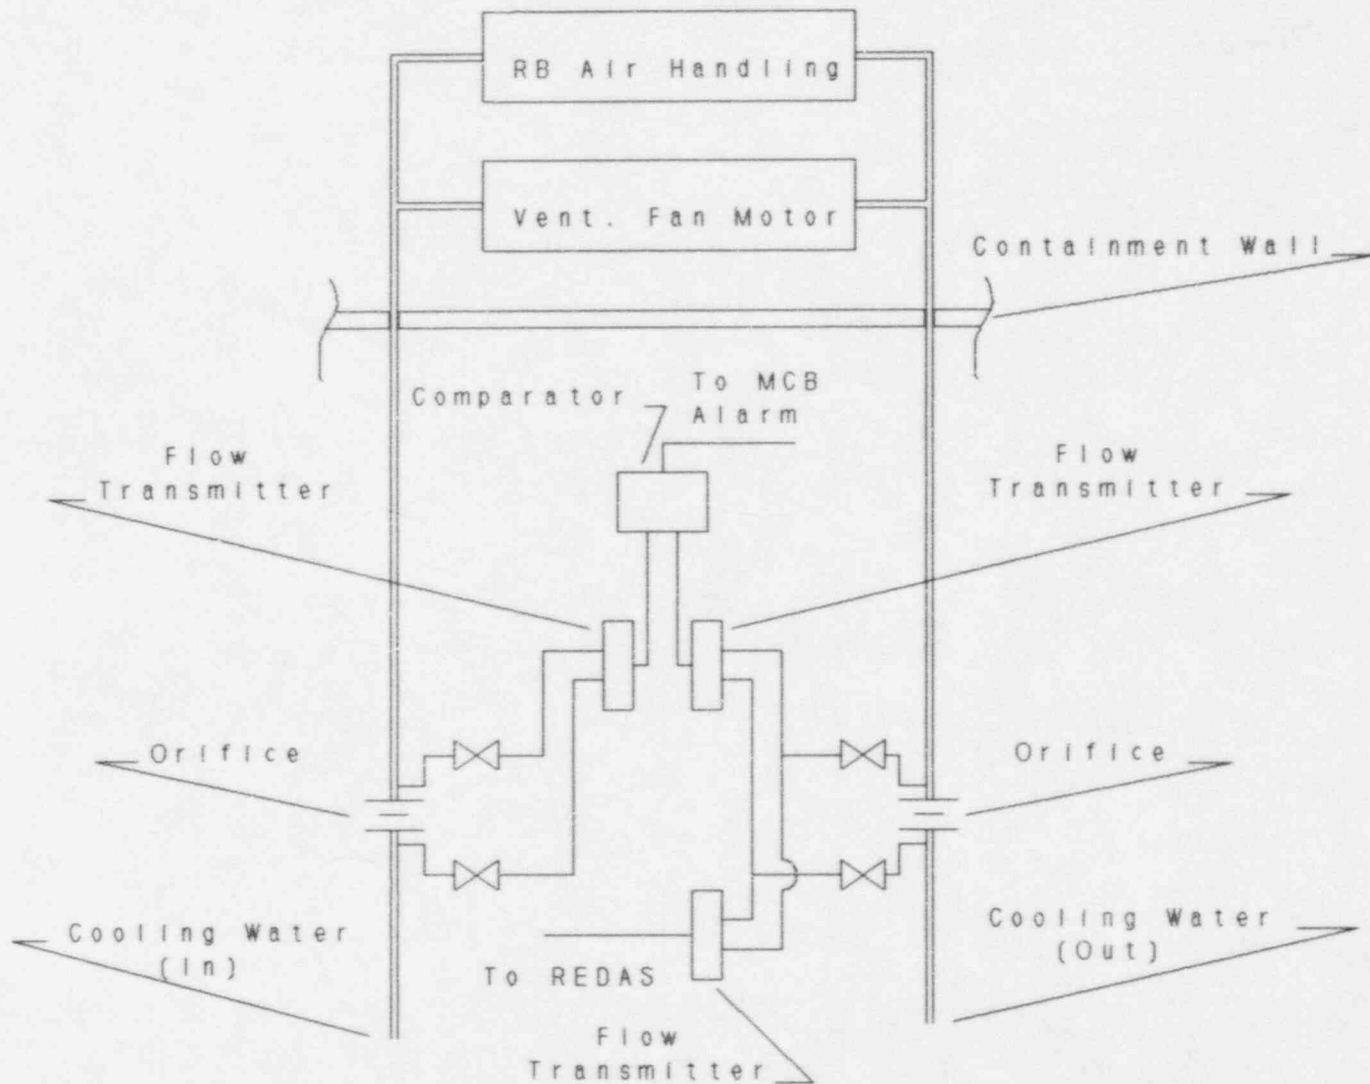
Attachment 1 - RB COOLER LEAK DETECTION

One of the safety functions of the SW system is to provide a redundant RB cooling function to the RB Spray System [BE], through the RBCUs, for the purpose of removing heat released inside the containment following a gross leakage of primary coolant or main steam. The SW system can provide cooling water to each of three RBCUs. Only two are in operation after an ES actuation. SW flow is isolated to the idle RBCU. The flow through a typical RBCU is illustrated in Figure 1 - RB Cooler Leak Detection. The SW flow to each RBCU is currently in excess of 1940 gpm.

If cooling water supply or return lines rupture, the leaking coil, or pipe, as well as any other component of the SW System inside containment, will initiate an alarm from differential FTs on the cooling water supply and return lines. The operator at the control board will then remotely close the isolation valves on the affected line. The remaining unit will operate in conjunction with the building spray system to provide heat removal capability in accordance with the plant design.

The high flow differential alarm sounds in the control room if there is a 90 gpm or greater difference between the inlet and return SW coolant flow lines. The installed instrumentation has a range of 0 to 150 inches (in.) of water which equates to 0 to 1943 gpm. The instrumentation is presently calibrated for a range of 0 to 35 in. of water, corresponding to 0 to approximately 930 gpm. Since SW flow can be in excess 1940 gpm with two of the three RBCUs in operation, the leak detection instrumentation is offscale high and is not capable of identifying a 90 gpm leak as required by the design basis.

A review of past calibration data sheets by engineering personnel indicates that the calibration range for the FTs was changed from 0 to 150 in. to 0 to 35 in. of water in 1976. Although this range is acceptable for CI system cooling, it is inadequate when the RBCUs are aligned to SW. The basis for this change has not been determined nor has the documentation been located. This deficiency appears to have been in place since the original plant construction, prior to power operation.

The cause of this deficiency was personnel error, apparently by the contract Architect & Engineering personnel performing the original system design. The engineers failed to properly evaluate the system interface requirements.

An evaluation of the calibration spans for the applicable flow transmitters will be performed. The evaluation will include a review of the need for this instrumentation, flow rates in effect for both SW and CI cooling, and an evaluation of the flow switch setpoints. This evaluation will be completed by January 1, 1997, and may produce additional corrective actions.
