UNITED STATES NUCLEAR REGULATORY COMMISSION WASHINGTON, D. C. 20555

BOARD NOTIFICATION: ALLEGATIONS RELATING TO IMPROPER CONSTRUCTION PRACTICES ON COMANCHE PEAK 4IN CONDENSERS

(BOARD NOTIFICATION NO. 84-124)

The attached enclosures are matters relating to alleged improper construction practices involving the Comanche Peak Steam Electric Scation main condensers (Units 1 and 2) expressed by an alleger during an interview conducted on August 24, 1983 by members of the NRC Office of Investigation Field Office, Region IV. Although the condenser units are components within the BOP classification, the allegations expressed raise concern as to the quality of workmanship that could impact on reactor safety.

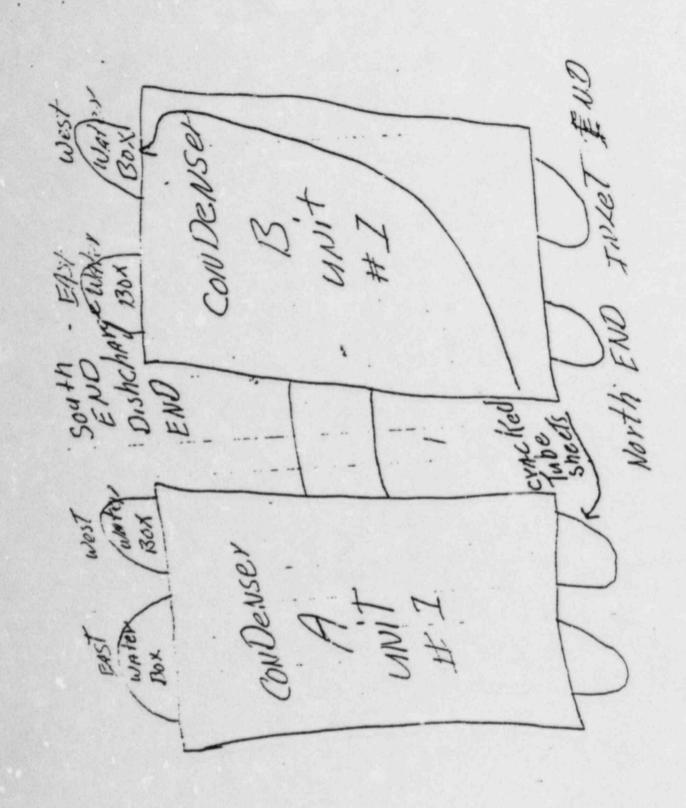
(At this point in the proceedings is referring to Exhibit 1.)

Here is your water boxes right here and your condensers. All right, in condenser A on the inlet end on the west box and it is in three sections. You have got some cracked tube sheets in here. Back there you have got some cracked tube sheets. You have got overrolled tubes or barely overrolled. They are supposed to be rolled 069 thousand is a perfect roll inside reading. They allow us to go to 071 thousand. We went up 90-some thousands.

should be twice as many support sheets in there and all that stuff. So they intergrooved the tube sheet and they still have got leaks over there on this section here and we are not supposed to have no leaks at all.

okay. Condenser B, Unit 1, west discharge water box and you have got a cracked tube sneet. Also, the tubes are overrolled severely.

on the east water box, condenser B, discharge end, you are heavily overrolled and you undoubtedly have got quite a few cracks in it. I can swear to that. I know you do because it swelled up so big.

Overroll on the west box, condenser A, Unit 1, discharge end.

East water box, discharge end, condenser A, you are still leaking, and overrolled.

You have got cracked tube sneets.

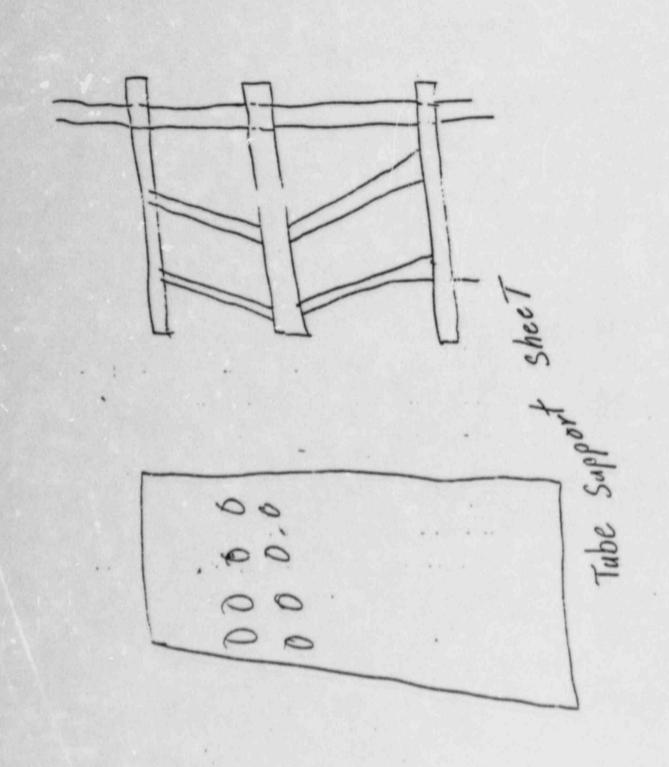
This is a real good example. These tube support sheets came in. We laid them on top of each other and we put dowel pins in them. Some of the noies was three-eighths of an inch off from the others, you know.

are going to have a problem here. These holes are way off. well, he calls Westinghouse, and Westinghouse says oh, there is nothing to it. Says, they are just three-eighths of an inch off. I said well, you have got three foot from the center of one sheet to the other, and when you start off with three-eighths of an inch off you are off quite a ways when you get to the other end, you know, the three foot.

If you go three-eighths of an inch off, over here you might be an inch and a half off, and by the time you turn it back in then automatically you are going to head the other way. So you are binding every sheet. You are cutting into the tubes.

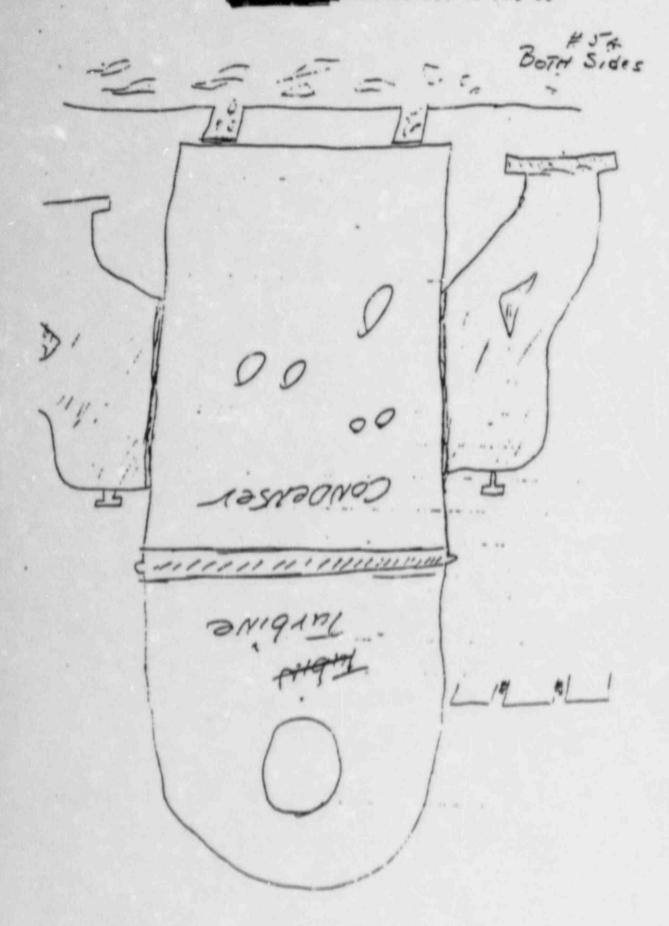
Exhibit 5A and 5B follows:)

well, this general foreman, he gets there and he starts welding all kind of stuff to hold it to keep from coming past it. Well, what we did was we jacked the turbine over. We went ahead and got it up. Well, instead of them making a final check to see whether they was in line or not, they just assumed they were and they was three-eighths of an inch off. So we welced it all together.

They took a reading and they was three-eighths of an inch off alignment. So they went up here and they took jacks and they started jacking and, boy, jacked it all the way over to where they want it and they release it, that little old expansion joint, and pulled it back. The little expansion joint was a one loop and it was an eighth of an inch thick and it had one little fillet weld on each side of it, real weak. They put several, several tons on it. I will show you what it looked like.

Right, it is non-Q. We are down here throwing that turbine back. They started having us jack it. We jacked it up and down putting all kind of stress on it, and well sideways. You know, you can tear
