ILLINOIS POWER

Subject: Clinton Power Station - Unit 1
Licensee Event Report No. 90-016-00

TITLE (4) **Breach of Secondary Containment Integrity During CORE ALTERATIONS Due to Unknown Personnel Blocking Open a Secondary Containment Access**

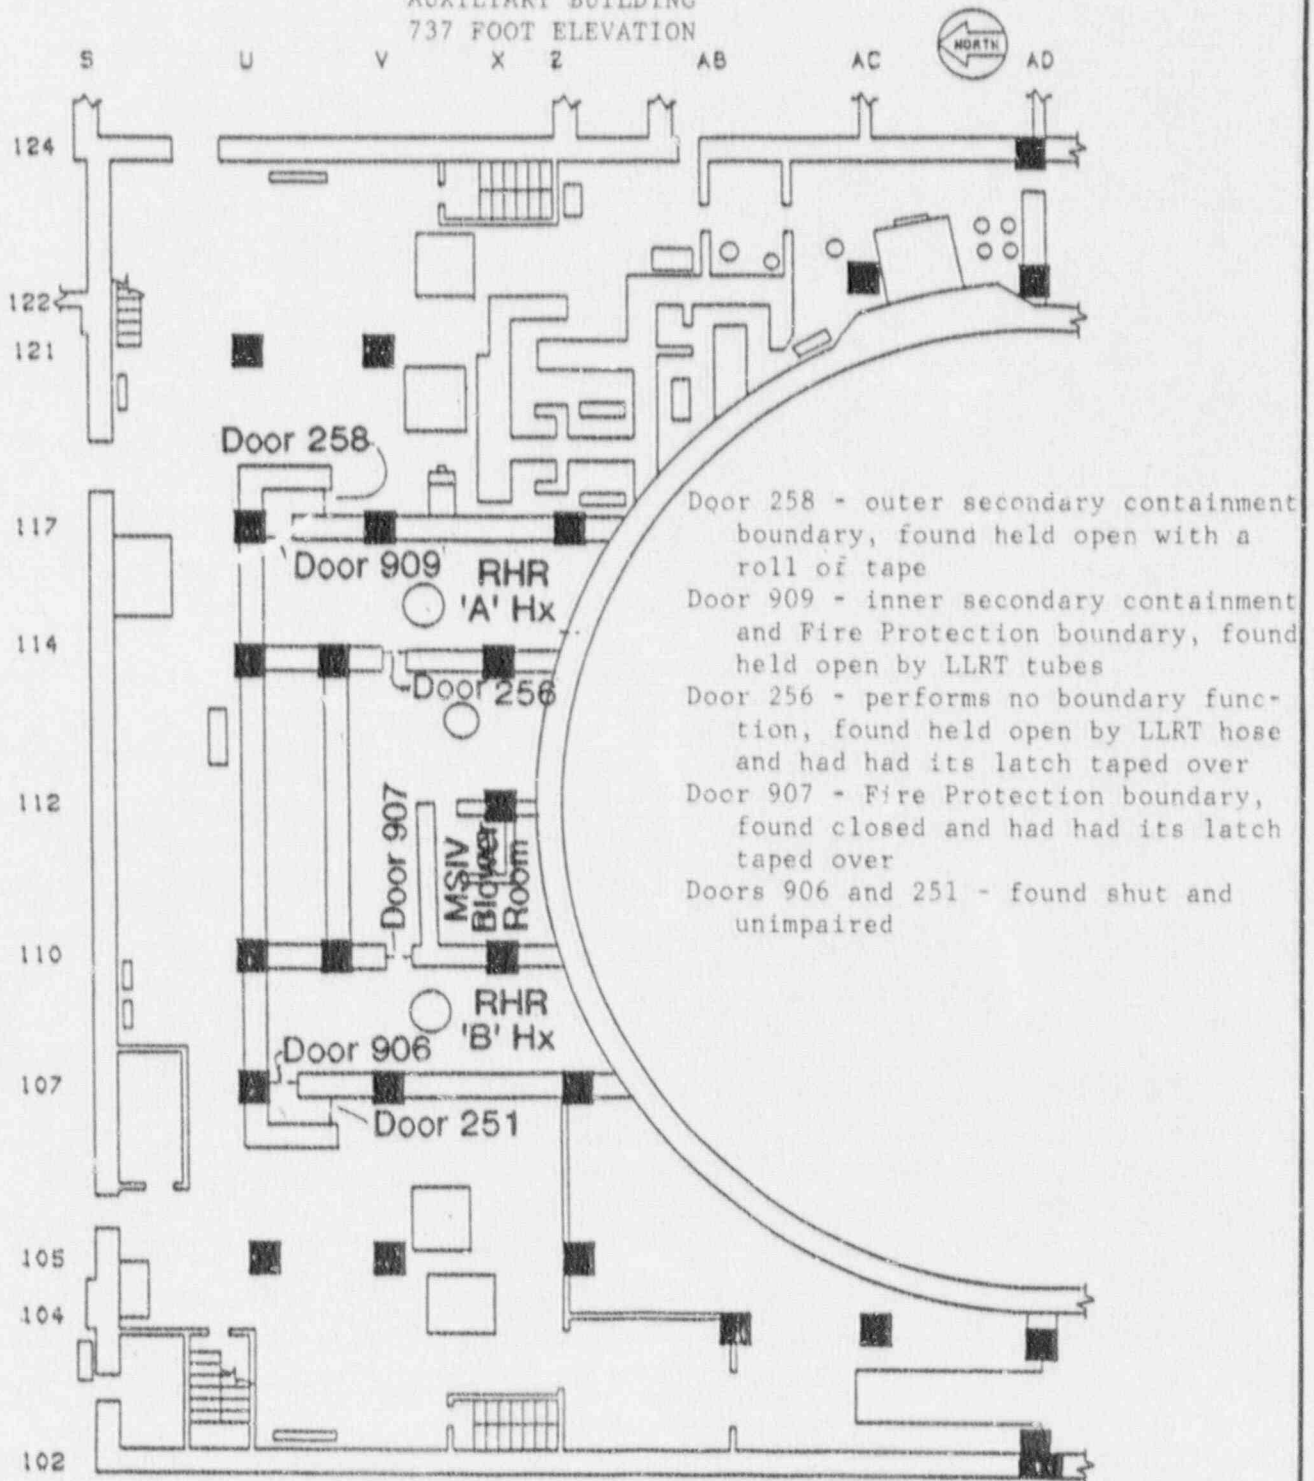
FIGURE 1

- ° The RHR 'A' HX room outer interlock [IEL] door, door 258, was held open with a roll of yellow tape between the door and door frame. Door 258 is a High Radiation and secondary containment integrity boundary normally locked shut (see Figure 1, on page 6). The Shift Supervisor (SS) and Radiation Protection Shift Supervisor (RPSS) maintain administrative control of the keys to unlock it.

- ° The RHR 'A' HX room inner interlock door, door 909, was held open approximately three inches by two three-eighths inch sleeved Local Leak Rate Test (LLRT) tubes [TBC] running under the door. Door 909, normally shut, latched and interlocked to door 258, is a Fire Protection and secondary containment integrity boundary (see Figure 1, page 6). The secondary containment electrical airlock interlock had been defeated.

- ° Door 256, between the RHR 'A' HX room and Main Steam [SB] Isolation Valve (MSIV) Leakage Control System (LCS) [BD] room, was found held open approximately three inches by an LLRT hose running under the door, and had had its latch taped over to prevent the door from latching (see Figure 1, on page 6). Door 256 does not perform any controlled boundary function except as a ventilation barrier during normal plant operations.

- ° Door 907, between the RHR 'B' HX room and MSIV Blower room, was found closed, but had had its latch taped over to prevent the door from latching (see Figure 1, on page 6). Door 907, normally shut and latched, is a Fire Protection boundary.

Illinois Power Company's (IP) investigation into this event included interviews of appropriate personnel with access under an approved Radiation Work Permit (RWP) into the RHR HX rooms on November 29, 1990. This investigation could not determine the cause of this event, since no person or persons can be identified who impaired the specified doors; however, the most probable cause is the lack of respect or knowledge by person or persons for the requirements of secondary containment integrity, High Radiation, and Fire Protection boundary doors.

- Door 258 - outer secondary containment boundary, found held open with a roll of tape
- Door 909 - inner secondary containment and Fire Protection boundary, found held open by LLRT tubes
- Door 256 - performs no boundary function, found held open by LLRT hose and had had its latch taped over
- Door 907 - Fire Protection boundary, found closed and had had its latch taped over
- Doors 906 and 251 - found shut and unimpaired

The RP technician took the following immediate action upon discovery of the above condition: 1) removed the roll of tape, and shut and locked door 258, 2) removed the LLRT tubes from under the door and shut door 909, 3) removed tape over the latch of door 256, but left the LLRT hose in place, and 4) removed the tape over the latch and shut door 907.

The secondary containment electrical airlock interlock for doors 258 and 909 was placed back into operation on December 20, 1990.

All personnel with access to the Protected Area were informed that no door is to be taped, blocked, or otherwise impaired without permission from the appropriate supervision.
