LICENSEE EVENT REPORT (LER)

| Facility Name (1)<br>Quad Cities Unit Two | Docket Number (2)<br>0 5 0 0 0 2 6 5 | Page (3)<br>1 of 0 6 |

Title (4)  
Failure to Start of the HPCI Turning Gear Motor due to Unknown Cause.

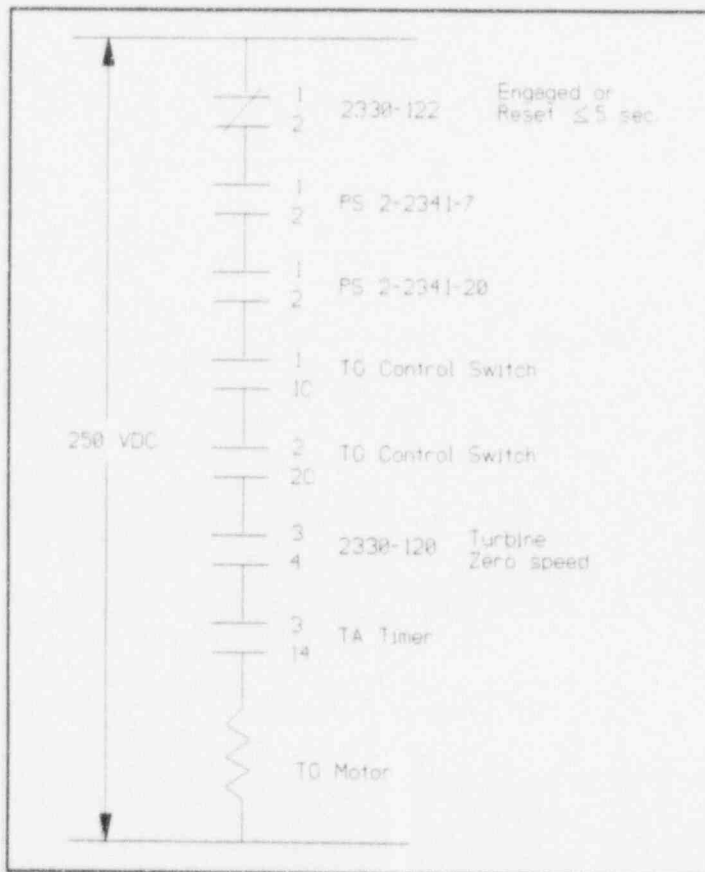
The actual root cause of this event is unknown. Troubleshooting indicates the most probable cause of the turning gear motor failure to start was associated with the turning gear motor logic. One of the contacts may not have changed state, thus creating an open circuit and not providing power to the turning gear motor. This was based on the following reasons:

Under normal operating conditions, power to the turning gear motor requires the following: (1) the 1-2 contacts of relay 2330-122 to be closed ('B' contacts needing relay 2330-122 de-energized); (2) the auxiliary oil pump running in order to pick up contacts 1-2 from pressures switches 2-2341-7 and 2-2341-20; (3) the turning gear motor control switch in "Normal, Start, or Engage" positions picking up switch contacts 1-1C and 2-2C; (4) the turbine at zero speed picking up contacts 3-4 on relay 2330-120 and; (5) the turning gear timer relay "TA" energized picking up contacts 3-14. The attached figure shows a simplified schematic of the interlocks that are required for the start of the turning gear motor.
