SUBJECT: PROPOSED INFORMATION NOTICE ON THERMOLAG FIRE RETARDANT
MATERIAL

NRC INFORMATION NOTICE NO. 91- : FAILURE OF THERMOLAG FIRE BARRIER MATERIAL
TO PASS 3-HOUR FIRE ENDURANCE TEST

Subject: TSI's Response To The NRC Information Notice No. 91-47
"Failure of THERMO-LAG Fire Barrier Material To Pass Fire
Endurance Test"

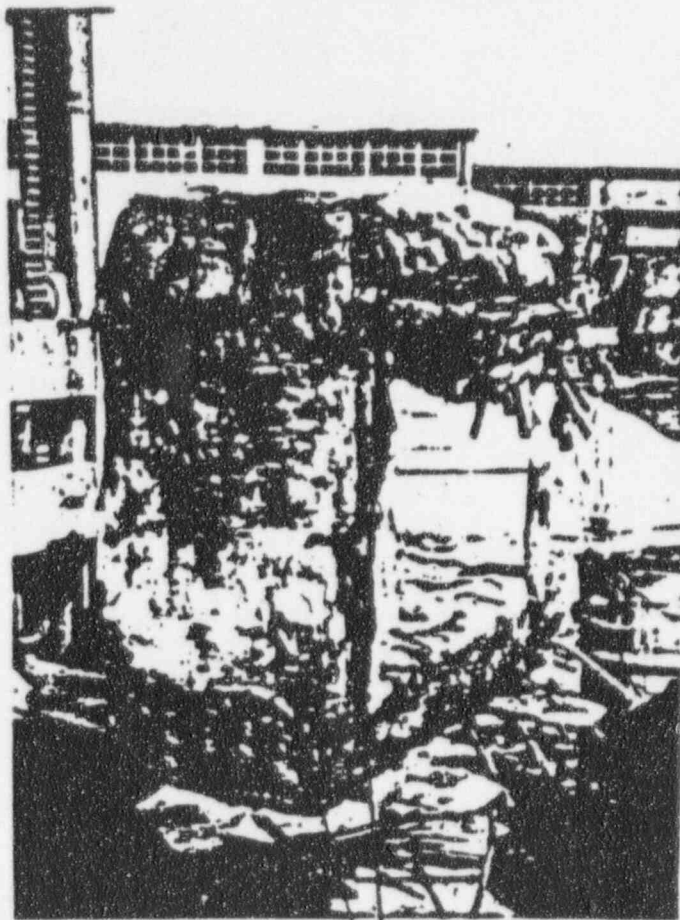
3. After 45 minutes of fire exposure, slight 'cracking' was observed in the Thermo-Lag 330-1 Subliming Coating Envelope System "CHAR FORMATION" on the air drop envelope and the upper horizontal leg envelope. These observations were made through the viewing windows of the Test Facility. Such cracking in the char formation is normal and has been repeatedly observed by the Author in other Thermo-Lag 330-1 Subliming Coating fire tests on Plates, Beams, etc.

Such char formation cracking usually occurs long after sublimation of the coating and is felt to be due to continued heating of the char and the resultant expansion of the char, a normally expected sequence of events. Figure 10 presents a photograph of the Cable Tray Test Specimen after the removal from the ASTM-E-119 Fire Simulation Facility. The char formation cracking, or checking, can be observed in the outer areas of the Thermo-Lag 330-1 Subliming Coating Envelope. However, it is important to note that the depth of this cracking or checking is limited to the char. This cracking or checking does not penetrate into the un-sublimed lower layers of the envelope system, as will be shown later in this report.

CRACKING IN CHAR FORMATION

FIGURE 10: PHOTOGRAPH OF CABLE TRAY AND AIR DROP TEST ASSEMBLY AFTER 65-MINUTES OF EXPOSURE TO THE TSI ASTM-E-119 FIRE SIMULATION FACILITY

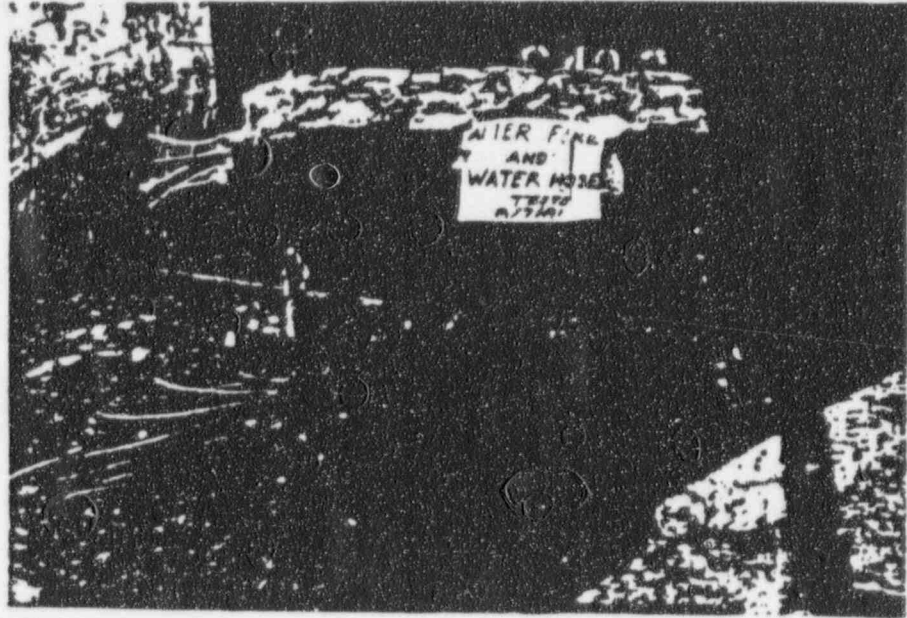
- a. Figure 20 presents a photograph of the TSI Cable Tray, Conduits and Air Drop Test Specimen immediately following the One Hour Fire Test and the Water Hose Stream Impingement Test. Figure 21 presents the same Test Specimen with portions of the Thermo-Lag 330-1 Subliming Coating Envelope System removed from the cable tray assembly. As shown, in Figure 21 'one' of the electrical cables in direct contact with the metal cable tray under went a slight decomposition and bubbling in the cable covering. This would account for the slight amount yellowish smoke that was observed to issue from within the cable tray opening after about 30 minutes of fire exposure. Cutting open the cable jacket bubbled area showed NO damage to the cables themselves, in so far as heat or fire damage is concerned.

FIGURE 20: PHOTOGRAPH OF THE THERMO-LAG 330-1 SUBLIMING COATING ENVELOPE SYSTEM PROTECTED CABLE TRAY, CONDUITS AND AIR DROP TEST ASSEMBLY FOLLOWING THE ONE HOUR FIRE TEST AND WATER HOSE STREAM TEST

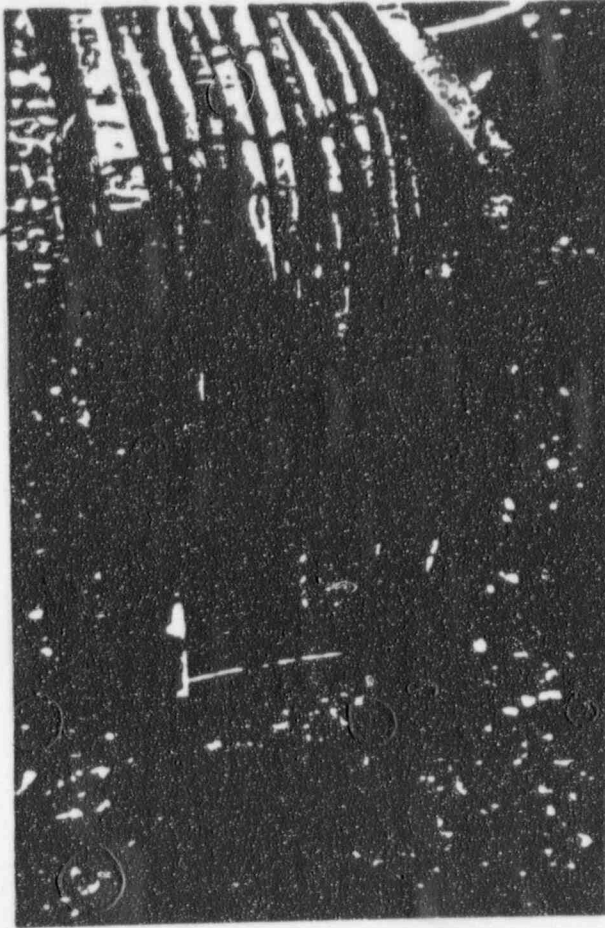
BUHLING OF CABLE
SURFACE COVERING
(CABLE IN DIRECT
CONTACT WITH CABLE
TRAY METAL SURFACE)

FIGURE 21: PHOTOGRAPH OF THE TSI CABLE TRAY, CONDUITS AND AIR DROP TEST SPECIMEN WITH PORTIONS OF THE PROTECTIVE COVERING REMOVED

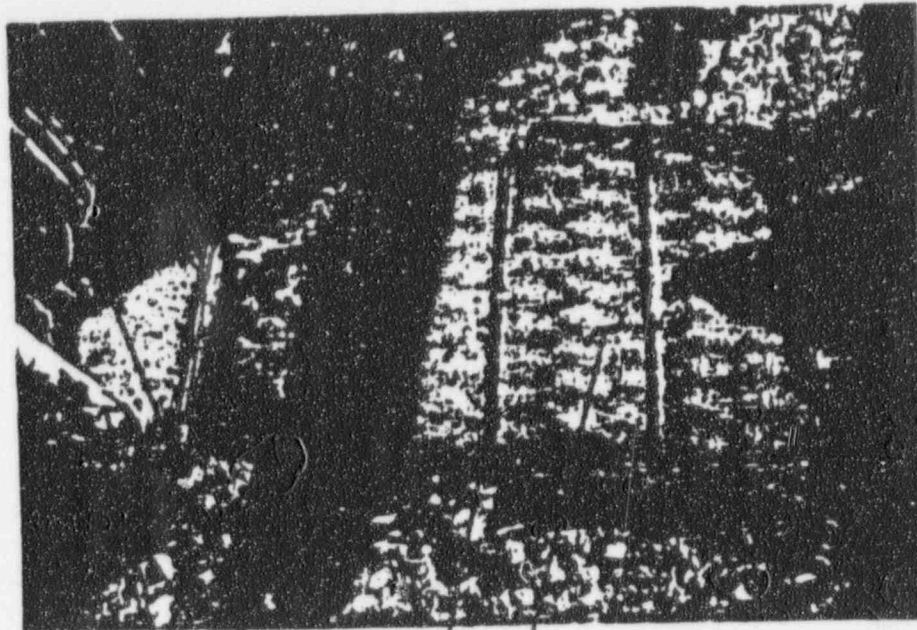
- b. Figure 22 presents a photograph of the interior surface of the Thermo-Lag 330-1 Subliming Coating Envelope System after the One Hour Fire Test and the Water Hose Stream Test (a solid cone water discharge from 10 feet was also used on this portion of the protective covering). As shown, the Thermo-Lag 330-1 Subliming Coating has not fully sublimed all the way through the original 0.469 dry film thickness and has not been damaged by the Water Hose Stream Test. No actual measurements were made of the unsublimed thickness. Essentially all of the dry film thickness was sublimed along the upper leg of the test specimen. Since the air temperature around the test specimen and the measured thickness of the protected envelope were essentially the same, the differences in convection heating would account for the unsublimed coating.

UNSUBLIMED THERMO-LAG 330-1 MATERIAL

FIGURE 22: PHOTOGRAPH OF THE INTERIOR SURFACE OF THE CABLE TRAY, CONDUIT AND AIR DROP TEST SPECIMEN THERMO-LAG 330-1 SUBLIMING COATING ENVELOPE SYSTEM AFTER THE ONE HOUR FIRE TEST AND WATER HOSE STREAM TEST

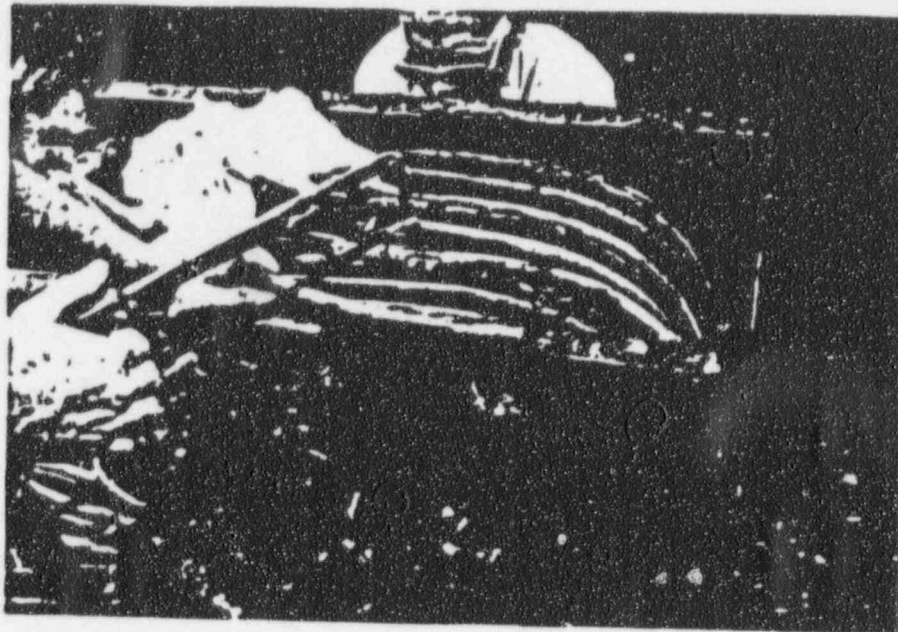
- c. Figure 23 shows a section of electrical cable being removed from the Test Specimen for a detail inspection of the interior cables. Figure 24 shows the actual physical condition of the cabling inside the section of removed cable. As far as a visual inspection is concerned, NO damage at all resulted to any

FIGURE 23: PHOTOGRAPH OF A SECTION OF ELECTRICAL CABLE BEING REMOVED FROM A CABLE BUNDLE IN THE TSI CABLE TRAY, CONDUIT AND AIR DROP TEST SPECIMEN AFTER A ONE HOUR FIRE TEST AND A WATER HOSE STREAM IMPINGEMENT TEST

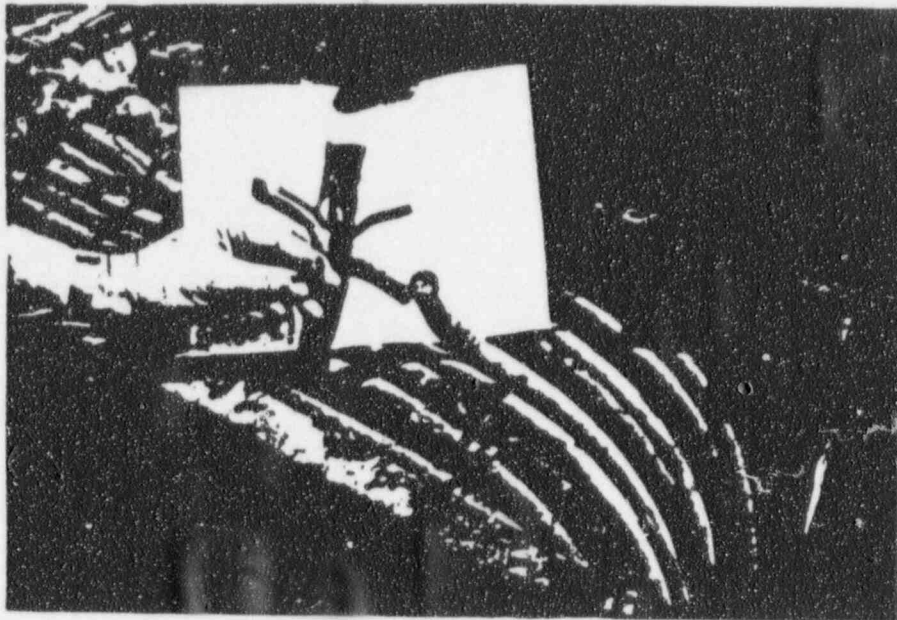
FIGURE 24: PHOTOGRPAH OF THE INTERIOR OF AN ELECTRICAL CABLE IN THE TSI CABLE TRAY, CONDUITS AND AIR DROP TEST SPECIMEN AFTER THE ONE HOUR FIRE TEST AND WATER HOSE STREAM IMPINGEMENT TEST

of the individual wires or cables. Even the paper lining on the cable covering was NOT scorched or burnt.
