LICENSEE EVENT REPORT (LER)

FACILITY NAME (1) Oyster Creek, Unit 1	DOCKET NUMBER (2) 05000219	PAGE (3) 1 OF 1
---	-------------------------------	--------------------

TITLE (4)
Inadvertent Repositioning of Primary Containment Isolation Valves

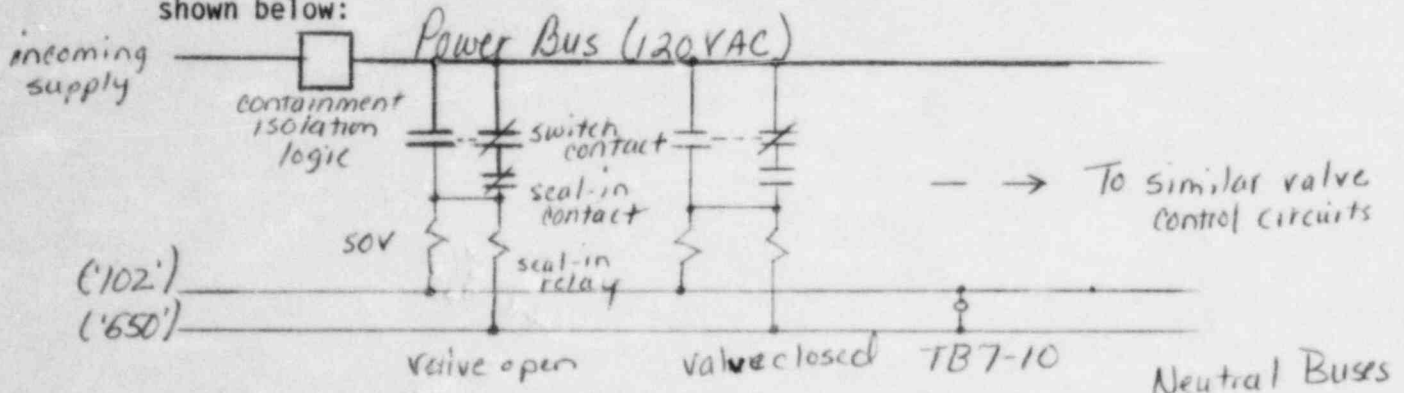
The computer tie-in previously discussed required that the neutral feed from panel 11F to panel 10F be interrupted due to the lifting of the '102' lead (11F neutral) from contact 10 of Terminal Board '7' (TB7-10) in panel 11F. The other contact on TB7-10 remained connected to the 10F neutral bus (referred to as the '550' neutral string). Since the '550' neutral string was disconnected from the panel 11F neutral, it was now possible for a voltage potential to develop between the two neutrals. As a result of a containment isolation switch relay modification conducted in 1981, the basic valve control circuit consisted of an SOV connected to the 11F neutral ('102') in parallel with a seal-in relay connected to the 10F neutral ('550'), as shown below:

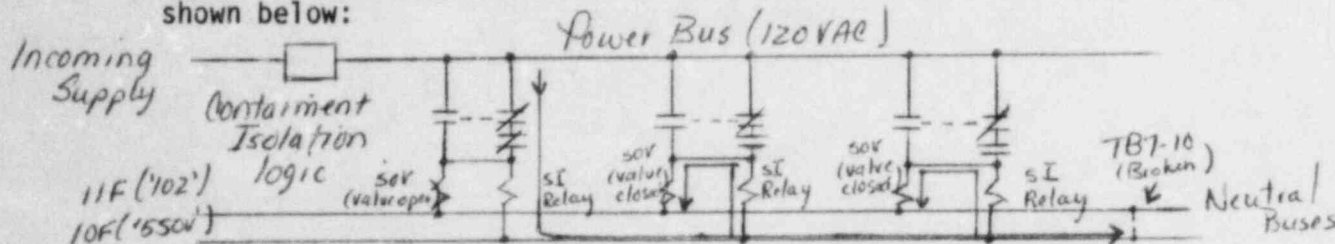
A total of 18 containment isolation valves (including MSIVs) have seal-in relays connected to the '550' neutral string. During normal operation with the valve open, the seal-in relay and SOV are energized. The seal-in contact is held shut by the energized seal-in relay. When power is interrupted to the control circuit, the SOV and seal-in relay de-energize, and the valve closes. Since the seal-in contact is now open, restoration of power will not cause the valve to automatically re-open. (The operator must place valve control switch to the 'open' position.) This was the intent of the 1981 control circuit modification. There is only one connection between the '102' bus and the '550' neutral string. This occurs at TB7-10. If the connection at this point is interrupted, an abnormal current flowpath can result from an energized seal-in relay (valve open) through a de-energized seal-in relay and SOV (valve shut) to the 11F neutral, as shown below:

This occurs due to the fact that the '550' neutral is 'floating' with respect to the 11F neutral once the TB7-10 connection is broken, and the current flow seeks a neutral (11F) through a seal-in relay and SOV in series. If sufficient voltage drop occurs across the seal-in relay for a closed valve, (determined by the number of valves initially open) the seal-in relay will energize. This shuts the seal-in contact for the closed valve, which allows full bus voltage to be applied across the SOV, resulting in the opening of the valve. Since the seal-in relays for all 18 valves are connected to the '550' neutral, all valves will open when the threshold voltage drop across their seal-in relays is reached. This theory explains the phenomena which occurred during the computer point termination on the day of the event.
