LICENSEE EVENT REPORT (LER)

FACILITY NAME (1) Fort St. Vrain, Unit No. 1	DOCKET NUMBER (2) 0 5 0 0 0 2 6 7	PAGE (3) 1 OF 0 8
---	--------------------------------------	----------------------

TITLE (4)  
Corrosion of PCRV Tendon Wires (Voluntary LER)

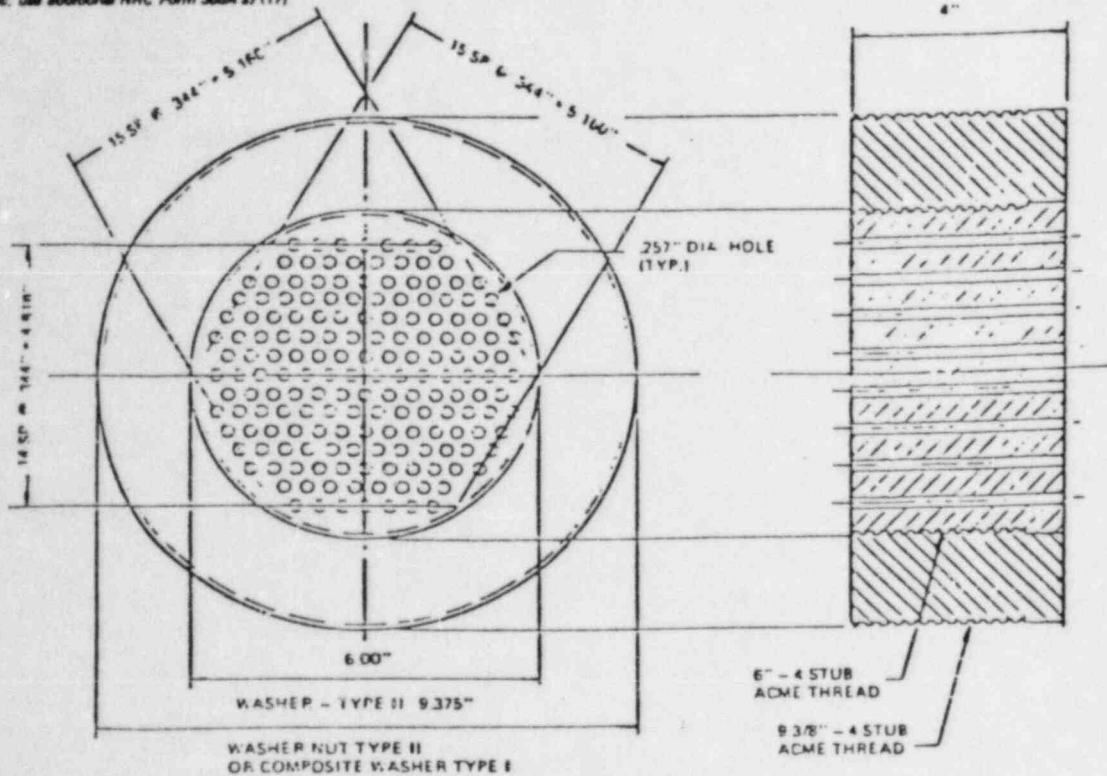
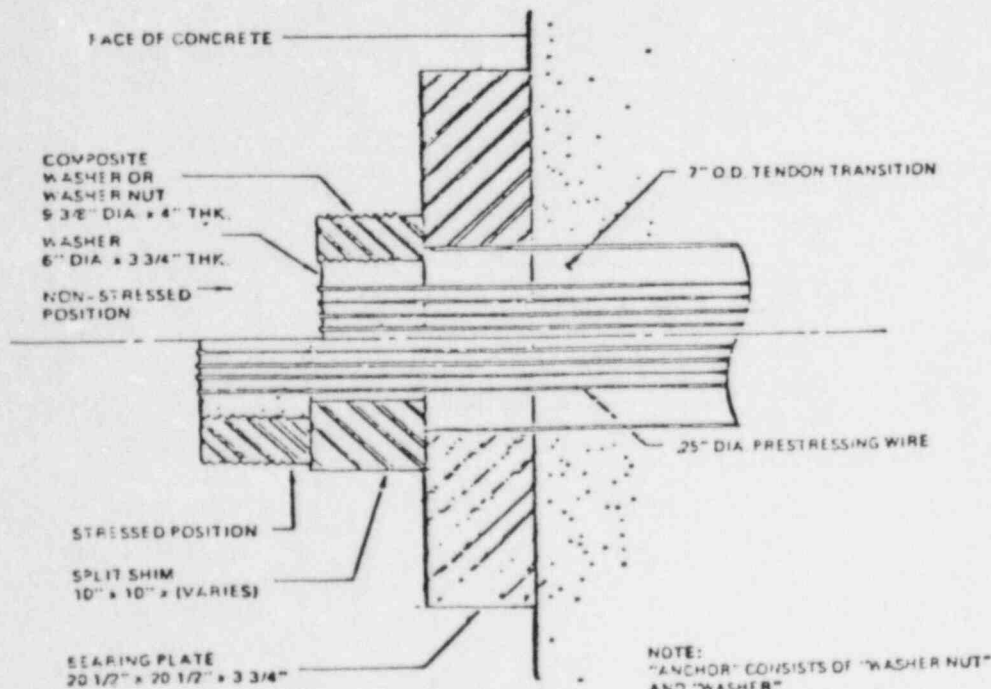
FIGURE 1

The Prestressed Concrete Reactor Vessel (PCRV) utilizes a system consisting of 448 prestressing tendons in two basic configurations consisting of 152 or 169 1/4 inch diameter wires. Each wire terminates at a buttonhead supported by an anchor (buttonhead) washer which seats through a split shim onto a bearing plate on the PCRV surface (see Figure 1). The tendons may be delineated into four different types according to the following table (also see Figure 2).
