In the Matter of  
DUKE POWER COMPANY, ET AL.  
(Catawba Nuclear Station, Units 1 and 2)  
Docket Nos. 50-413 and 50-414 *OK*

REVIEW AND EVALUATION  
OF TRANSAMERICA DELAVAL, INC.,  
DIESEL ENGINE RELIABILITY AND  
OPERABILITY - CATAWBA NUCLEAR  
STATION UNIT 1

August 1984

Pacific Northwest Laboratory  
Richland, Washington 99352

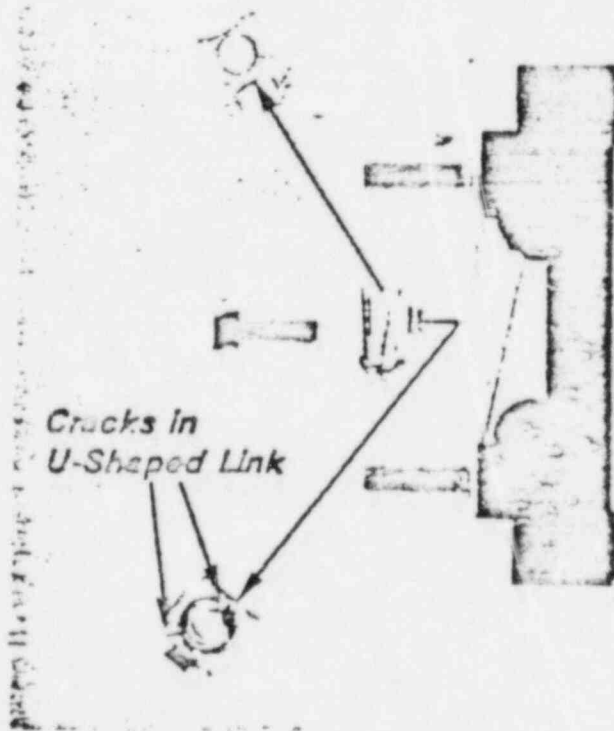
Exploded View of States Company Terminal Block

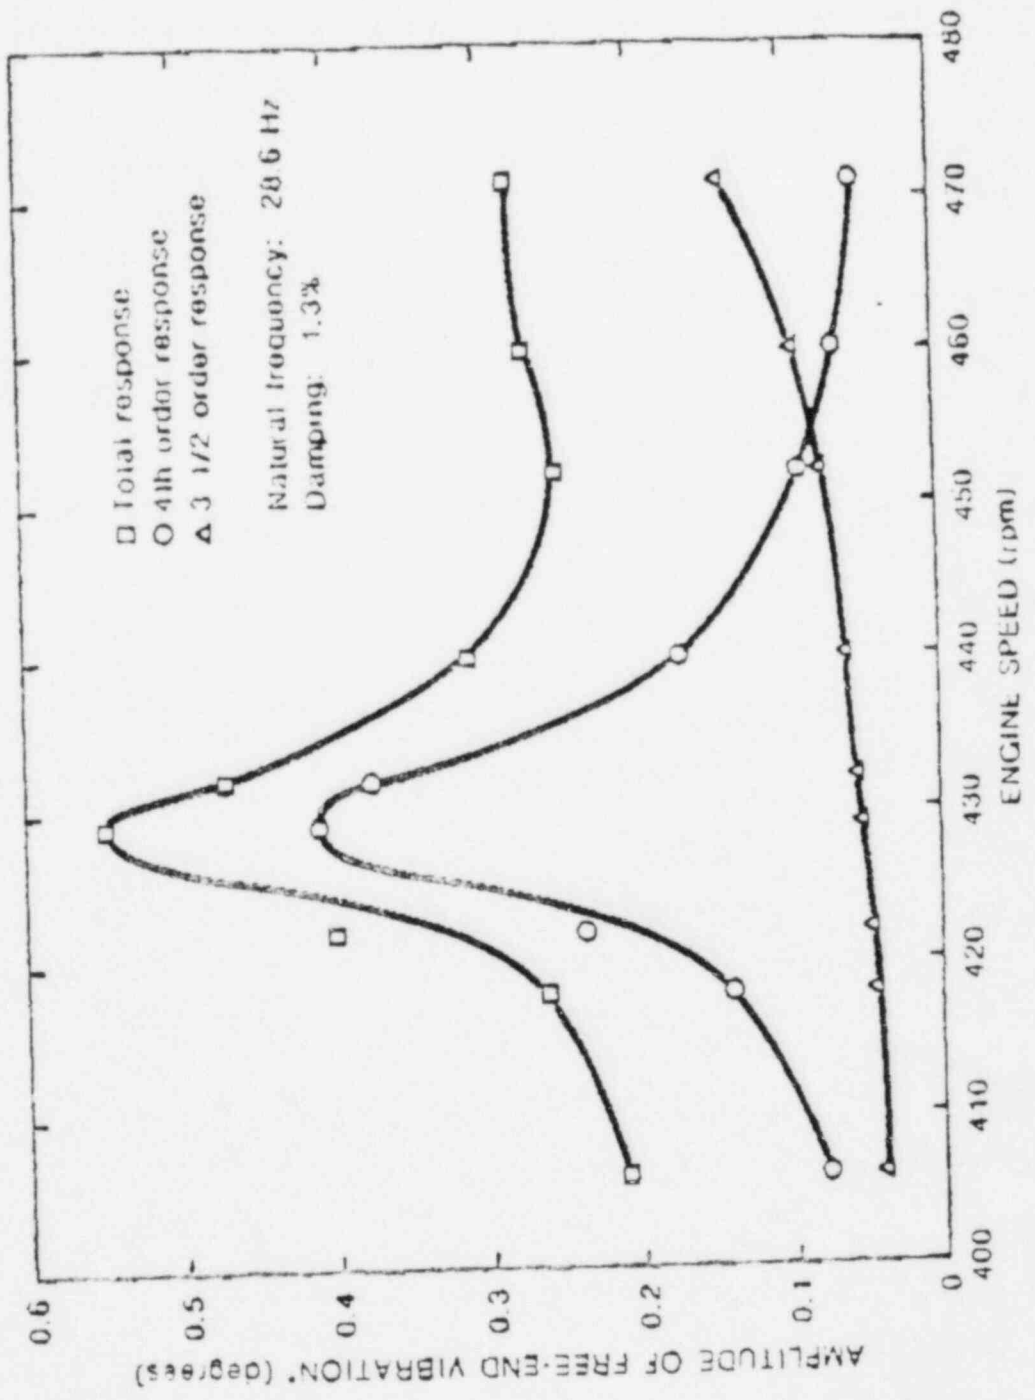
Figure 4-1. Variable speed response of EDG 1A.  
\*Amplitude of nominal shear stress is 8452 psi/degree of free-end vibration, assuming the shaft is vibrating in its first mode.

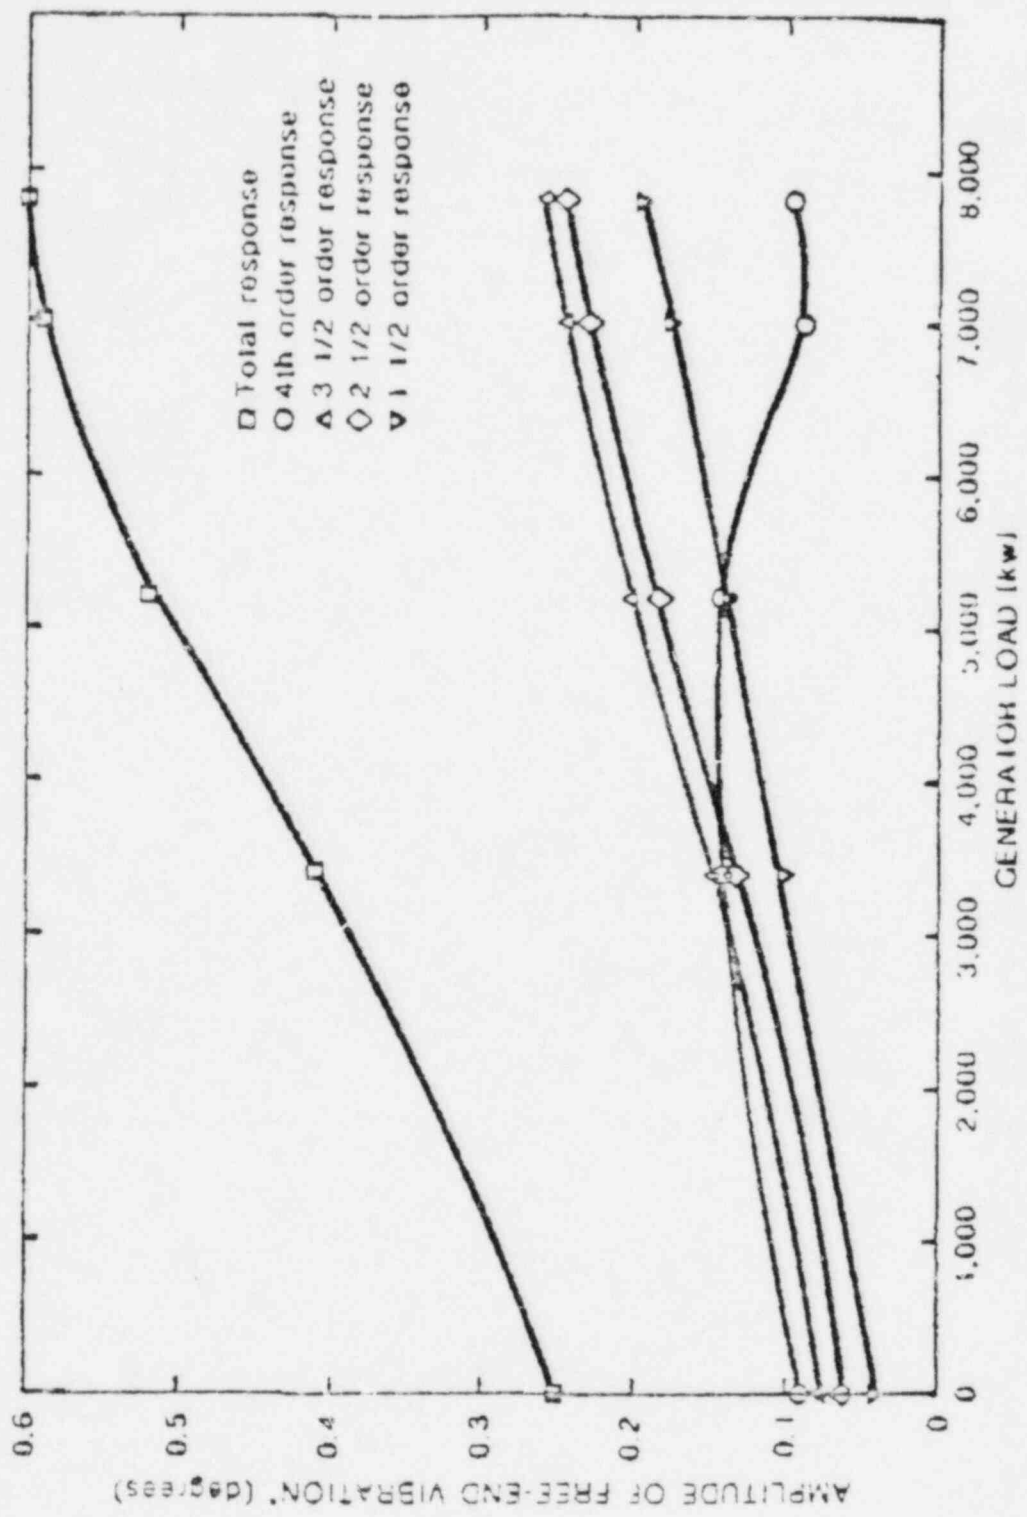
Figure 4-2. Variable load response of EDG 1A.  
 \*Amplitude of nominal shear stress is 3M52 psi/degree of free-end vibration, assuming the shaft is vibrating in its first mode.
