FACILITY: Point Beach Nuclear Plant, Unit 2

SUBJECT: SUMMARY OF NOVEMBER 2, 1995, MEETING ON STEAM GENERATOR INSPECTION RESULTS AND REPAIR PLANS

STEAM GENERATOR INSPECTIONS AND REPAIR OPTIONS

NOVEMBER 2, 1995

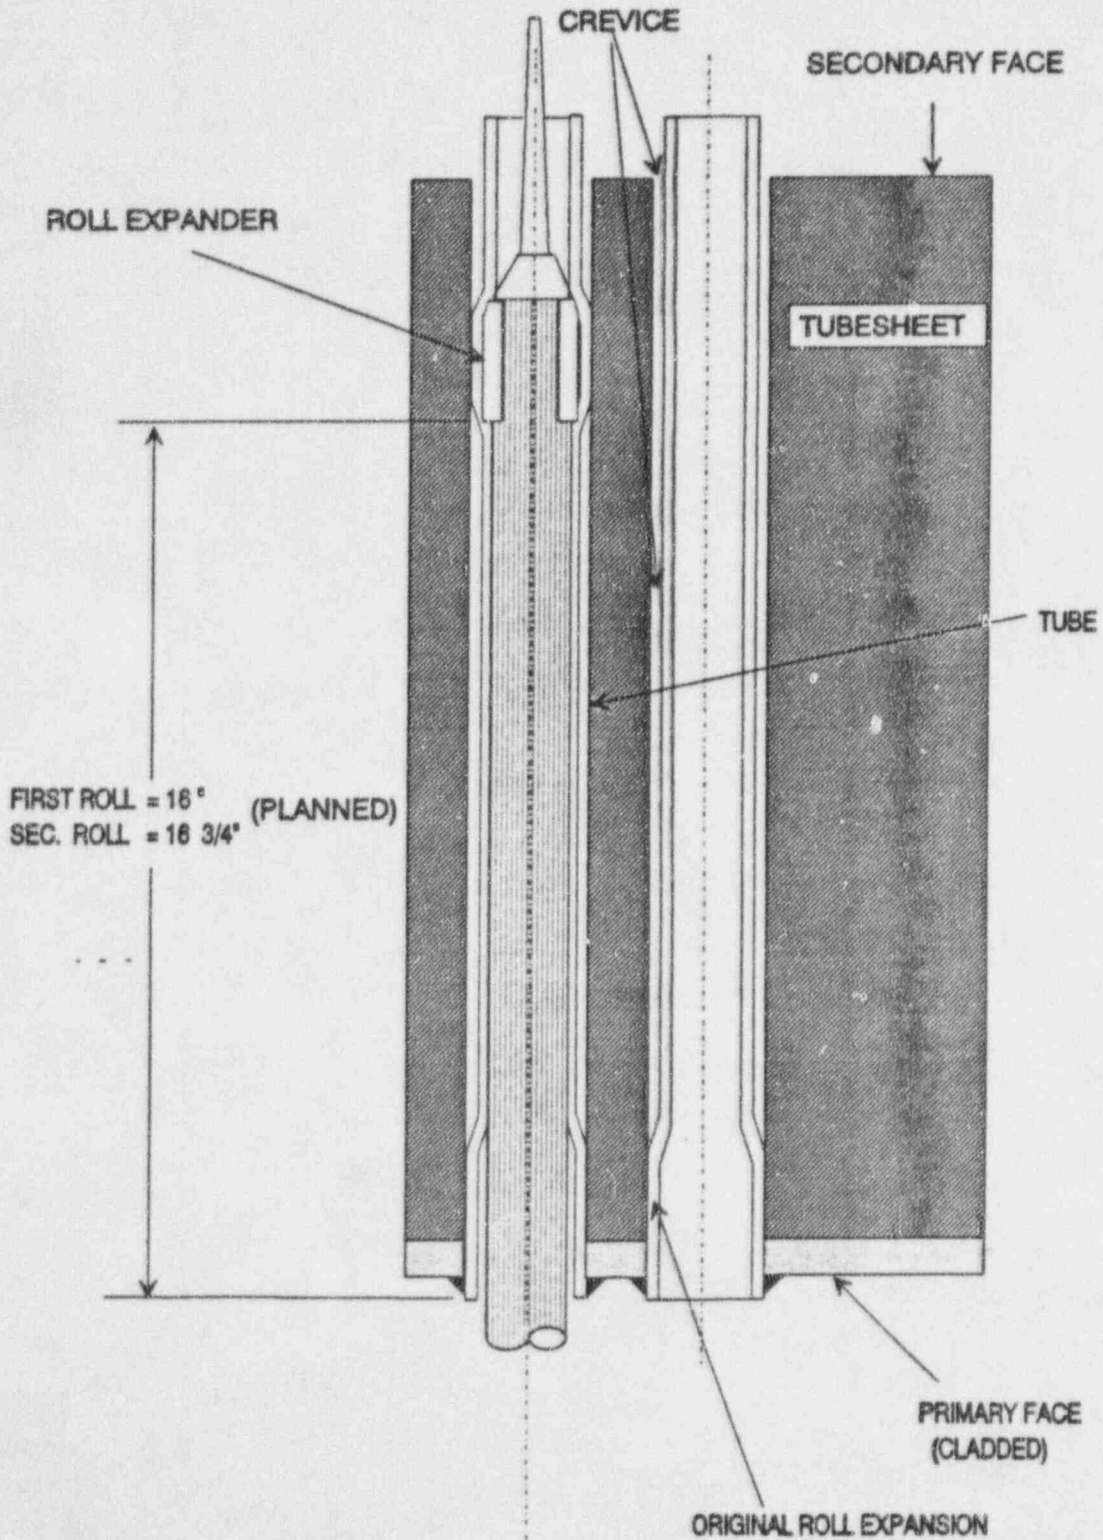
REPAIR ROLL SKETCH

- *Intra-Tubesheet Re-Roll and F^* Criteria*
 - Hard roll placed in upper half of tubesheet
 - Forms new lower pressure boundary for tube
 - Requires evaluation for upper vs. lower re-roll
 - Requires adoption of F^* criteria in TS

PB-2 REPAIR ROLL JUSTIFICATION APPROACH

- **OBTAIN F* LICENSING APPROVAL**
 - **BASIS:**
 - » **SAME SGs AS IP-2**
 - » **SIMILAR OPERATING CONDITIONS**
 - » **APPROVED IP-2 F* SUBMITTAL**
 - **DOCKET 50-247, AMMENDMENT 180**
 - **MARCH 13, 1995**
 - **TOPICAL BAW-10195P**
- **IMPLEMENT USING IP-2 RE-ROLL QUAL.**
 - **ISSUE PB-2 REPAIR ROLL QUAL. REPORT**
 - » **BOUND THROUGH IP-2 QUALIFICATION**
 - » **TIE IN F* APPLICABILITY TO PB-2**
