Closeout of IE Bulletin 80-08: Examination of Containment Liner Penetration Welds

Prepared by R. S. Dean, W. J. Foley, A. Hennick

PARAMETER, Inc.

Prepared for
U.S. Nuclear Regulatory
Commission

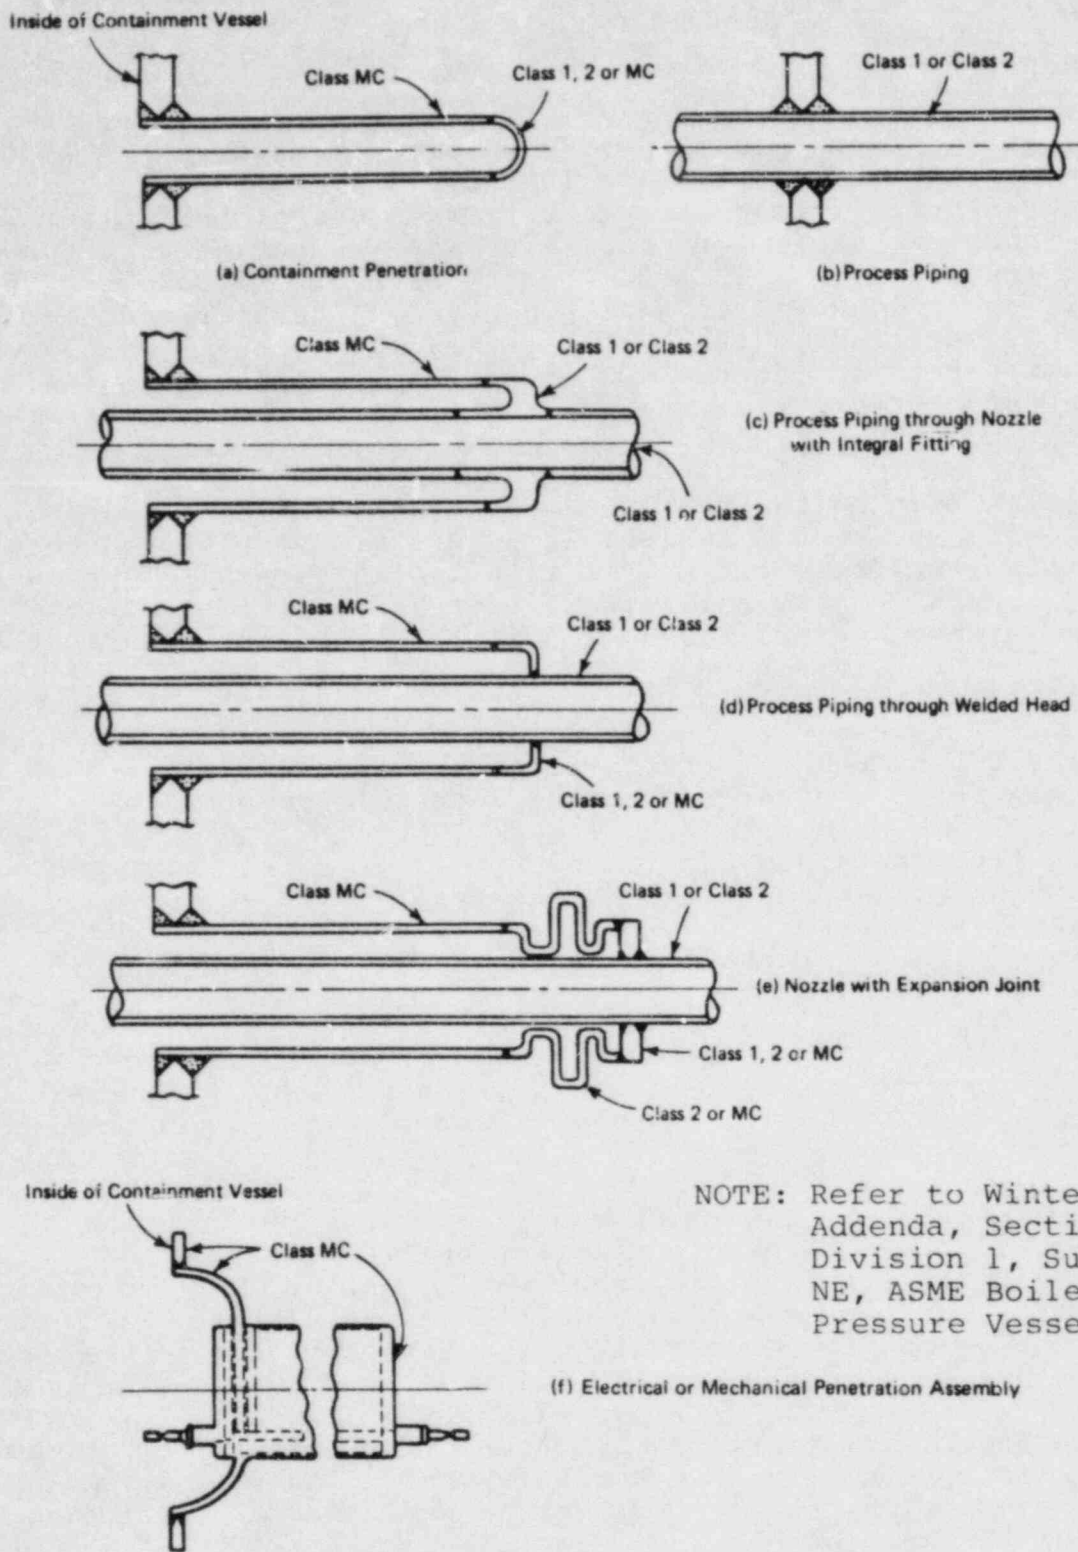
FIG. NE-1120-1 TYPICAL CONTAINMENT PENETRATIONS

- a. It joins a flued head to the penetration sleeve similarly to that shown by Figure NE-1112-1(c) of the ASME Code, Section III, included for reference on Page A-3 of this report.
- b. The penetration contains high energy steam or water piping.

This flued head penetration design is of particular safety concern because the Class MC penetration sleeve encloses the Class 1 or Class 2 process pipe-to-flued head butt weld (see copy of ASME Section III, Figure NE-1120-1(c) on Page A-3), making it inaccessible for inservice inspection. Failure of the process pipe weld, especially where the piping contains high energy steam or water, would result in local pressure loading of the nearby containment sleeve butt weld. Quality monitoring of this sleeve weld, then, becomes essential to the containment integrity.
