Northeast
Nuclear Energy

Reference: Facility Operating License No. DPR-65
Docket No. 50-336
Licensee Event Report 95-038-00

LICENSEE EVENT REPORT (LER)

TITLE (4)
Hydrogen Monitor Flowpath Design Deficiency

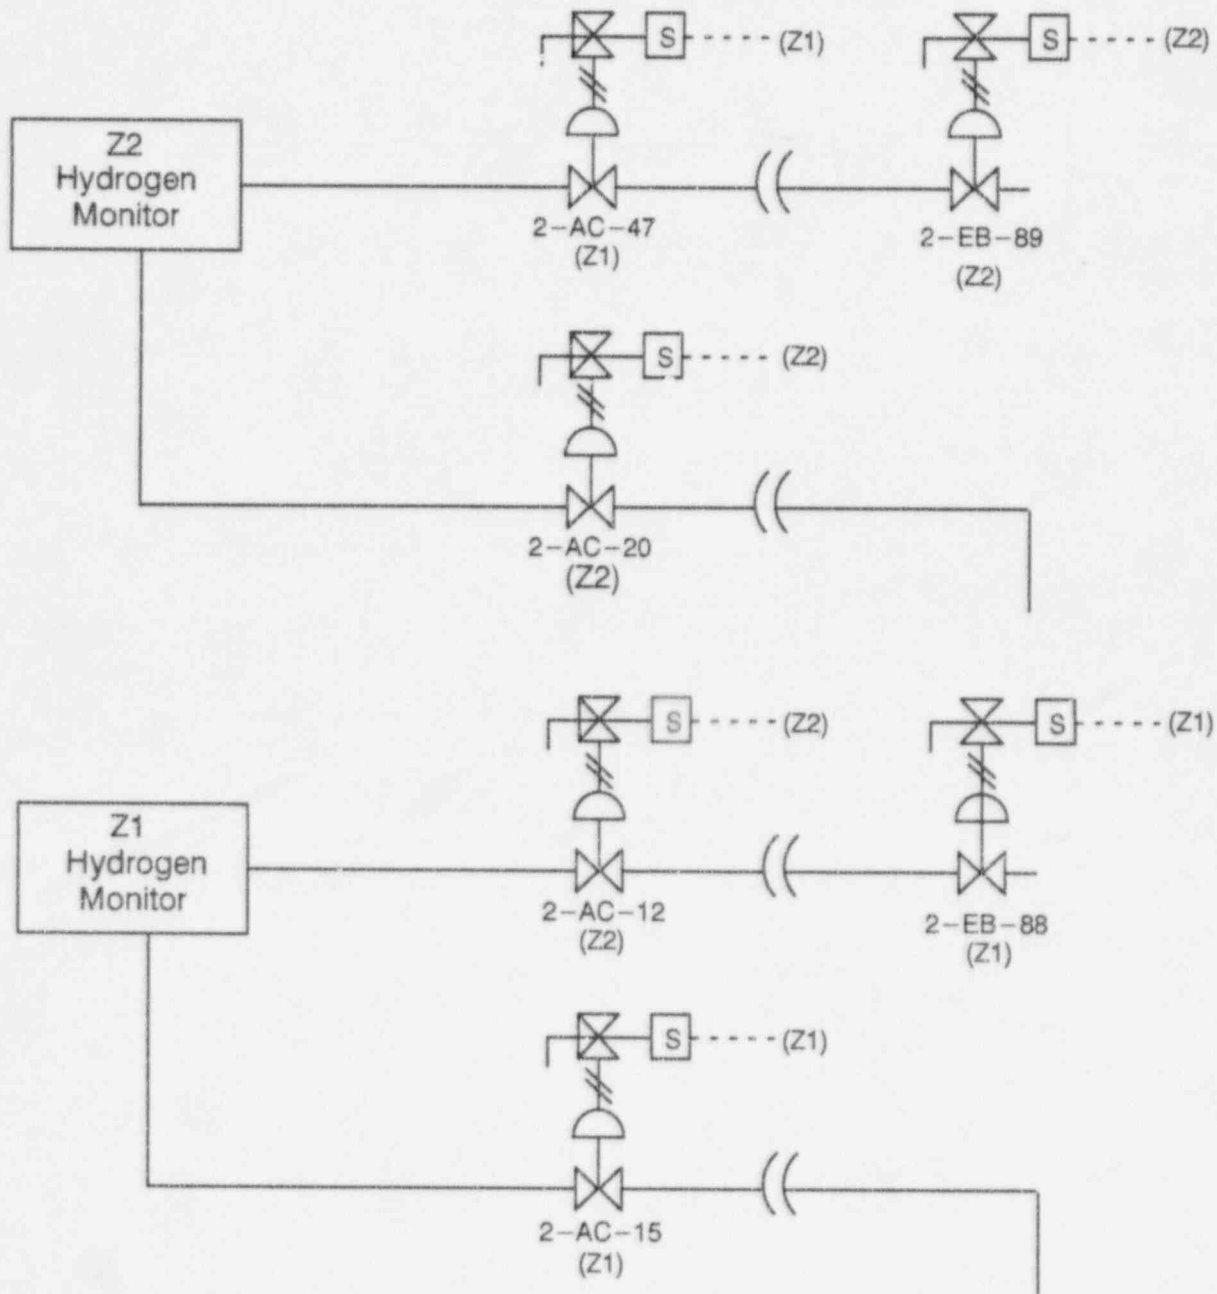
The cause of this event is a design deficiency in that the system was initially designed to meet the containment isolation single failure protection requirements. This resulted in the inability to open the valves for hydrogen sampling in the event of a LOCA and a loss of a DC bus. Without procedures to provide instructions on how to provide power to open the valves for hydrogen sampling in the event of a LOCA and a loss of a DC bus, this design deficiency resulted in a failure to meet Regulatory Guide 1.97 requirements.

Both hydrogen monitors have similar but separate flowpaths (see figure). The hydrogen monitoring system and PASS use the normal containment radiation monitor for the sampling flowpath post LOCA. The Facility 1 Hydrogen monitor has a Facility 1 suction line isolation valve inside containment and a Facility 1 return line isolation valve outside containment powered by Facility 1 DC power. The outside containment suction isolation valve is powered by Facility 2 DC power. The containment isolation signals are the same facility as the power to the valves. Therefore, following a LOCA that initiates a containment isolation signal coincident with the loss of the Facility 2 DC bus, the outside containment isolation valve cannot be opened to allow for hydrogen sampling when required by the Emergency Operating Procedures.

The above also applies to the Facility 2 Hydrogen monitoring system for DC power alignment.

The corrective action was to provide procedure guidance in an Operations Procedure that would provide electrical power to the respective outside containment isolation valve that would be de-energized due to a single DC bus failure. The Operations Procedure directs to the operators to align hydrogen monitoring in accordance with the Post Incident Hydrogen Control operations procedure. In this procedure, in the event of a loss of a vital DC bus, guidance was provided to install an electrical jumper for power to the de-energized valve. By providing direction in the procedure for installation of an electrical jumper to allow normal valve control opening of the containment isolation valves for Hydrogen monitoring post accident, (coincident with a loss of a DC Bus) there is no affect on any system performance because all actions can be performed inside the control room in a very short period of time. The Hydrogen monitoring system is credited for manual initiation within 12 hours following the accident.
