## Nuclear Information and Resource Service

October 16, 1995

**RE: Safety Evaluation of the Core Shroud Fix at Oyster Creek Nuclear Generating Station**

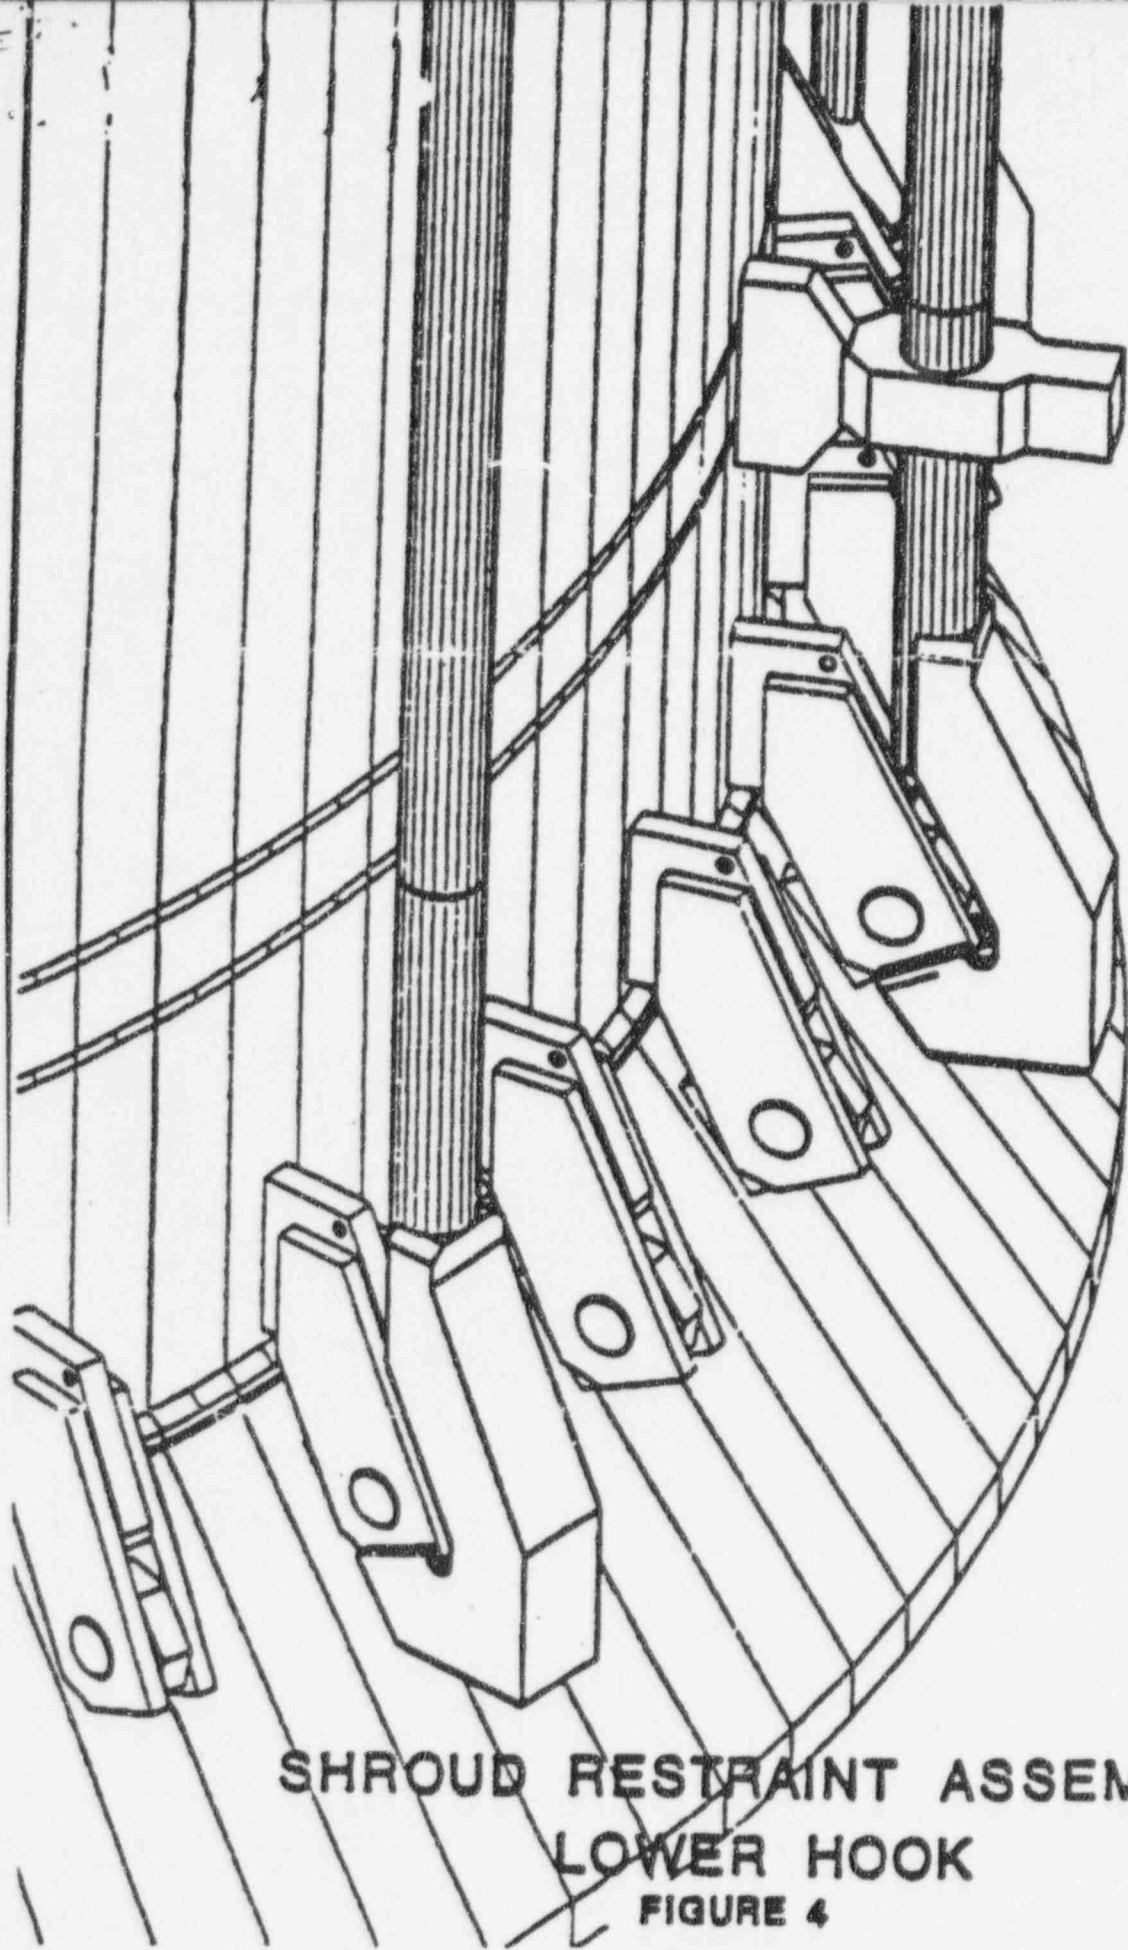
SHROUD RESTRAINT ASSEMBLY  
LOWER HOOK  
FIGURE 4

Specifically, NIRS concerns with the Oyster Creek's Core Shroud Repair focus on the Shroud Restraint Assembly Lower Hook depicted in Figure 4 of the NRC Safety Evaluation dated November 25, 1994. [Attached]

NIRS contends that the lower hooks for the restraint assemblies are dependent on the originally installed gussets, which in turn are composed of plates of Type 304 stainless steel and Inconel 600. NIRS contends that the anchor system utilized for the core shroud fix is dependent upon a susceptible material which has been subject to long-term exposure by the same harsh operational environment that incubated cracking of the core shroud. These conditions are identified in NUREG/CR-5754 "Boiling Water Reactor Internals Aging Degradation Study."

NIRS contends that both the NRC and the licensee ignored information contained within NUREG/CR-5754 which warns that it is "essential to control or eliminate stressors" (emphasis added). To the contrary, GPUN incorporated "a susceptible material" in the fabrication of the anchor system for the core shroud fix, namely, Type 304 stainless steel and Inconel 600 which have been subjected to aging conditions for 25 years during the reactor's operation.

NIRS is very concerned about the inspection timetable for the Shroud Restraint Assemblies. NIRS contends that the growth rate mechanism for Intergranular Stress Corrosion Crack is not fully understood by industry and the NRC. Therefore, a conservative inspection schedule program which would include frequent, comprehensive and enhanced inspections would be called for.
