U.S. NUCLEAR REGULATORY COMMISSION
OFFICE OF INSPECTION AND ENFORCEMENT
REGION III

Report No. 050-329/78-20; 050-330/78-20

Subject: Consumers Power Company
Midland Nuclear Power Plant, Units 1 and 2
Midland, Michigan

Settlement of the Diesel Generator Building

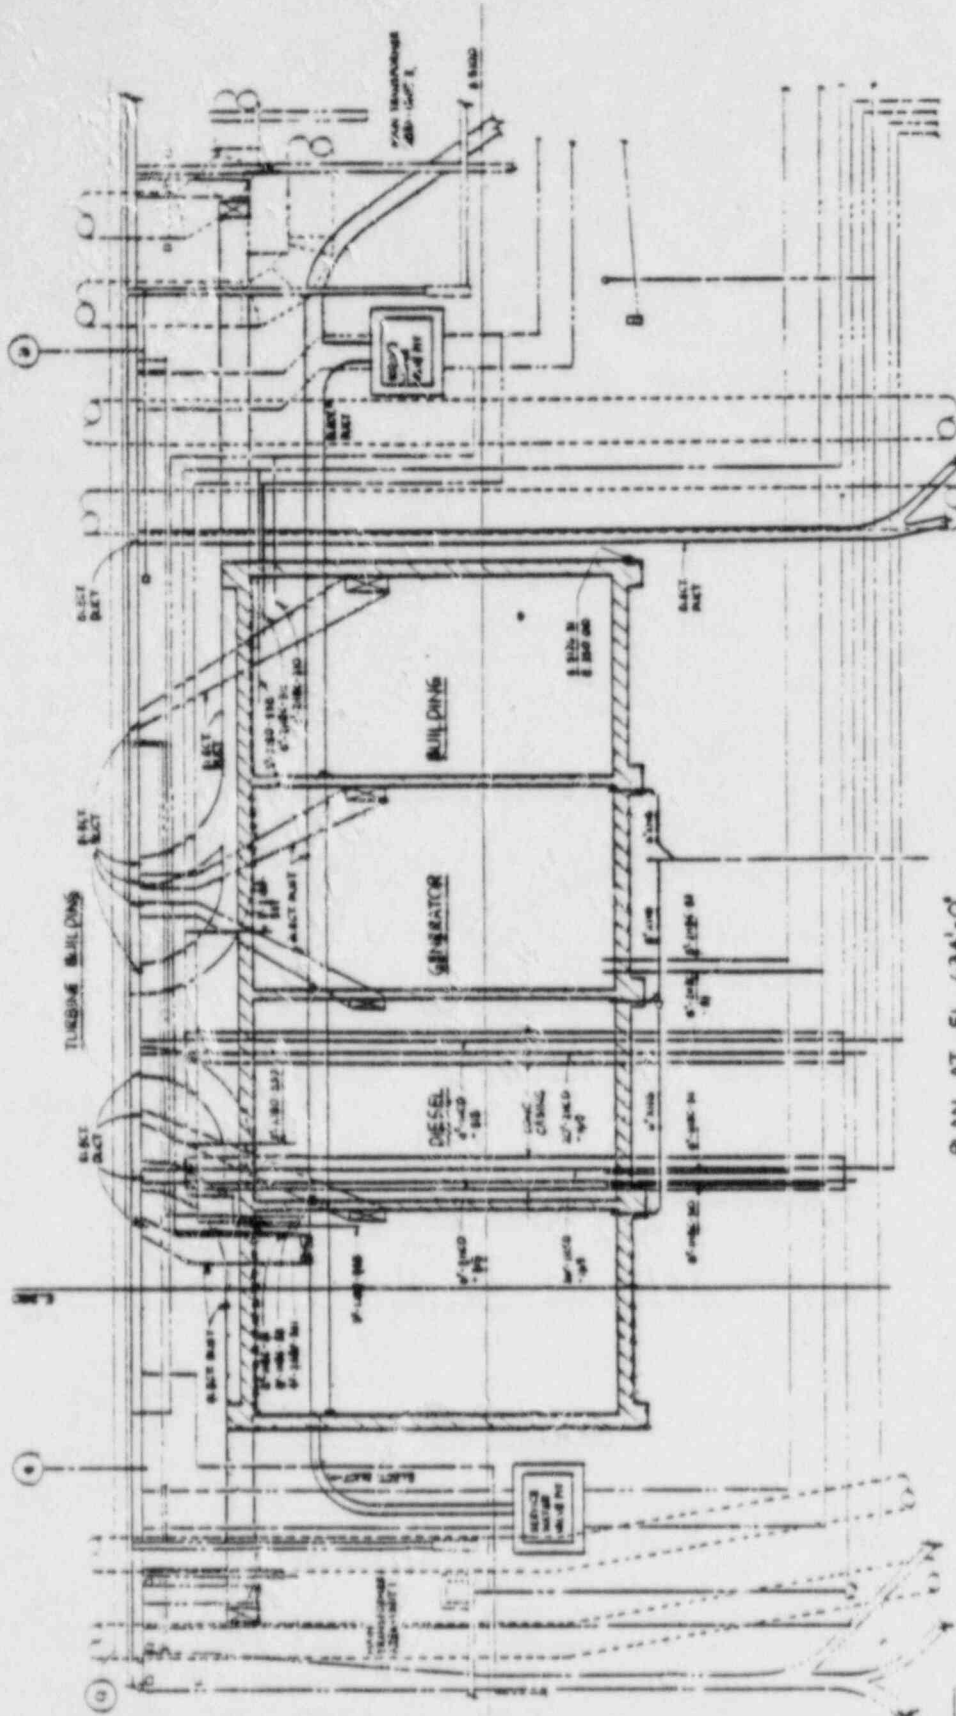
TOTAL SETTLEMENT OF WALLS FROM 7-14-78 TO 6-29-79 IN INCHES

(20 FEET OF SURCHARGE)
