WOLF CREEK

Subject: Docket No. 50-482: Inservice Inspection Program
Relief Requests

ISI RELIEF REQUEST IIR-23

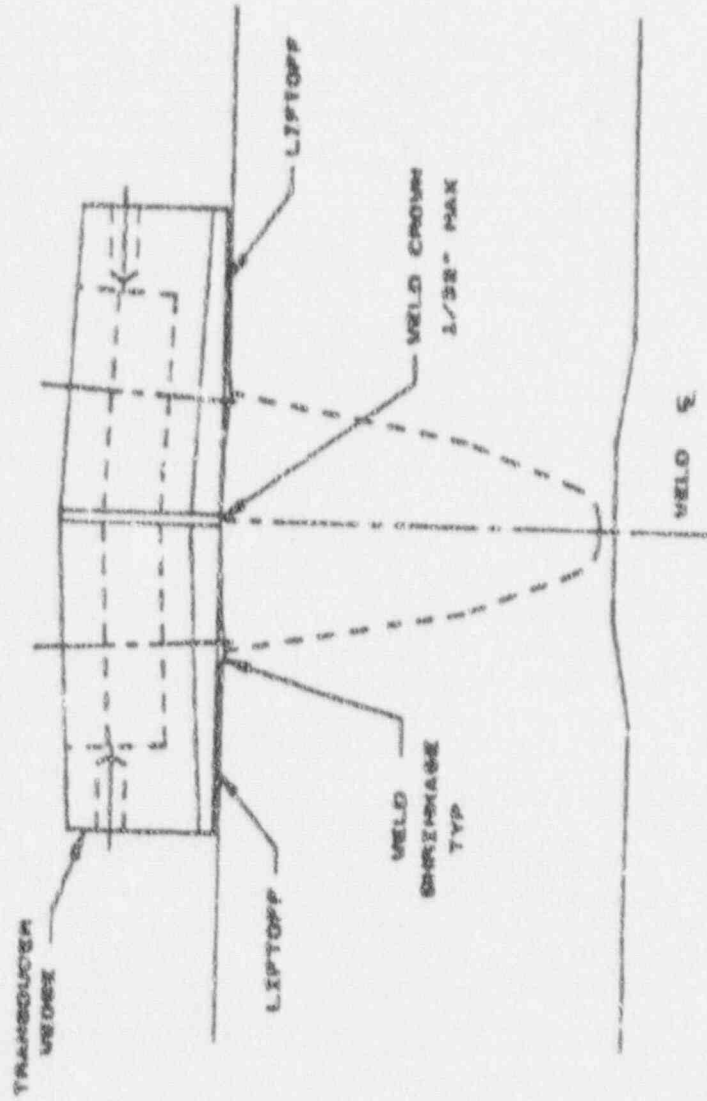
FIGURE 1

Basis for Relief: The transducers used to examine Cast Stainless Steel (CSS) were too large to maintain sufficient contact in the circumferential scanning mode (reference Figure 1). They did, however, maintain adequate contact when scanning perpendicular to the weld axis.

With welds F207, F307, F407, F305, F405 and F306, the weld crown and weld shrinkage causes transducer lift off. With welds F203 and F303, the weld taper causes transducer lift off.

Basis for Relief: The transducers used to examine Cast Stainless Steel (CSS) material were too large to maintain sufficient contact when running along the weld crown (circumferential examination). Thus, resulting with 0% inspection using the circumferential scan (reference Figure 1).

TYPICAL CIRCUMFERENTIAL SCAN LIFTOFF

Alternate Examination: The code required volumetric examination will be completed perpendicular to the weld axis from two (2) directions.

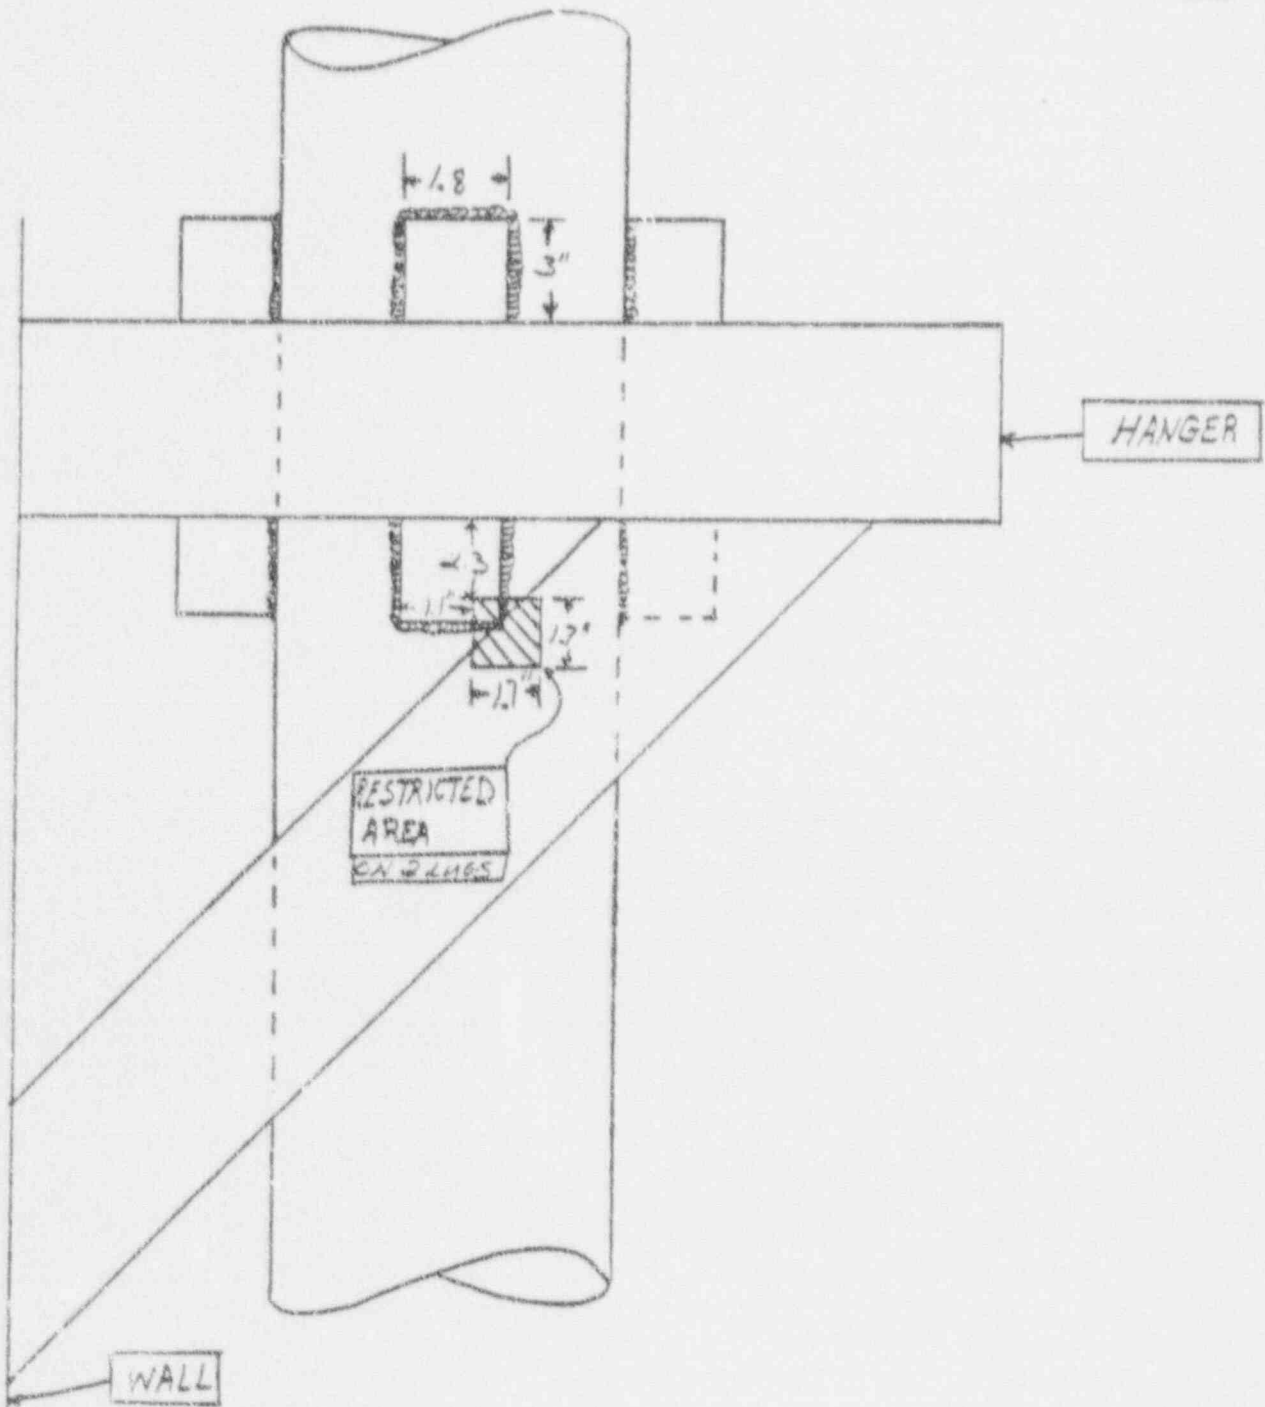
Figure 2

Basis for Relief: The surface examination of the subject integrally welded attachments (lugs) are 24% obstructed on two (2) of the lugs. The obstruction is a result of a permanent hanger that is used to support the Residual Heat Removal (RHR) piping. The diagonal supports of this hanger cross over the required inspection area on two of the lugs (reference Figure 2).

WELD # 1-EJ-Q2-C020

RESTRICTED DUE TO HANGER

Alternate Examination: None; the Code required surface examination will be completed to the maximum extent practical.

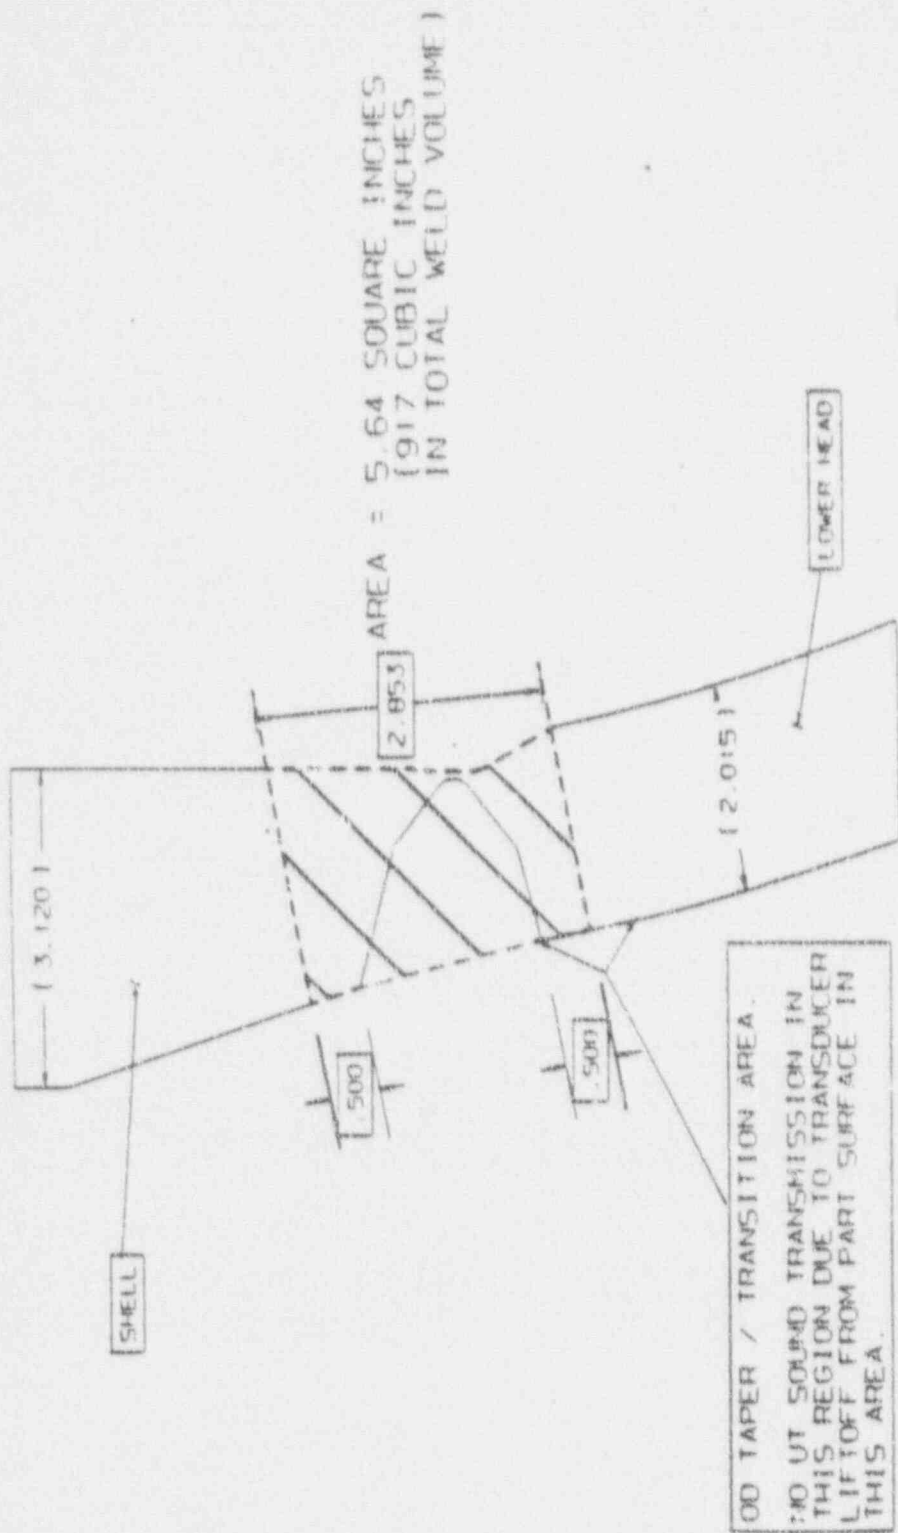
Figure 3A

The circumferential examination was 100% limited due to the weld configuration (reference Figures 3A through 3D for the percentage breakdown).

AREA OF INTEREST

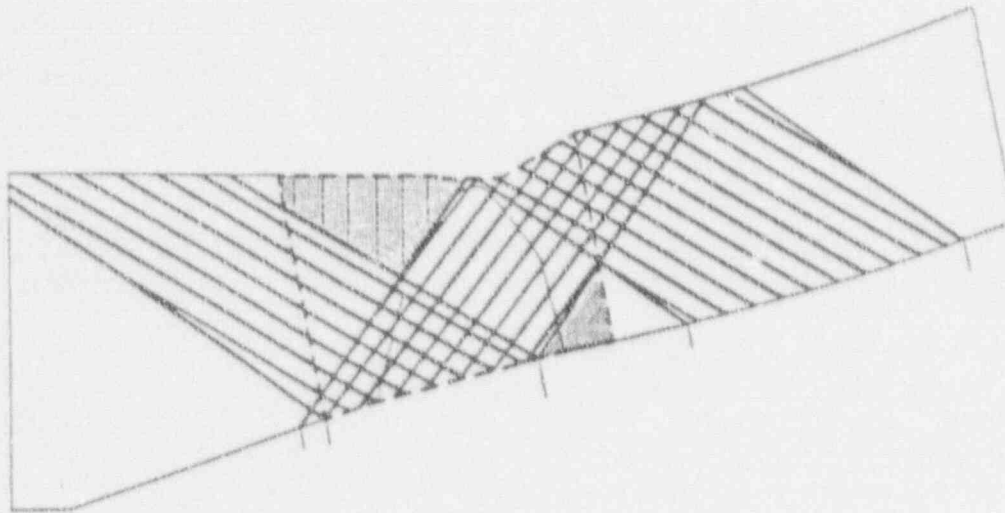
AREA COVERAGE
BEAM DIRECTION TOWARDS SHELL:
UPPER REGION - 2.06 SQUARE INCHES
236 CUBIC INCHES
36 PERCENT
LOWER REGION - 0.388 SQUARE INCHES
45 CUBIC INCHES
7 PERCENT
TOTAL:
PERCENTAGE OF WELD EXAMINED: 43
PERCENTAGE OF WELD NOT EXAMINED: 57
BEAM DIRECTION TOWARDS HEAD:
3.76 SQUARE INCHES
430 CUBIC INCHES
67 PERCENT
TOTALS:
PERCENTAGE OF WELD EXAMINED: 67
PERCENTAGE OF WELD NOT EXAMINED: 33

[Hatched Box] = AREA OF INTEREST NOT EXAMINED

TOTAL WELD COVERAGE
WITHOUT EXTERNAL
RESTRICTIONS

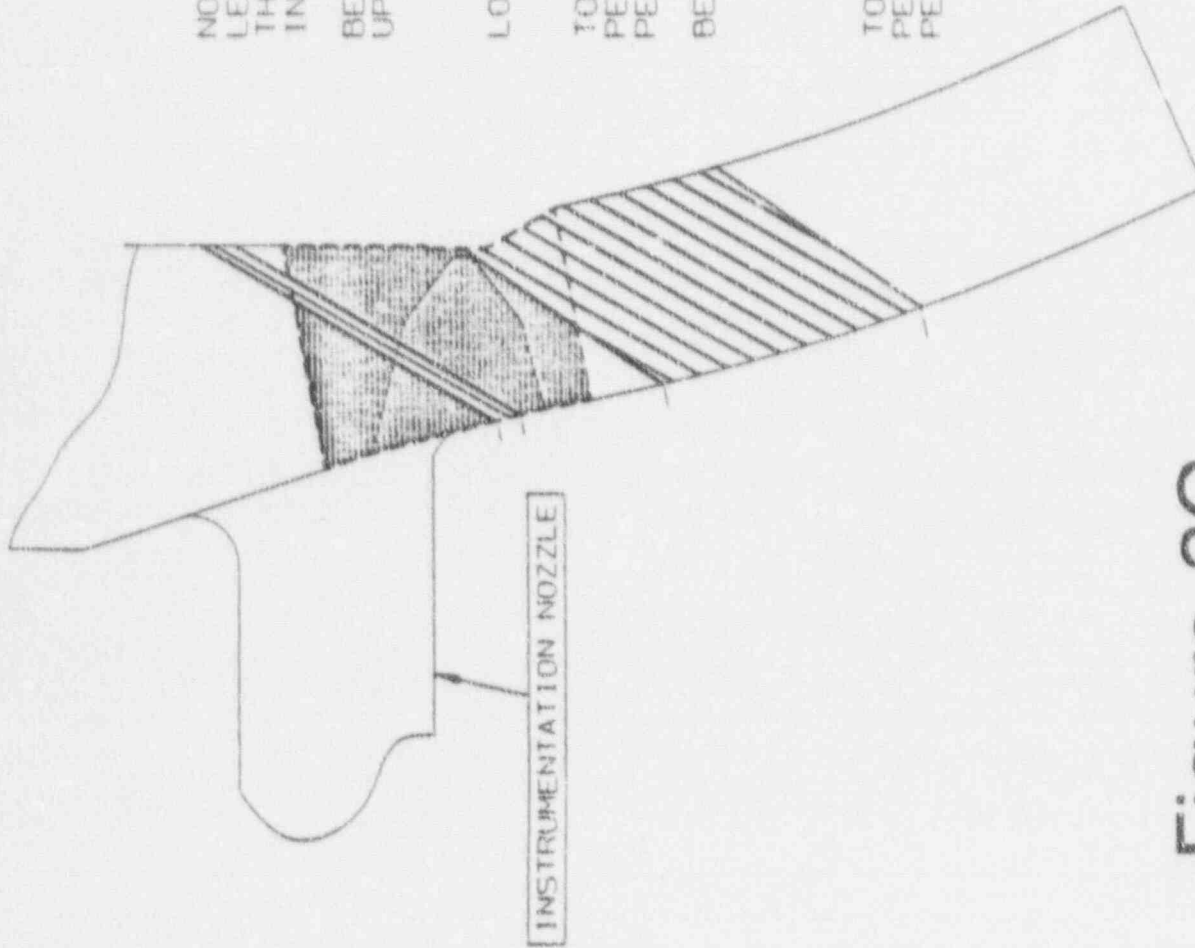
Figure 3C

AREA COVERAGE BY INSTRUMENTATION NOZZLE

NOTE:
 LENGTH OF RESTRICTION 4 INCHES @ 2 LOCATIONS
 THIS YIELDS 5.0% OF THE TOTAL WELD IS UNDER
 INSTRUMENTATION NOZZLE.

TOTALS:
 PERCENT OF WELD EXAMINED: 0.9
 PERCENT OF WELD NOT EXAMINED: 4.1

TOTALS:
 PERCENT OF WELD EXAMINED: 0.0
 PERCENT OF WELD NOT EXAMINED: 5

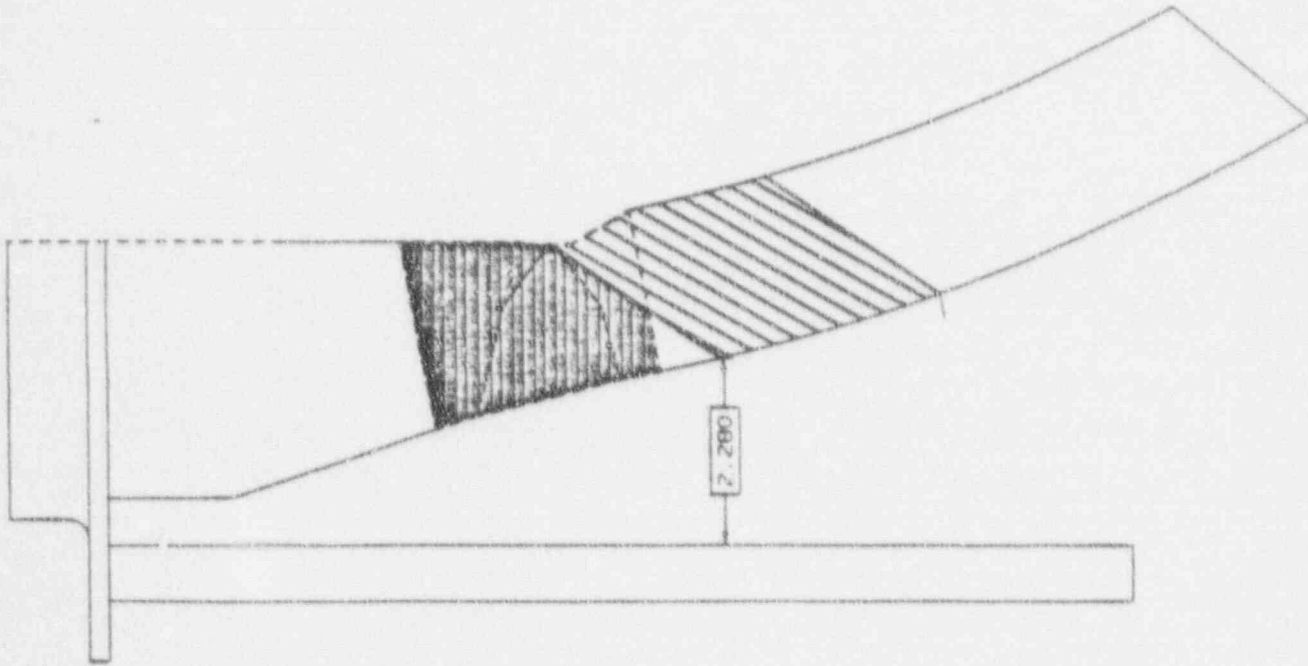
COVERAGE IN AREA WITH INSTRUMENTATION NOZZLE

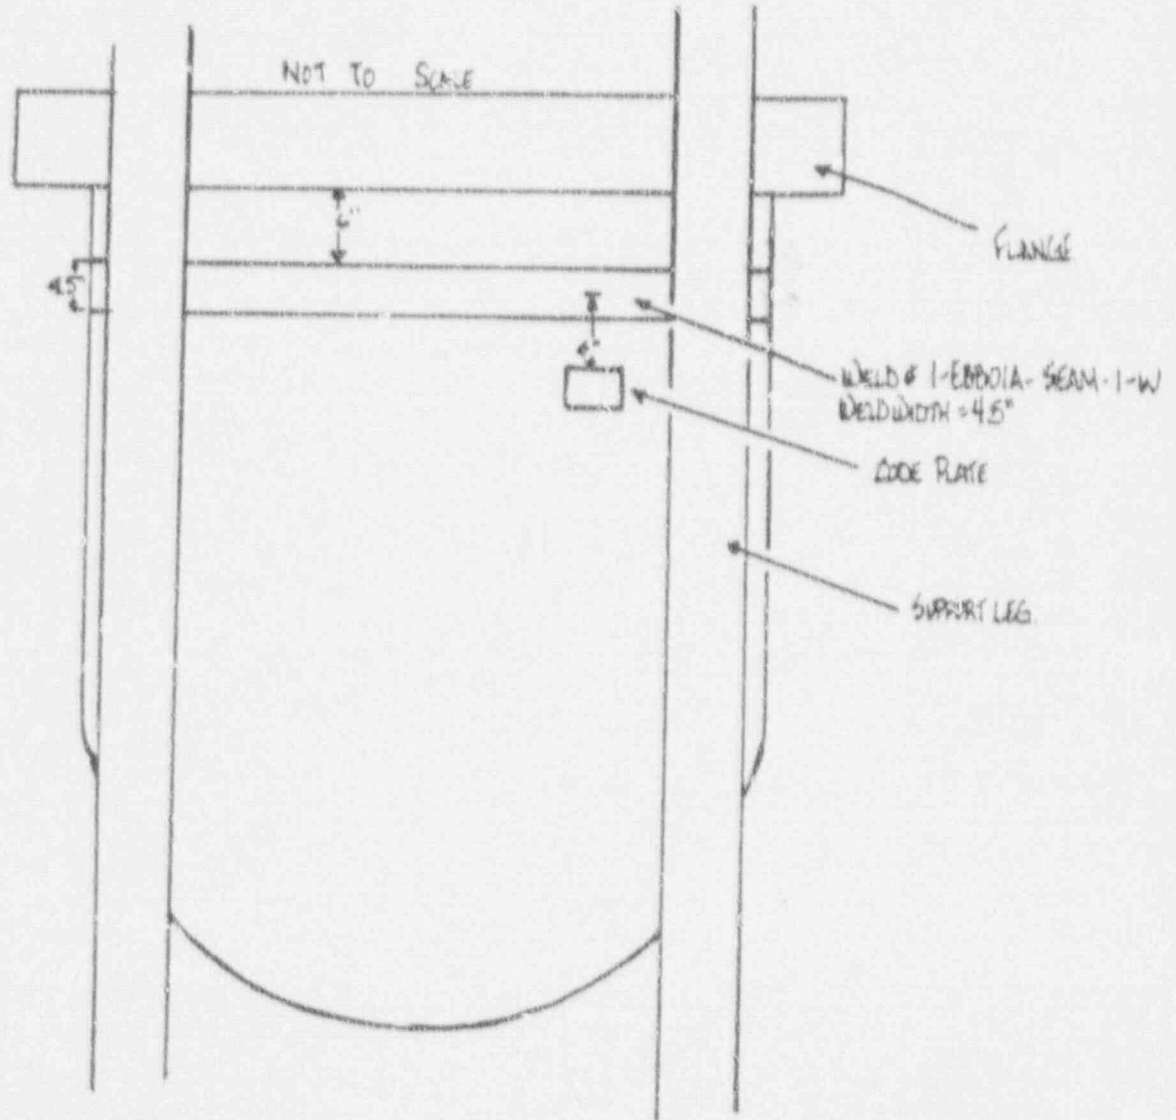
Figure 3D

AREA COVERAGE UNDER LEG
NOTE:
LENGTH OF RESTRICTION : 0 INCHES
AT 4 LOCATIONS, THIS YIELDS 24.6% OF THE
TOTAL WELD AREA UNDER THE SUPPORT LEGS.

TOTALS:
PERCENT OF WELD EXAMINED: 2.4
PERCENT OF WELD NOT EXAMINED: 22.2

TOTALS:
PERCENT OF WELD EXAMINED: 0.0
PERCENT OF WELD NOT EXAMINED: 24.6

COVERAGE IN AREA WITH BIT LEGS

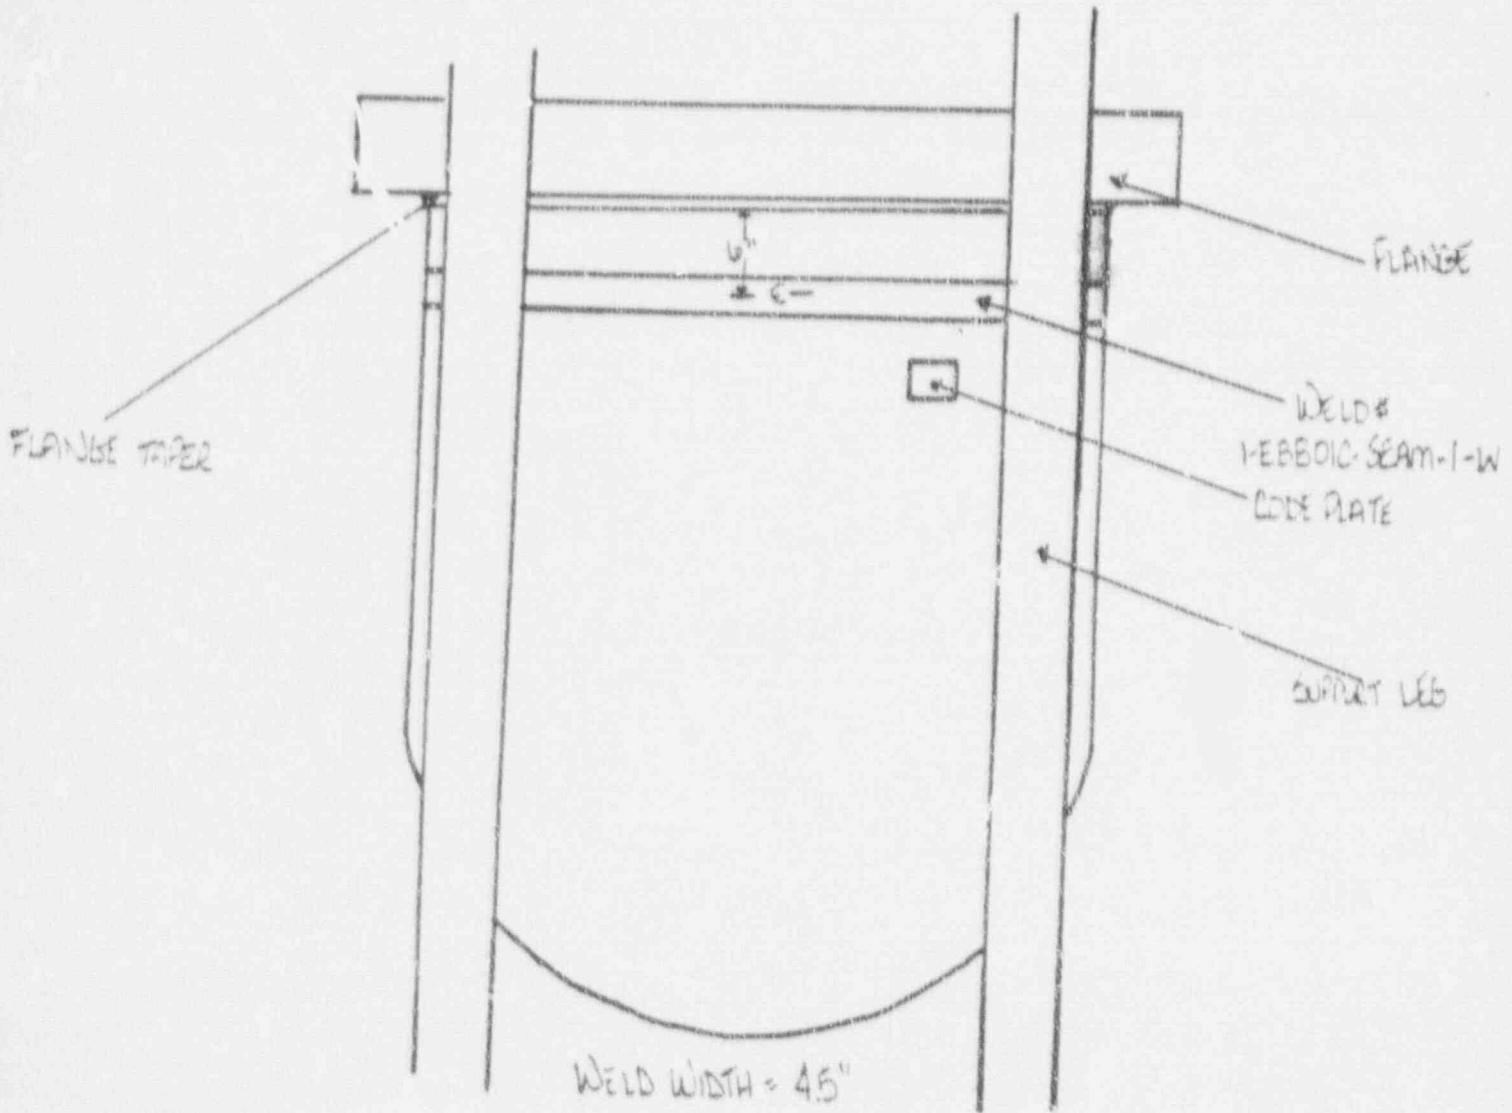
Basis for Relief: The volumetric examination of the subject weld is 22.4% obstructed by four (4) supports. The 60° axial scan on the tubesheet side is 20% obstructed by the support flange. The obstruction results from insufficient base metal between the weld and flange to complete this angle beam examination. There is approximately 1% obstruction due to weld taper and the code data plate. Reference Figure 4 for weld layout.

SUPPORT LEG LOCATIONS

- 39 1/4" to 63 1/4" CCW FROM DATUM X0, FULL SCAN AREA
- 42 3/4" to 66 3/4" CW FROM DATUM X0, FULL SCAN AREA
- 44" to 68" CCW FROM DATUM IV, FULL SCAN AREA
- 38 1/2" to 62 1/2" CW FROM DATUM N, FULL SCAN AREA

CODE PLATE LOCATION

- 29 1/2" to 30 1/2" CW FROM DATUM X0
- 4" to 8 1/4" BELOW WELD Q.

Alternate Examination: None; the Code required volumetric examination will be completed to the maximum extent practical.
