To T.E. Johnson
Subject Problem Alert
Large Settlements Due to
Incorrectly Placed Backfill
Copies to K. Wiedner
J. Milandin

Subject: Large Settlements Due to Incorrectly Placed Backfill

MIDLAND PLANT UNITS 1 & 2
CONSUMERS POWER COMPANY
SEVERAL DATA
TIME RATE

TIME/RATE SETTLEMENT OF DIESEL GENERATOR BUILDING

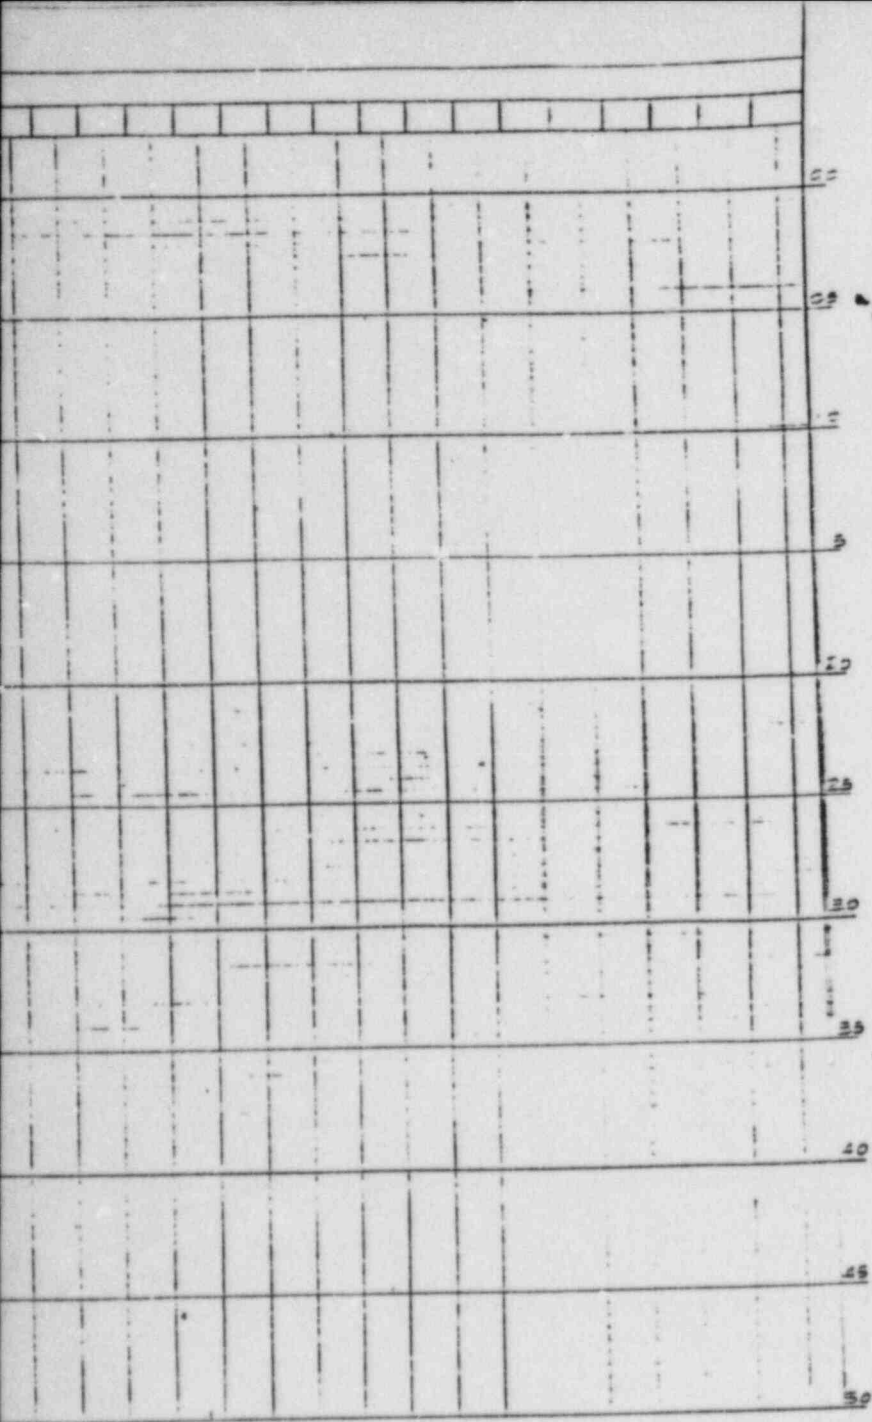
1. DIRT BANKS ISOLATED BETWEEN 11-10-70 AND 11-24-70
2. THE 30 SETTLEMENT MARKERS ON THE OUTSIDE OF THE BLDG. WERE NOTICED IN 11-15-70. SETTLEMENT FROM THIS DATE WAS ESTIMATED FROM DATA USING CONST. SLOPES INSTALLED ON 02-26-71.
3. THE AVERAGE SETTLEMENT WAS OBTAINED BY AVERAGING DATA FROM BOTH THE CONST. SLOPES AND THE 30 MARKERS SHOWN IN KEY PLAN.

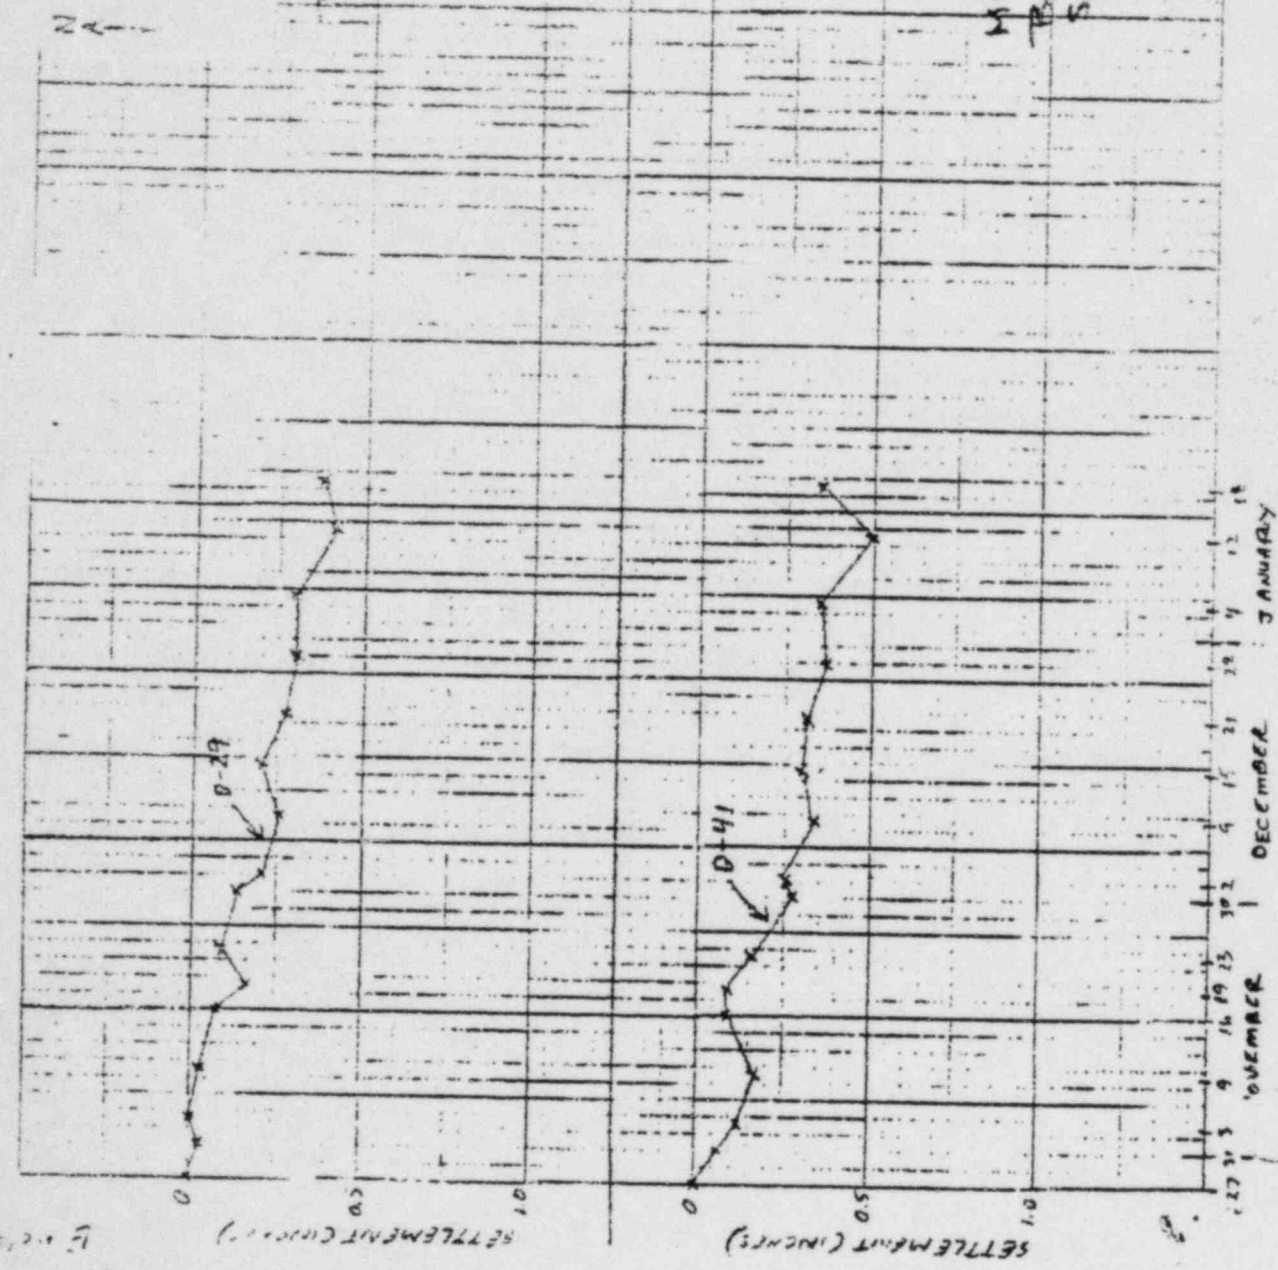
1. The criteria for maximum settlement is 0.5". Although the curve for marker U-41 on January 12, 1982 reads 0.5", Consumers does not consider this to be an accurate reading, as demonstrated by the January 18, 1982 reading which shows about 0.4".
2. Other measured points also show the dip which occurred on January 12, 1982. Consumers speculates that survey inaccuracies may be at fault for the January 12, 1982 readings.
3. Consumers feels the current data demonstrate that the fill beneath the BWST foundations is now in secondary consolidation. The secondary consolidation rate for the tanks has been estimated to be 1/2" per decade.

Mr. Kane replied that the settlement data for markers U-29 and U-41 do not clearly indicate that the foundation soils beneath the valve pit are in secondary consolidation. If the questionable readings of January 12, 1982 are excluded, and average smooth settlement curve through the plotted points could be drawn since November 24, 1981 (the date for placing the third and final surcharge load increment) which would indicate the foundation soils are still in primary consolidation. Mr. Kane requested that the settlement data for the other markers be provided for review.

MIDLAND
 BORATED TANK
 SETTLEMENT DATA
 1/25/02
