Lesson to be learned in public presentations

General Description of Plant Fill Problem and Its Extent

List of Vu-graphs for ACRS Presentation - Geotechnical Engineering

**CONSUMERS POWER COMPANY
 MIDLAND UNITS 1 AND 2**

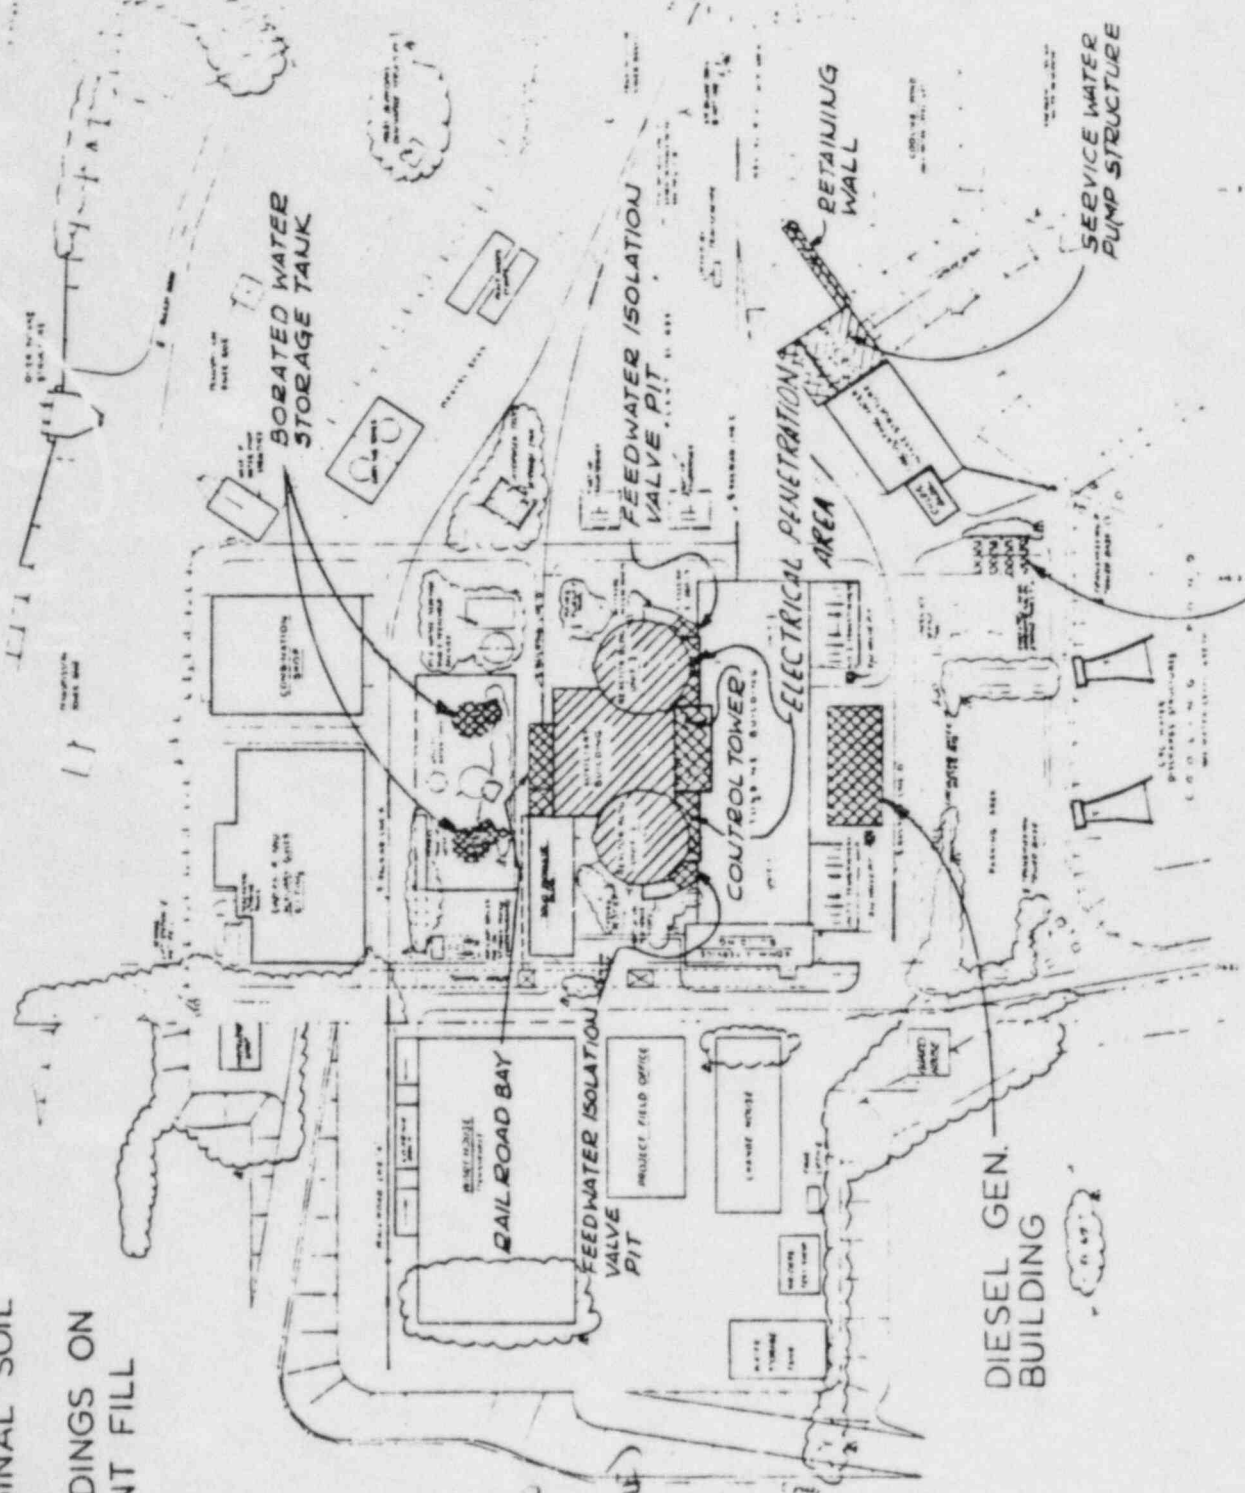
GES-1

Show plan view of Cat-I structures on competent natural soils and on plant fill
Plant grade El. 634 - Top of natural soil El. 600 ± - Top of hard-stiff natural
silty CLAY w/ silt, ^{sand} and gravel varies El. 585 to 600
Bedrock is quite deep (Lk. black SHALE) El. 240 ±
Distinguish separation from reactor Bldg.

see same cut I
 Show structures on
 natural soils & on plant fill
 Imp't. Elevations
 Plant grade El 634
 Top of natural soils El 600
 Top of hard-stiff competent
 penetration clay, El 585 to 600
 Bedrock is quite deep (4th SHALE)
 ~ El 240 ±

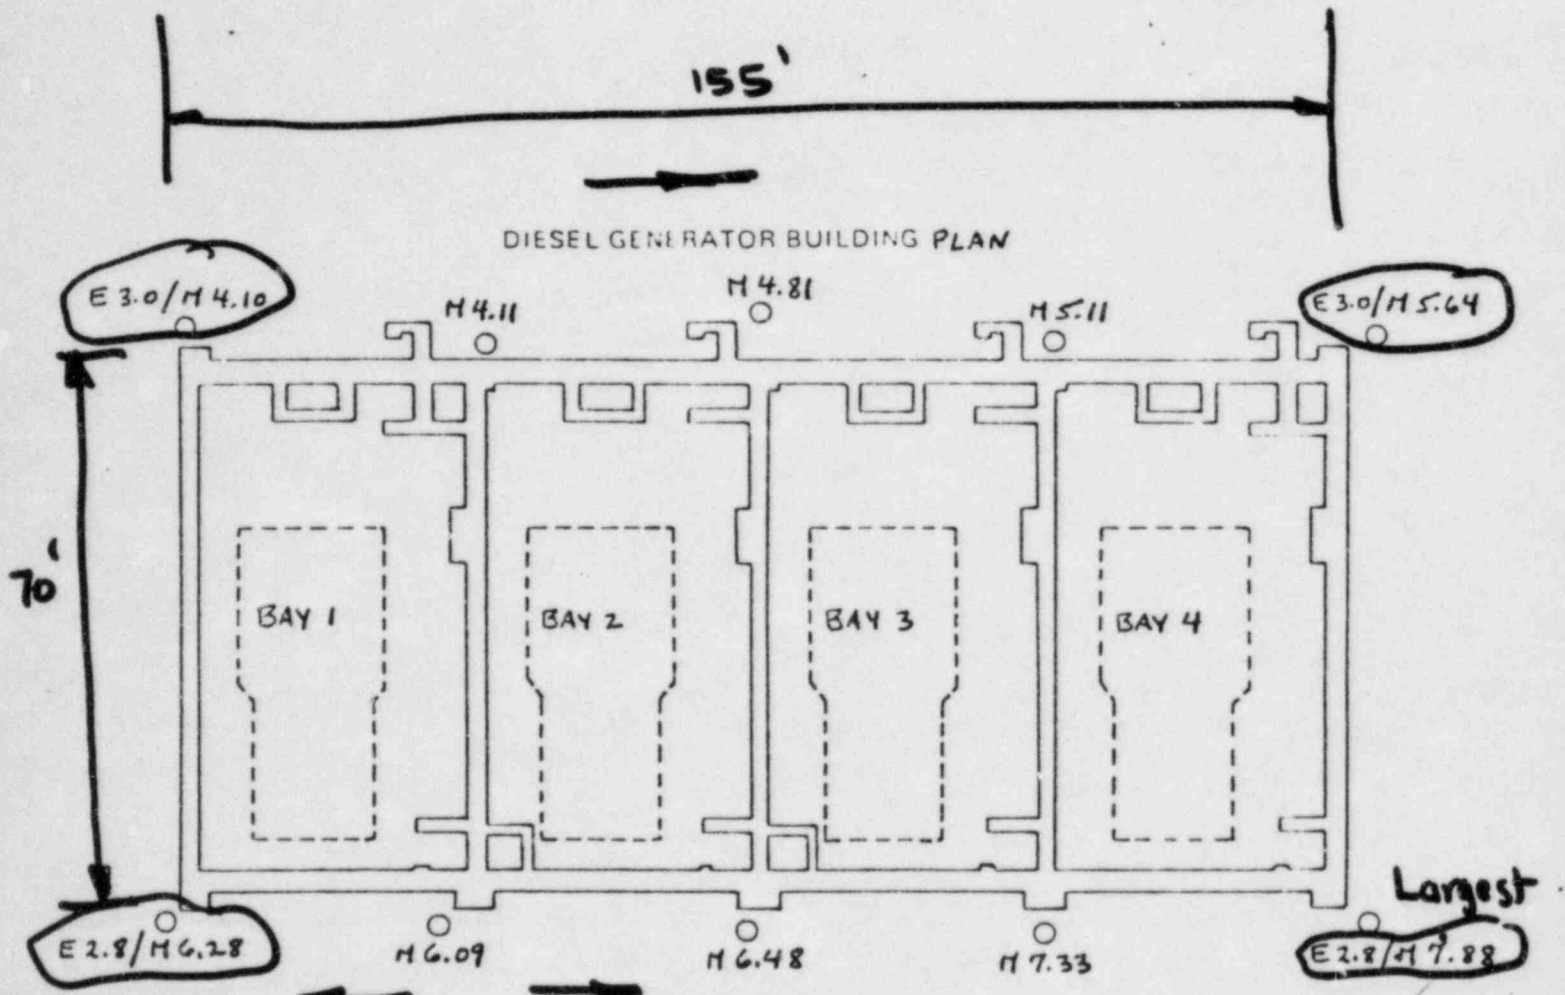
ESTIMATED VERSUS MEASURED
SETTLEMENTS

- DGB comparison of estimated versus actually measured settlements ^{includes surcharge effect}
- Settlement of Plant Fill Under Its Own Weight - Include plan of boros anchors
- Settlement of 8" service water line within the surcharge area (Max settlement = 1.35')

DGB - comparison of estimated versus measured

E 3.0 / M 5.64
ESTIMATED / MEASURED AS OF 12/81
for 40yr
plant
life

Largest
Include
settlements
under
surcharge

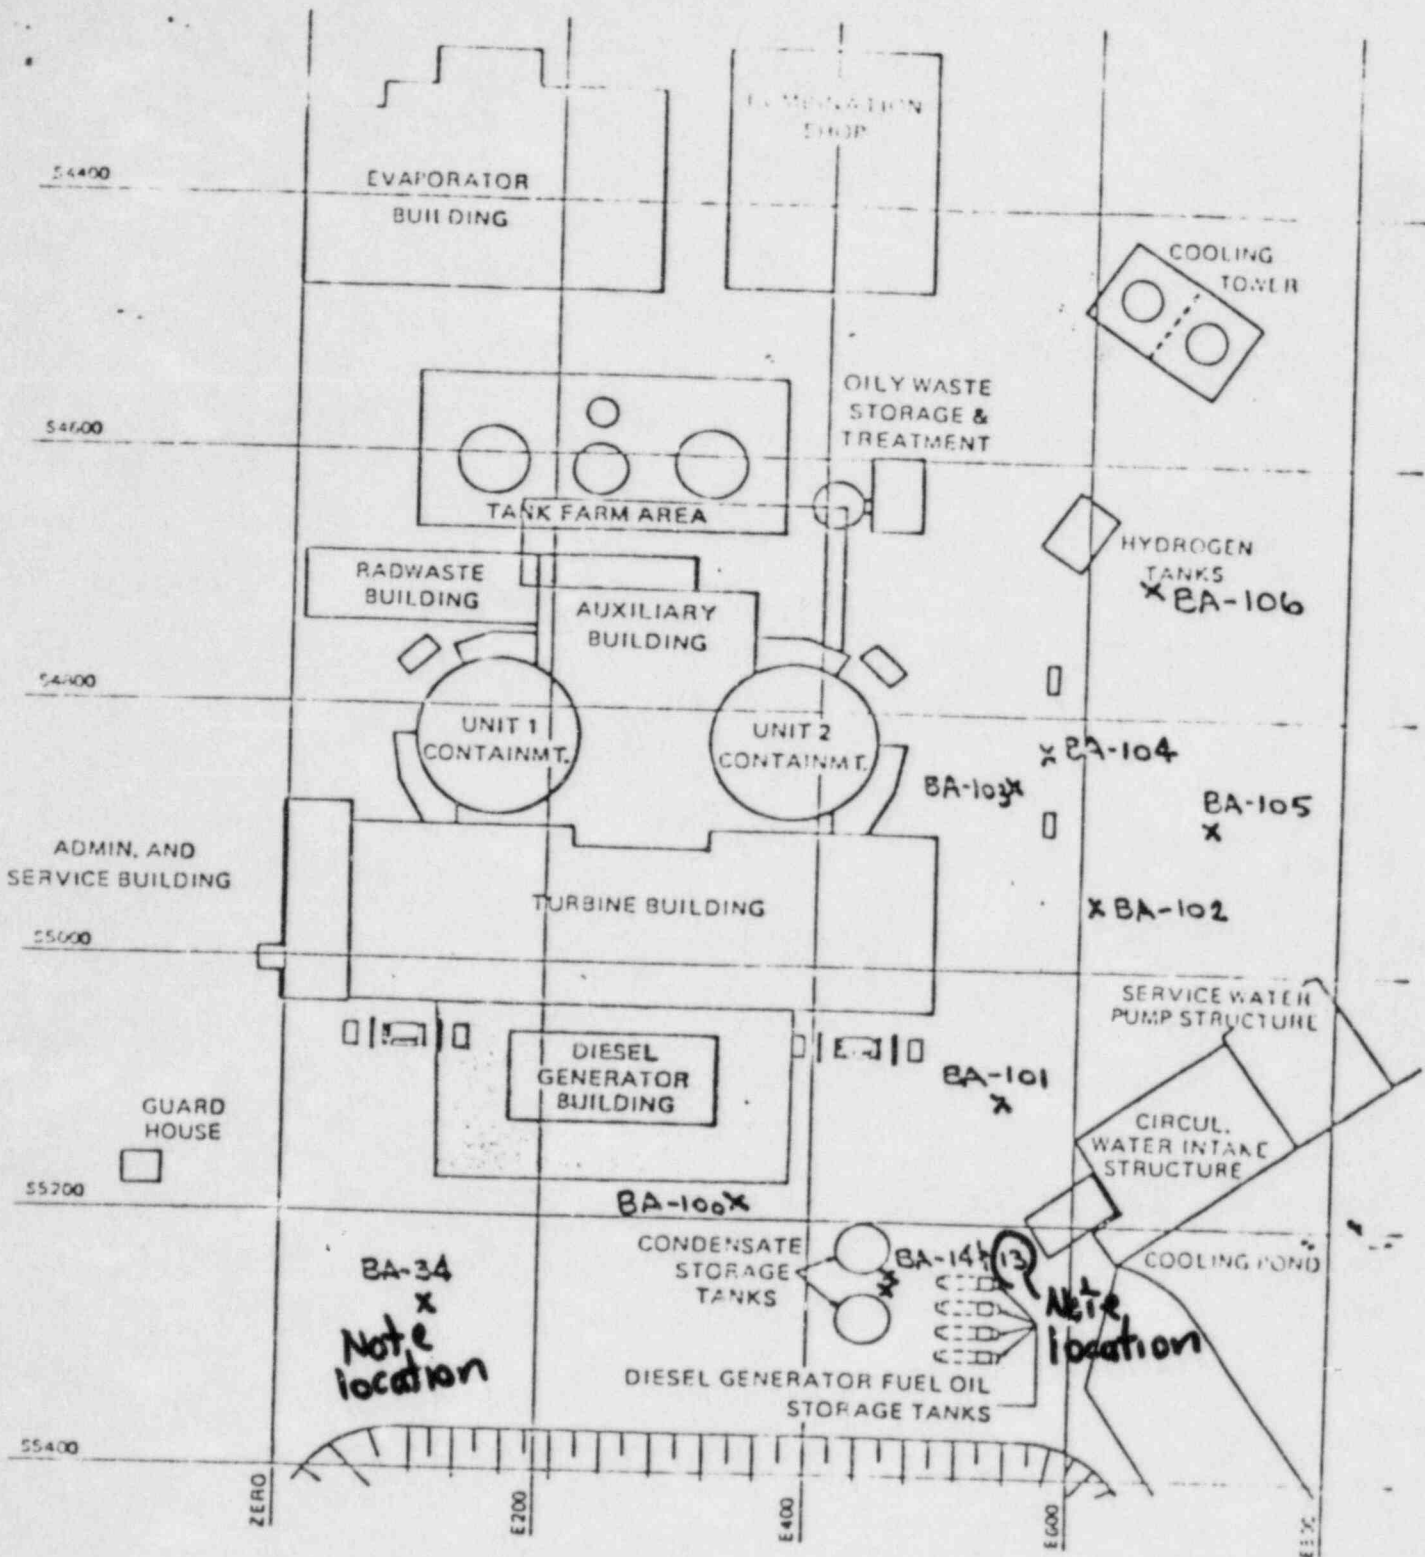
BORROS ANCHOR LOCATIONS

Fill reached plant grade
in 1977 (one year later
when settlement was measured)

Reason for difference in settlements (BA-13 & BA-34)
is likely due to the highly variable fill densities

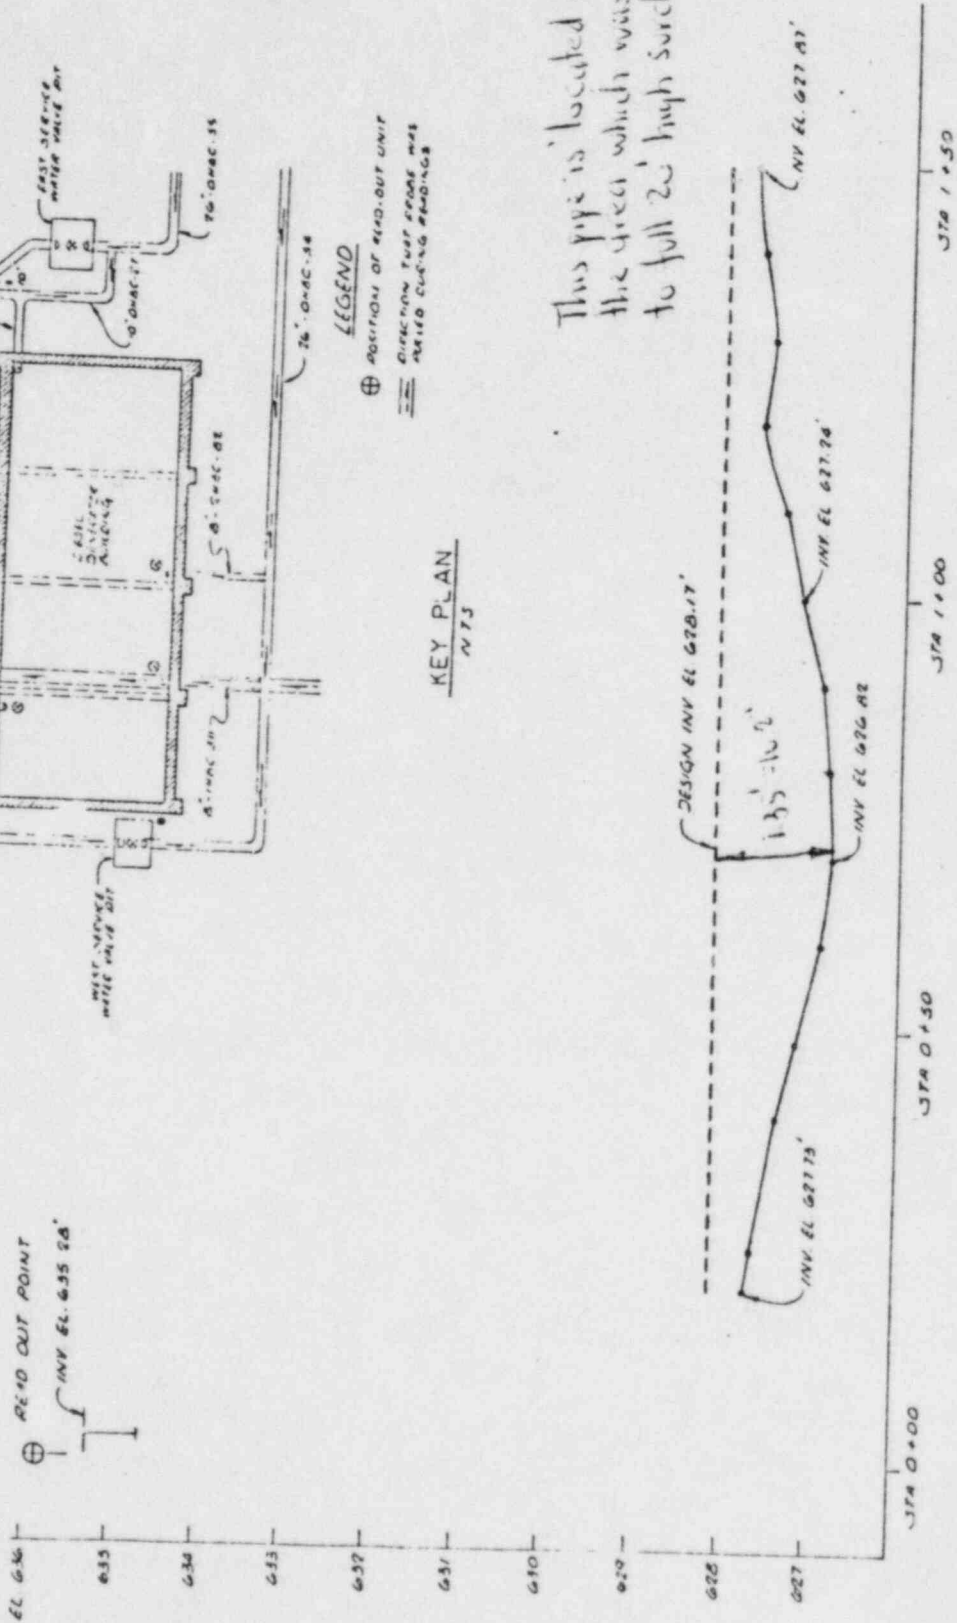
PROFILE 8"-1HBC-81

This pipe is located within the area which was subjected to full 2' high surge

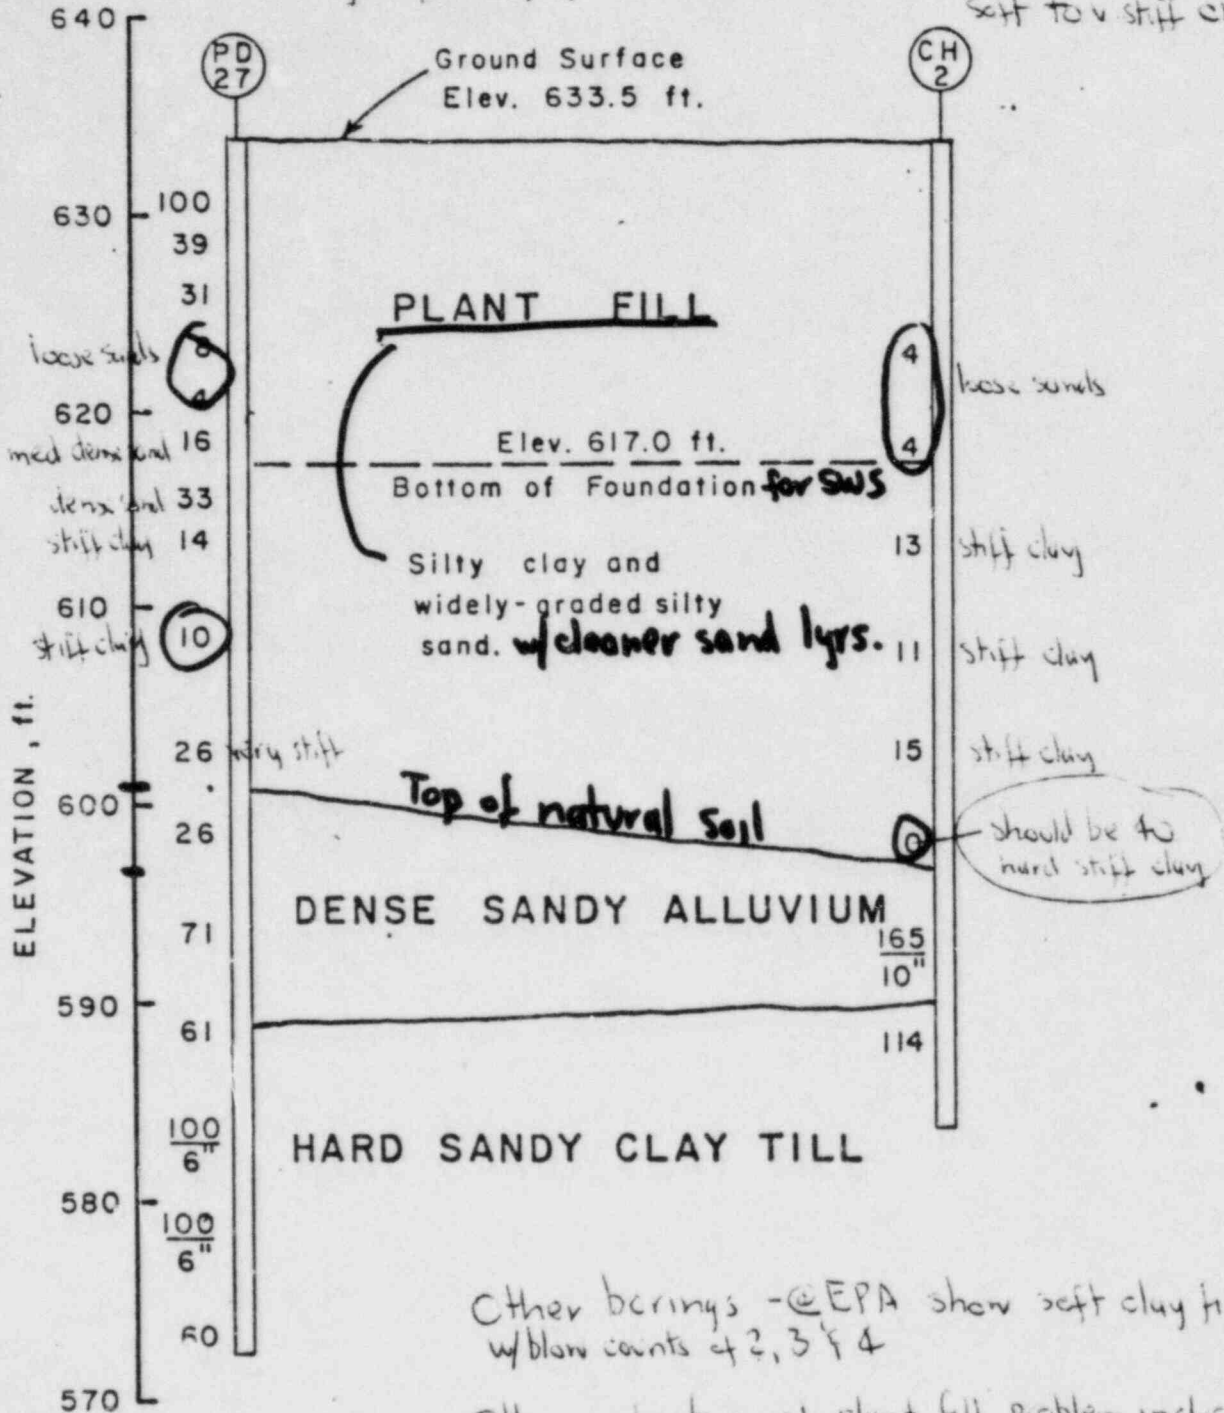
SIMPLIFIED SOIL PROFILE AT SERVICE WATER PUMP STRUCTURE

Sample borings CH-2 and PD-27 show loose sand fill

Other borings, such as the AA series, show soft clay fill beneath the EPA with blow counts as low as 2, 3 and 4

Not acceptable fill mat'ls. or indicative of well compacted fill

Borings reflect highly variable fill consistency - loose to v dense SANDS soft to v stiff CLAYS

Other borings - @EPA show soft clay fill w/ blow counts of 2, 3 & 4

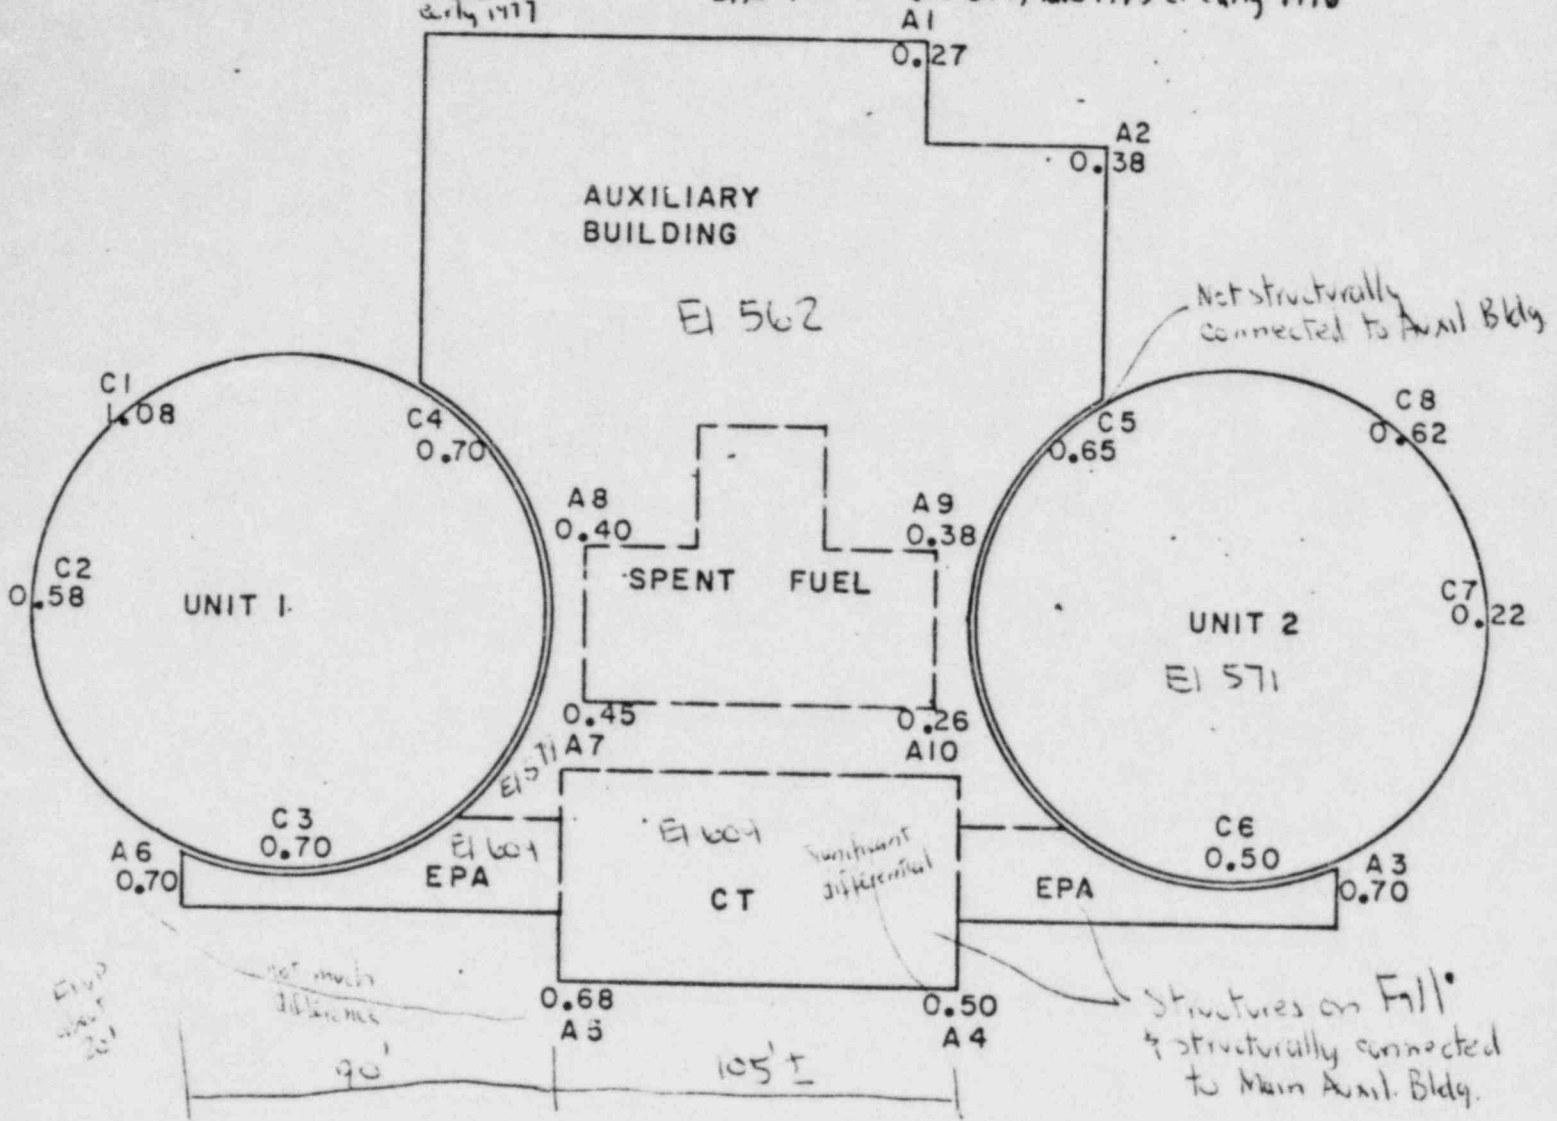
PLAN OF POWER BLOCK
SETTLEMENTS (FEB, 1976) THROUGH AUG., 1981

ask Applicant to respond to settlement records in this area go back this far

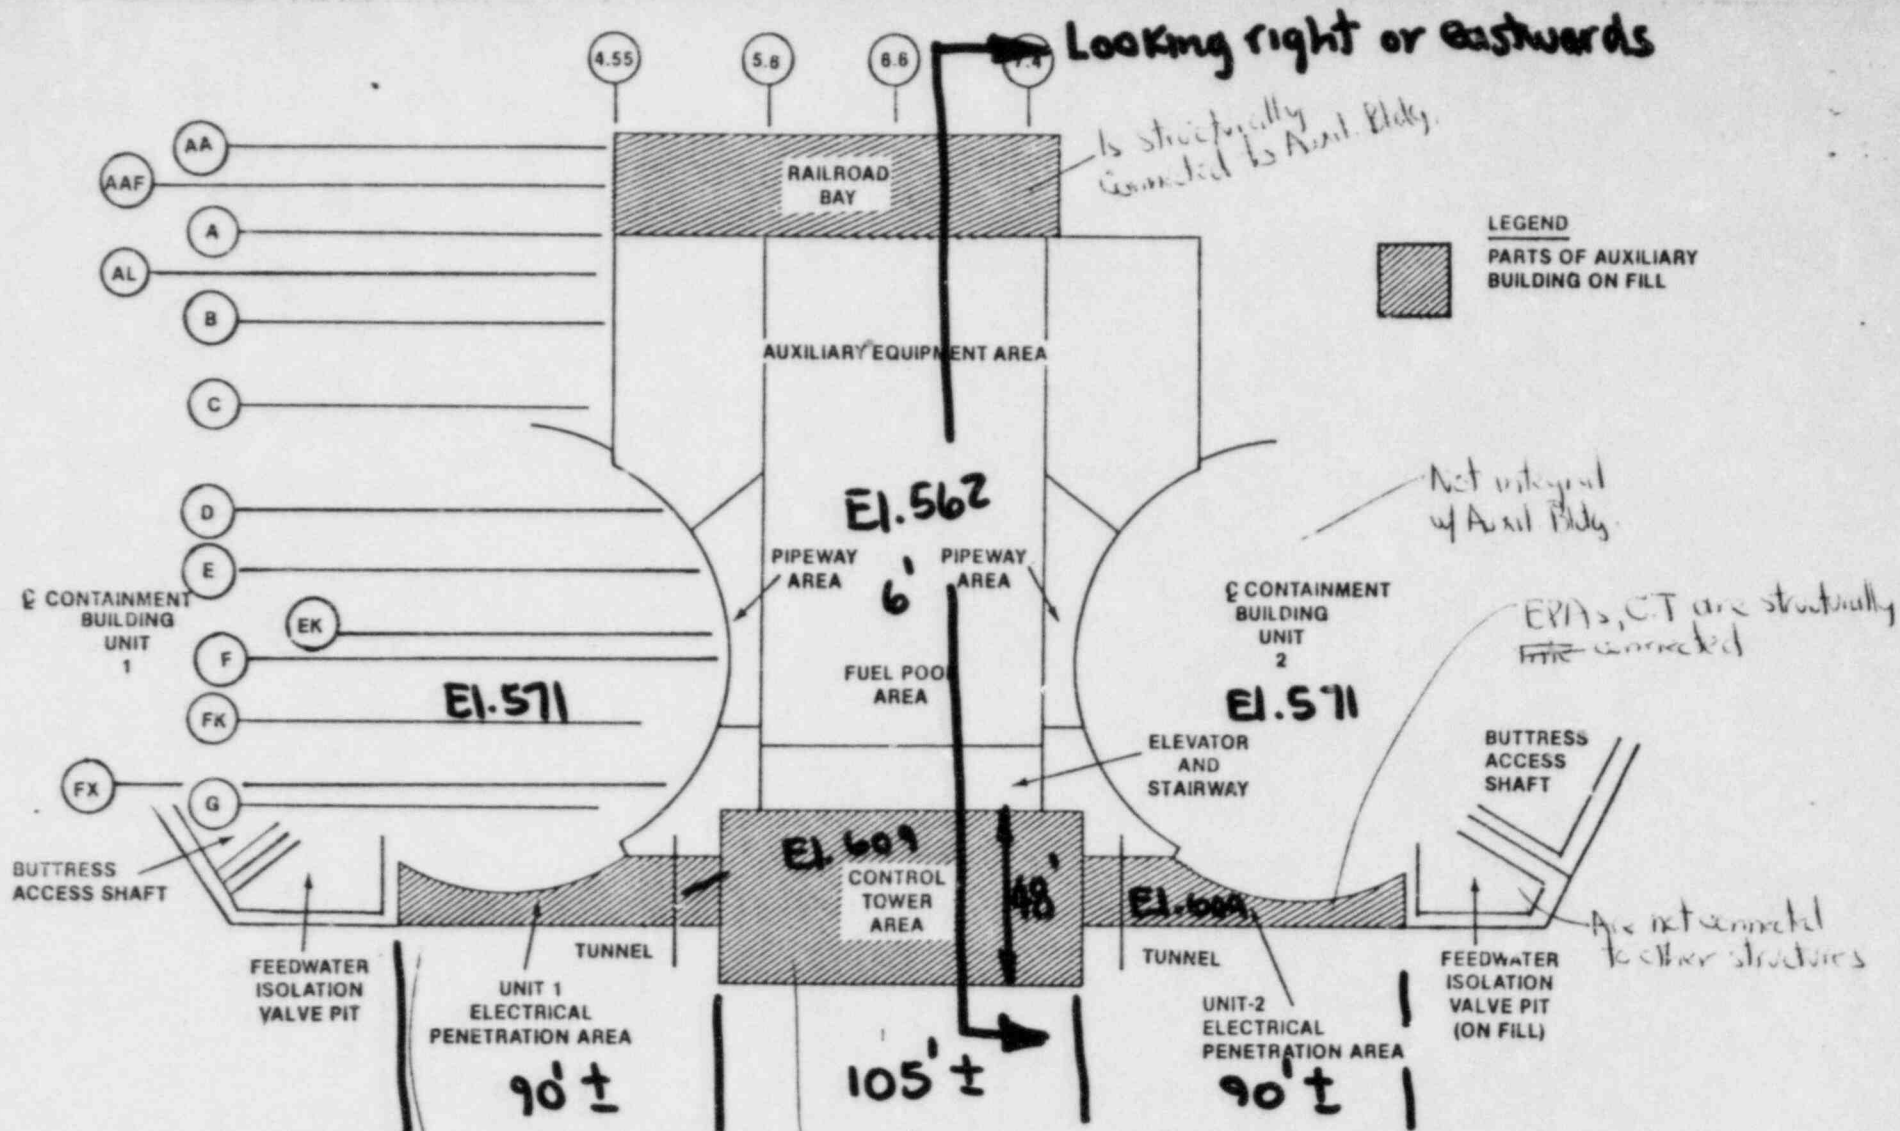
FIGURE II-1 GES-52

Note individual structures

Note reactor containments are ^{NOT} connected to Main Auxiliary Bldg

Note that EPA, C.T., and RR piping are structurally connected

- Staff assessment of proposed underpinning fix:
- Provides a positive solution for eliminating foundation problem
 - EPA & C.T. loads will be transmitted to very competent foundation layer
 - Monitoring during construction will permit verification of foundation adequacy and will include:
 - check on bearing capacity (Cone penetrometer)
 - Allowable bearing pressure 6 KSF EPA
 - 8 KSF C.T.
 - 25 KSF Temp. pier base

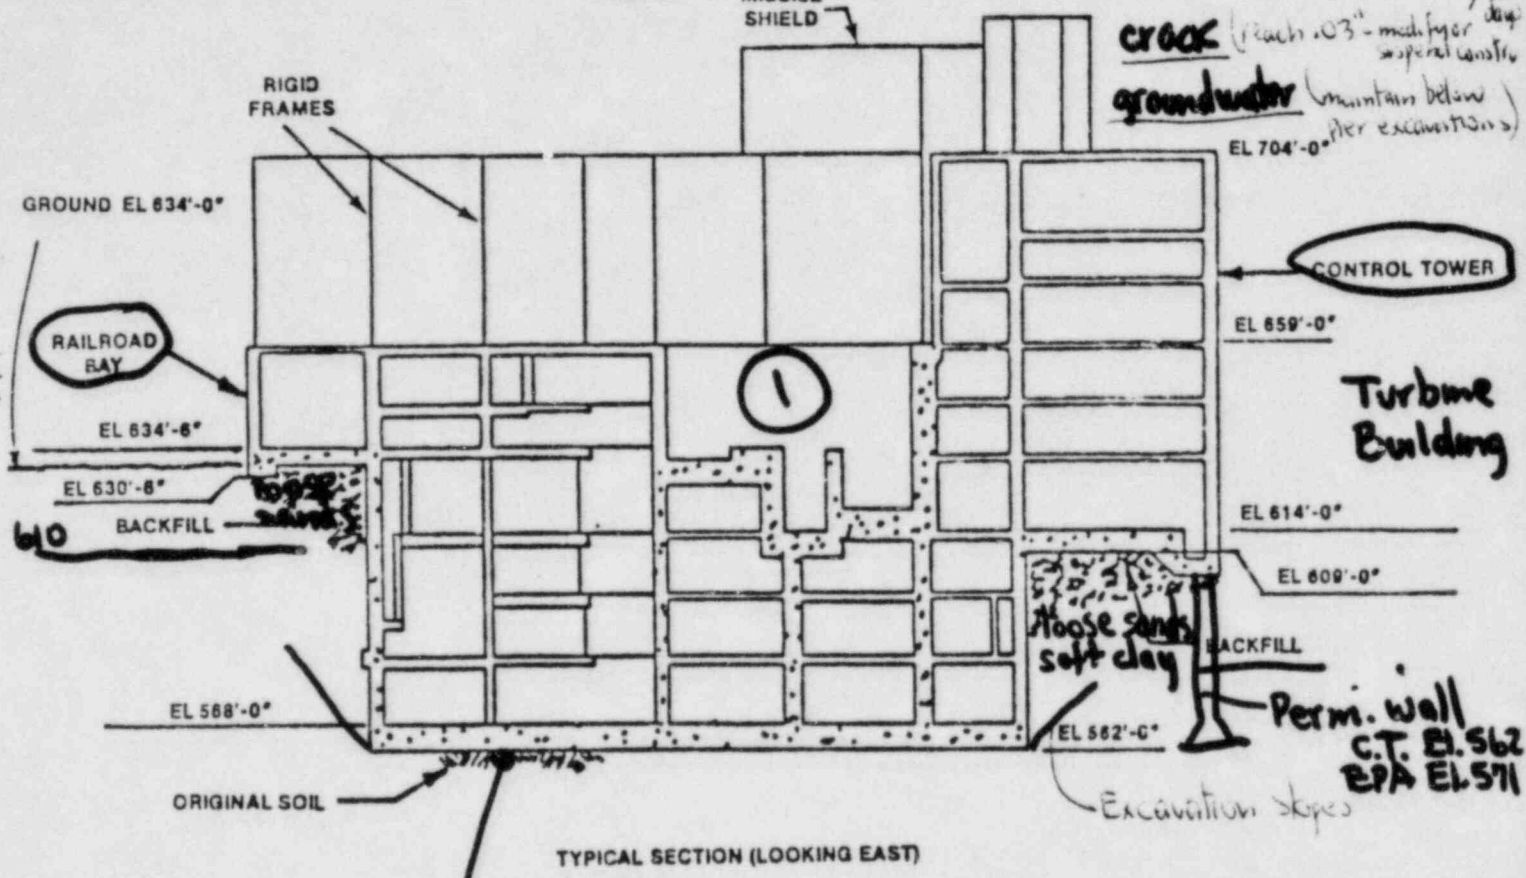
GRS-53

② Foundation - Very STIFF & HARD CLAY (CL)
 Median blow counts = 56 blows/ft
 LL 42, PL 20, $w_{nat} = 20\%$
 fines 90 to 98% $\delta_{total} = 130pcf$
 Median undrained strength = 7.6 KSF

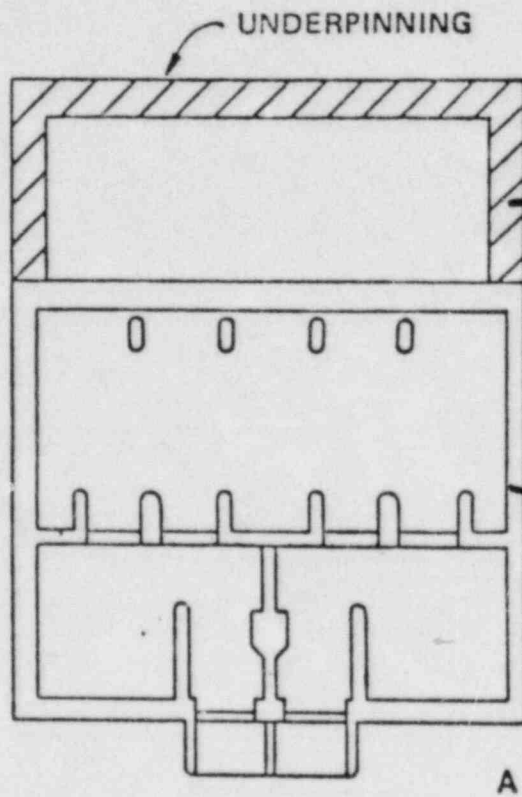
UNDERPINNING GENERAL LAYOUT

Portion on fill to be underpinned

Portion on till

- Piers will be founded on very competent foundation layer
- Positive solution will eliminate plant fill problem
- Monitoring during construction will permit verification of foundation adequacy

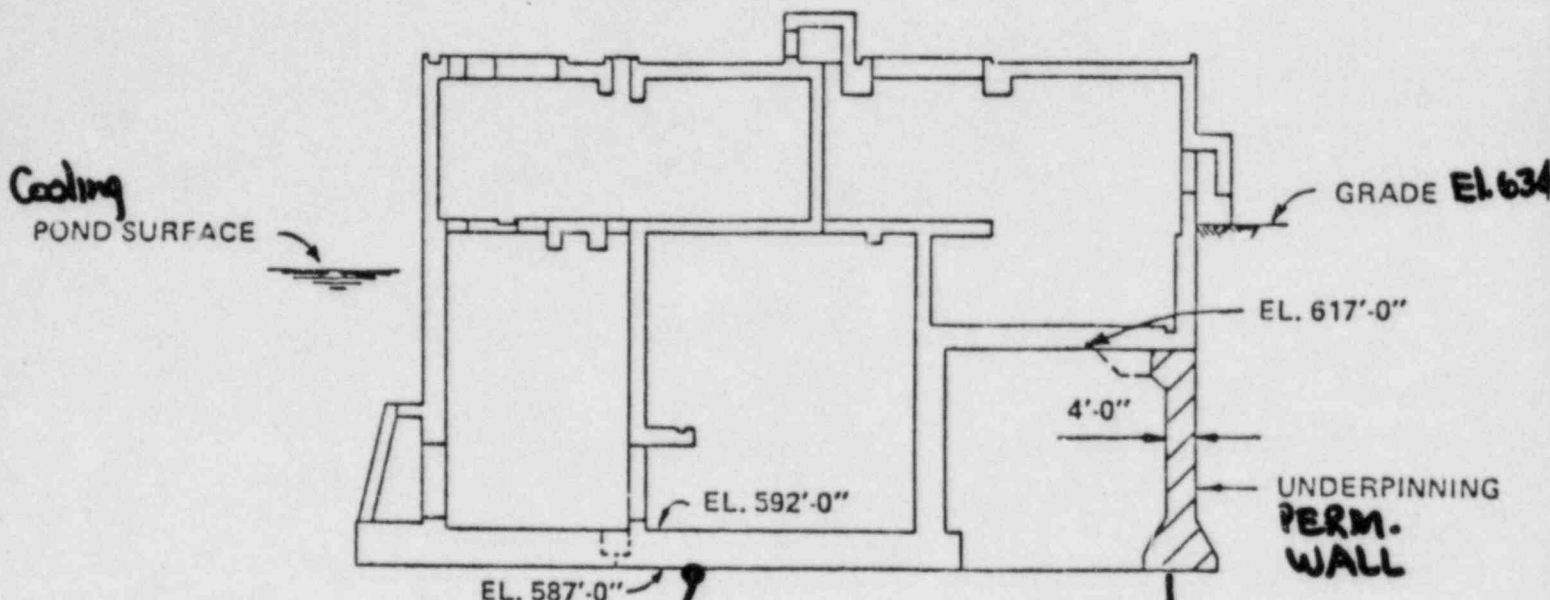
GES-56

Foundation layer ^{will be} ~~is~~ a hard sandy CLAY ^{or a dense silty clay} fill, that has top elevation around 590
 (IV medium = 75 blows (range 50 to 120), LL 17, PL 11, $w_n = 17\%$, $S_{total} = 145\%$, $S_{dry} = 134\%$
 $f = 50$ to 70% , ^{adapted} ~~medium~~ undrained shear strength of 8 ksf E of 6,000 to 9,000 ksf.
 Preconsolidation stress up to 40 tsf)

The Staff and its Consultants concur with the Applicant that the hard sandy CLAY ~~and dense silty clay foundation~~ ^{is} ~~are~~ competent and acceptable foundation materials to support the proposed permanent underpinning wall and thereby eliminate the plant fill problem in the SWPS area.

Foundation
 Hard sandy CLAY TILL
 Top Elev. \approx 590
 Median N = 75 blows/ft (50 to 120)
 LL 17, PL 11, $W_n = 9\%$ $\gamma_t = 145 \text{ pcf}$
 $\gamma_{dry} = 134 \text{ pcf}$
 fines 50 to 70%
 Adopted undrained shear strength = 8 KSF
 Heavily preconsolidated (98 tsf) $E = 6000 \text{ to } 9000 \text{ KSF}$

Foundation monitoring during construction will include checking groundwater, verifying adequate bearing capacity, soil modulus, settlement characteristics and controlling maximum elevation differences between adjacent pier bottoms

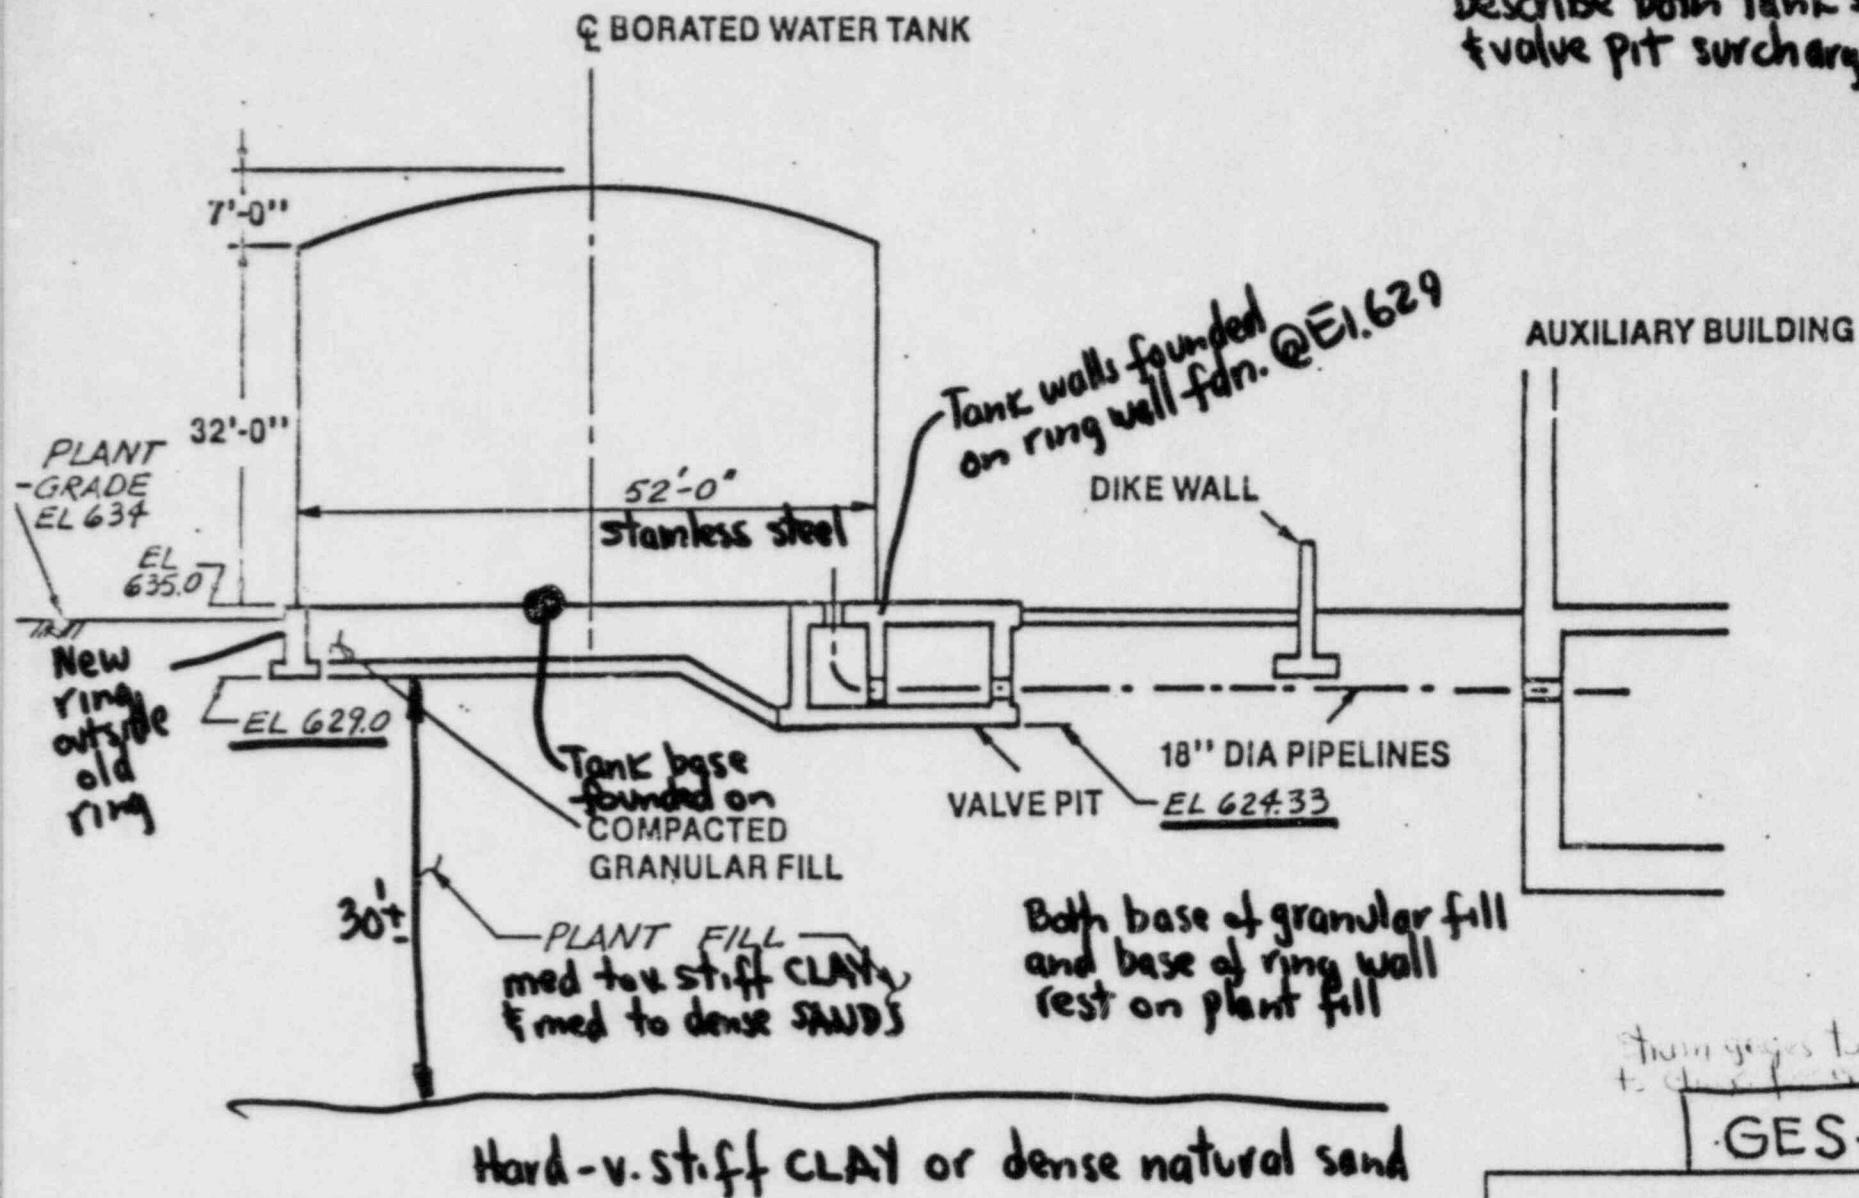
FIGURE 2

To demonstrate the adequacy of the BWSJ foundations, the Applicant filled the tanks with water to surcharge the plant fill. Shortly thereafter cracks (0.63 inch limit 1 & 0.35 inch limit 2) were discovered in the ring wall foundation near the juncture of the tanks and the valve pit structures.

Differences in technical opinion do exist between the Staff and the Applicant as to what was the major cause of the cracking. **a design inadequacy where a non-unif.**

Applicant - Major cause was ~~non-uniform~~ loading between valve pit and ring wall which resulted in differential settlements and localized areas of over stress

Staff - Consider the major cause to be inadequate compaction that lead to unanticipated larger settlements

that of constructing a new reinforced concrete ring beam around the existing ring beam and releveling Unit 1 tank (Suffered the largest settlement). Mr. Rinaldi to discuss.
New ring beam has been designed allowing for conservative estimates of differential settlement in the future

BWST foundation settlement will be monitored during years of plant operation as well as the critical stress areas between valve pit and the ring wall with a strain gage system. The objective of the monitoring will be to verify that differential settlements estimated in the redesign of the new ring beam are not exceeded and that ^{significant} cracking is not occurring

Staff assessment:
 The completed surcharge programs will result in tolerable future settlements which have conservatively been designed for in the NEW RING BEAM design. Settlement monitoring will permit verification of estimates

Strain gauges to be installed to check for settling

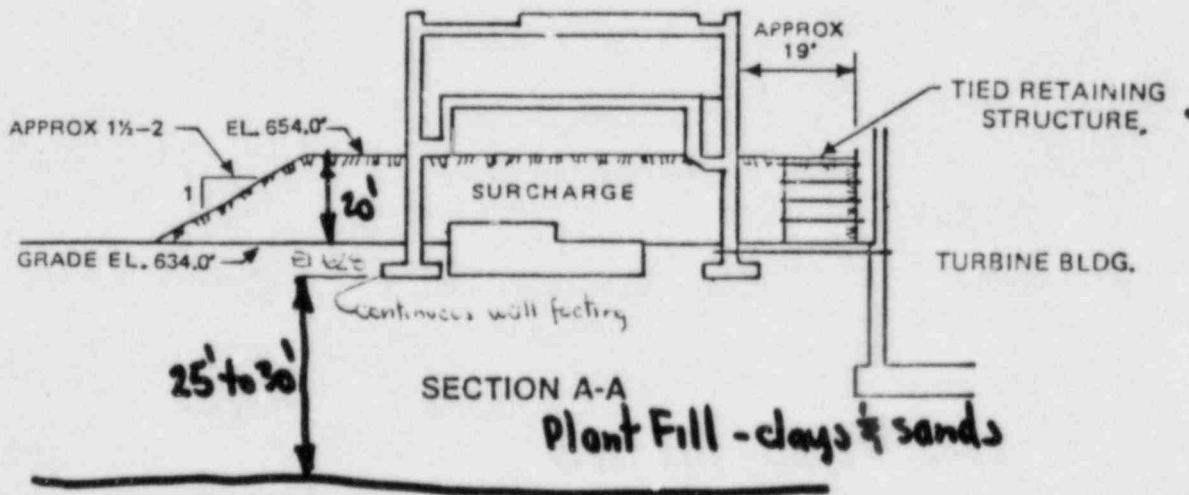
CONSUMERS POWER COMPANY MIDLAND UNITS 1 AND 2
GENERAL LAYOUT OF SURCHARGE LOAD DIESEL GENERATOR BUILDING
FIGURE I-1 GES-58

Show plan and sectional view of surcharged DGB area. The DGB is supported on continuous wall footings founded @ El. 628 (Approximately 25' to 30' of plant fill beneath structure). The plant fill is heterogeneous and consists of cohesive soils and granular soils, to a greater extent on the north side.

In July 1978, with the building about 60% complete, the settlements recorded indicated values greater than what had been anticipated for the entire plant life. Investigations showed the plant fill was settling under its own weight.

About 60% completed when problem discovered in July 1978

To correct the settlement problem, the Applicant elected to surcharge the DGB and complete the structure at the same time the surcharging was being placed

Describe surcharging (Placement of 20' of sand inside cut, etc)
~~So~~ Full 20' height of surcharge was held for about 4 1/2 months and then removed

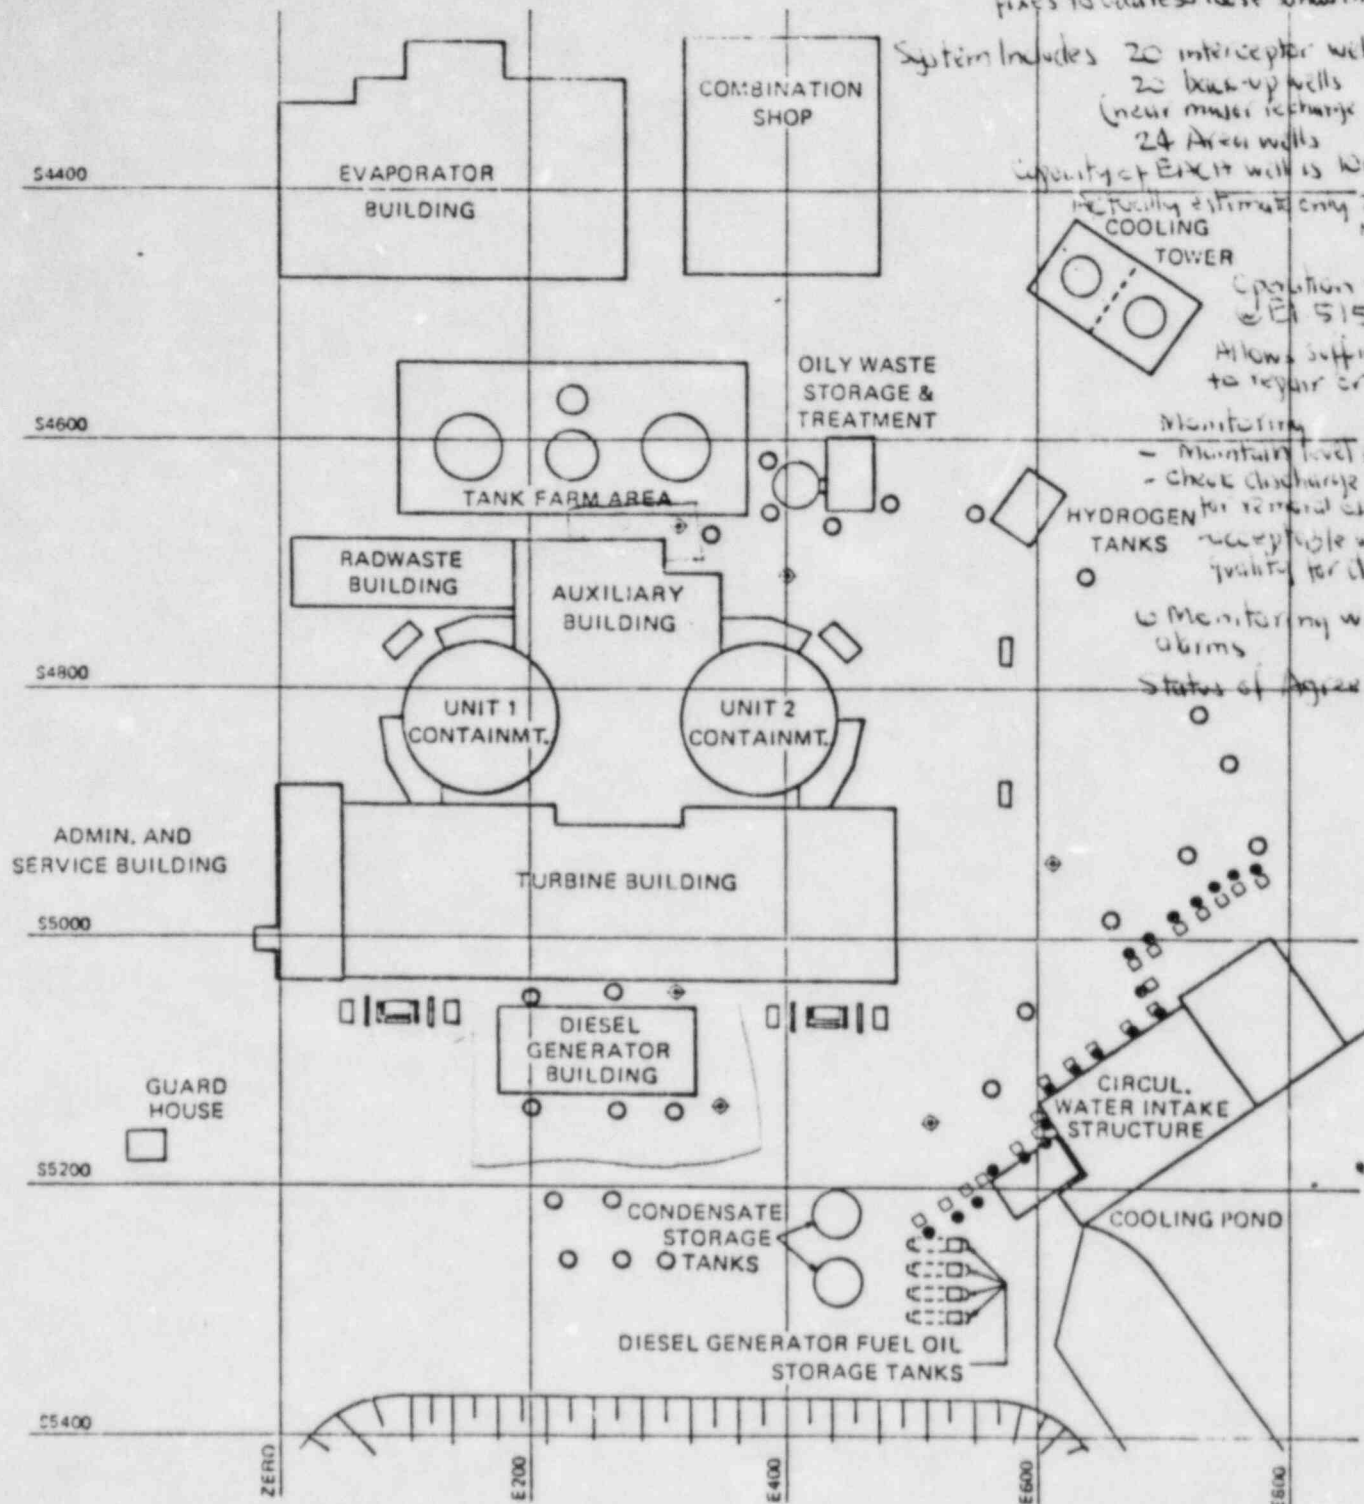
GES-60

Permanent dewatering system is necessary because of potentially liquefiable loose sands in plant fill (above El. 610) in areas of DGB and RR Bay area. ^{Foundation problems with} Loose sand backfill at other locations (SWs, EPA, underground piping) have been remedied with other fixes

Necessary - Potentially liquefiable loose sands on plant floor
 - Other locations (EPA, SWS, piping) have plans to address loose sands in those areas

20 Interceptor Wells - 20 Back-up Interceptor Wells
(Show location - located to pick-up main recharge source - cooling pond)

Capacity of each well is 10 gpm - Estimate ONLY 22 wells are needed to keep plant dewatered

- Maintain groundwater @ El. 575 during plant operation in DGB & RR Bay areas

System Includes 20 Interceptor wells
 20 back-up wells (near major recharge source)
 24 Area wells
 Capacity of EXCIT well is 10gpm
 Accuracy estimate only 22 wells NEEDED

Operation - Maintain @ El 515
 Allows sufficient time to repair or shut down.
