Lesson to be learned in public presentations

General Description of Plant Fill Problem and Its Extent

List of Vu-graphs for ACRS Presentation - Geotechnical Engineering

**CONSUMERS POWER COMPANY
 MIDLAND UNITS 1 AND 2**

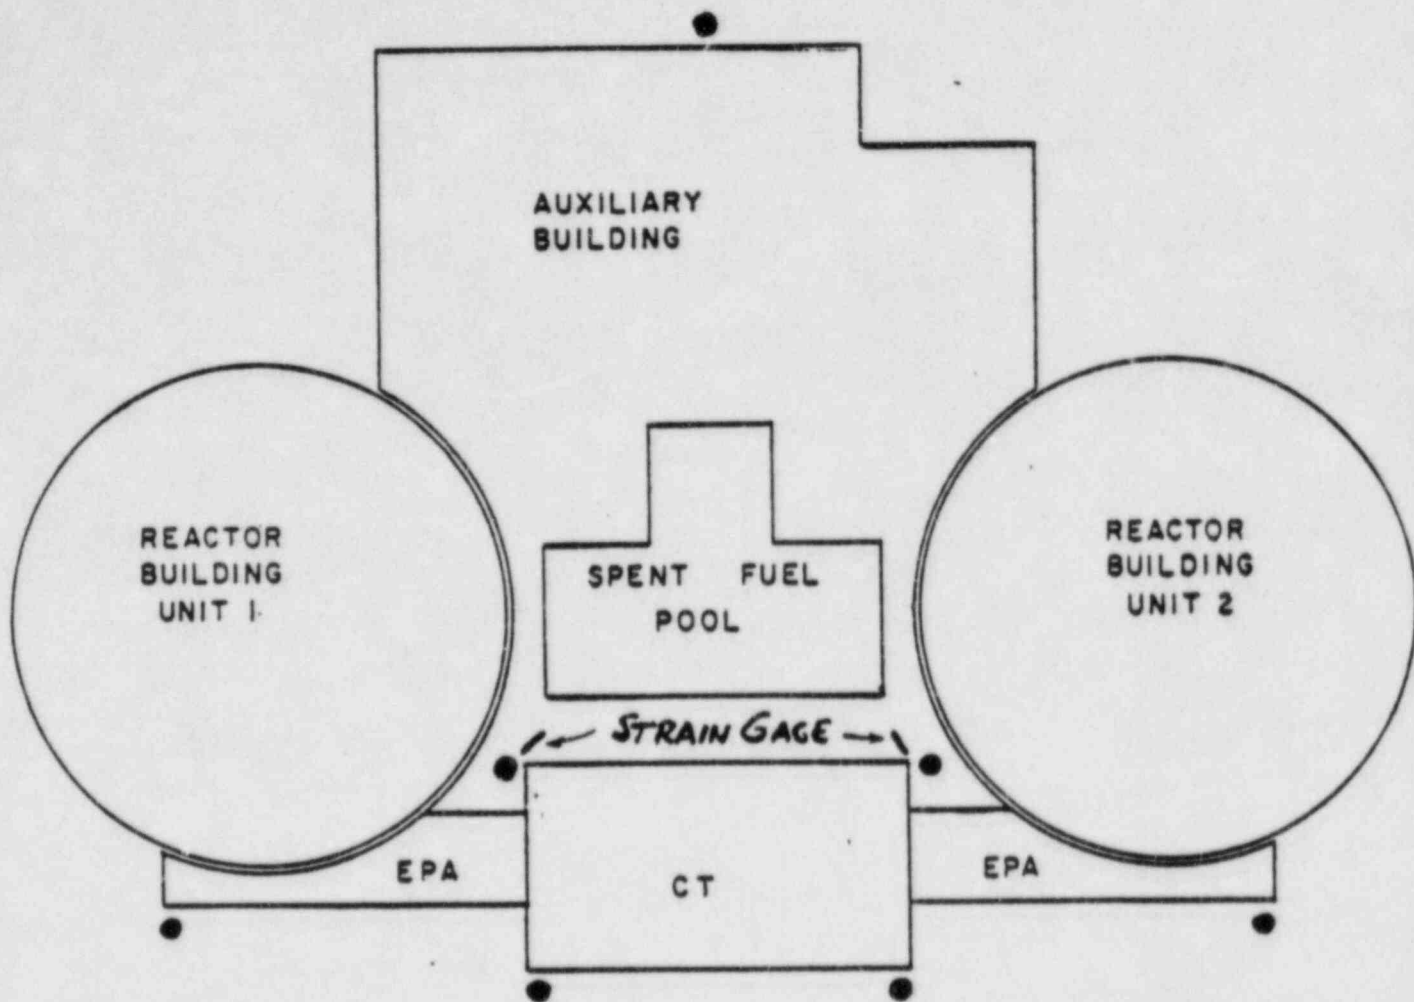
GES-61

PLAN SHOWING INSTRUMENT LOCATIONS
 THAT WILL BE USED TO CONTROL
 CONSTRUCTION
