UNITED STATES
NUCLEAR REGULATORY COMMISSION
REGION I
475 ALLENDALE ROAD
KING OF PRUSSIA, PENNSYLVANIA 19406

Docket No. 50-423
File No. RI-89-A-0052

Inspection Report No. 50-423/81-09

Facility Name: Millstone, Unit 3

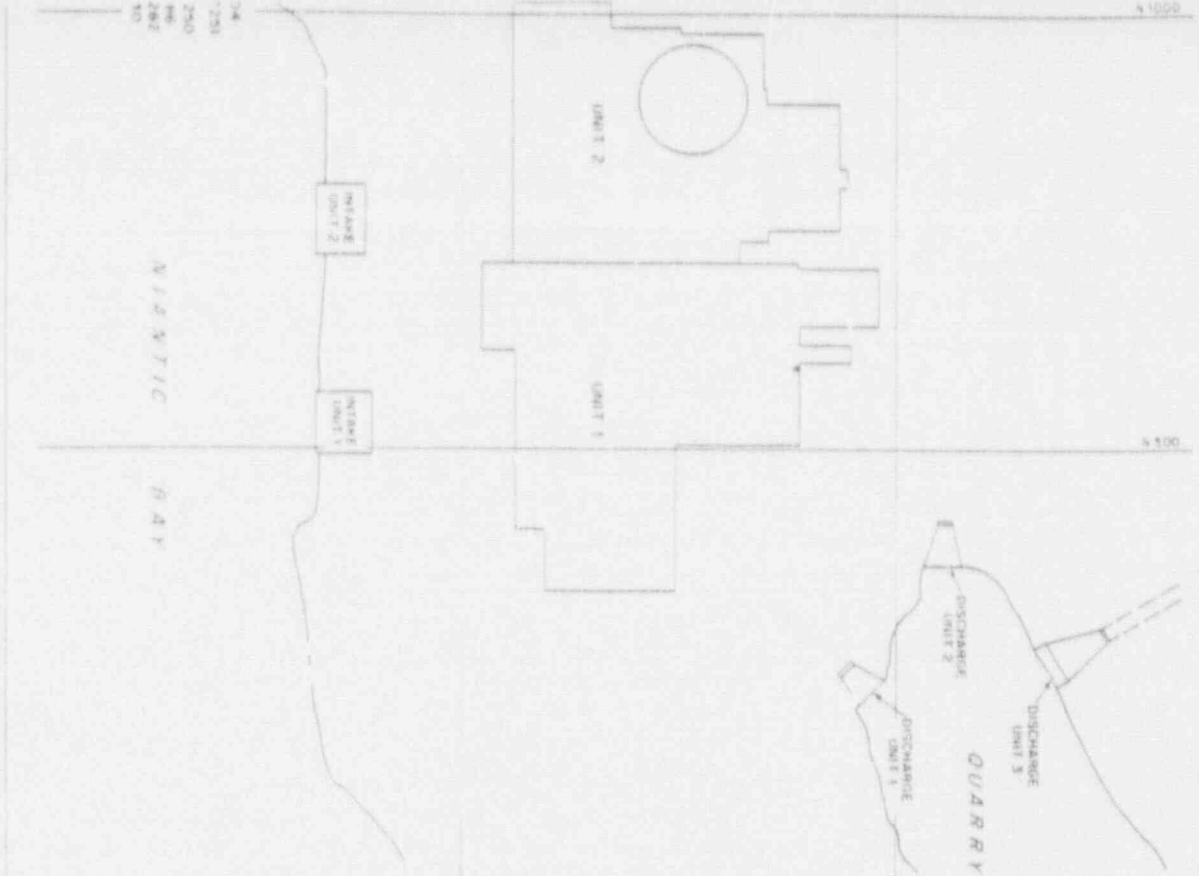
**FIGURE 2.5.1.1B
GENERALIZED LOCATION OF FAULTS
MILLSTONE NUCLEAR POWER STATION
UNIT 2
FINAL SAFETY ANALYSIS REPORT**

The location of geologic faults at the Millstone site have been identified through extensive site drilling and excavation. These faults were documented in the Millstone Unit 3 Final Safety Analysis Report (FSAR) which was reviewed by the NRC. None of the faults were identified as a safety concern due to their age and inactivity. A copy of the chapter in the FSAR that identifies the location of the faults is enclosed for your review as Attachment 2.
