LER Number
454:95-005

Title of Event: Fire Protection Report Discrepancies Due To Inadequate Evaluations During Preparation of Original Analysis

BYRON NUCLEAR POWER STATION

FIRE PROTECTION REPORT DISCREPANCIES DUE TO INADEQUATE EVALUATIONS DURING PREPARATION OF ORIGINAL ANALYSIS

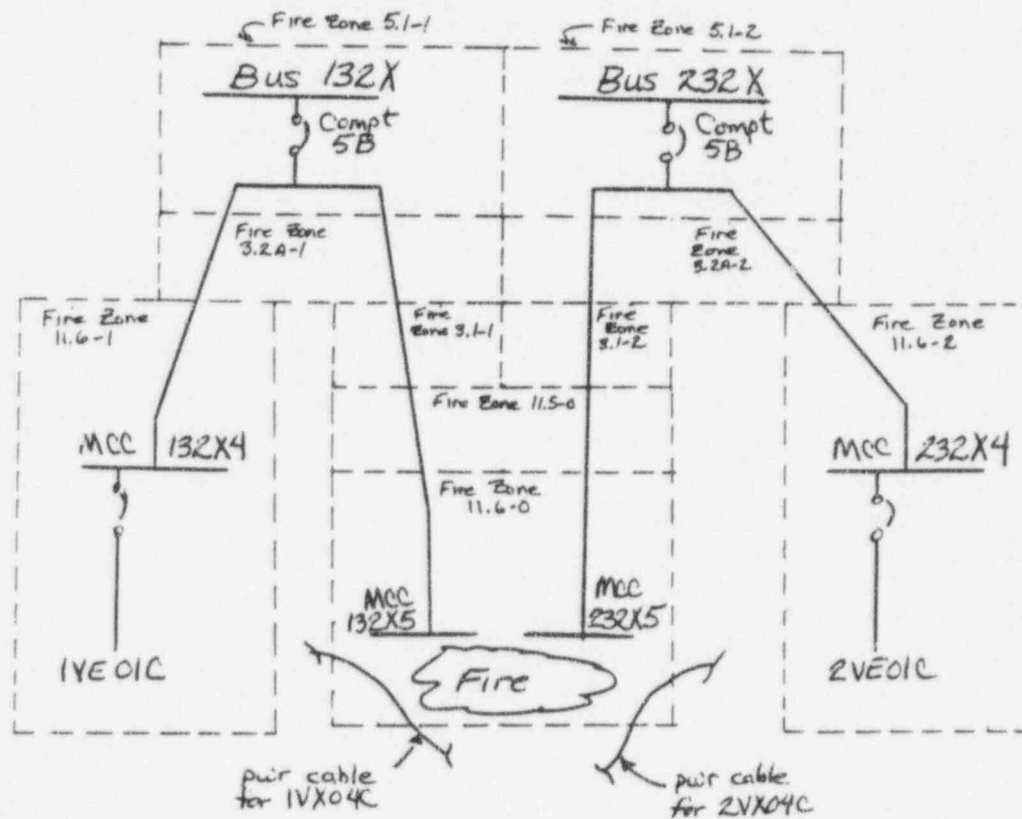
Figure 1: Configuration of Fire Zone 11.6-0

At 1000 hours on 10/10/95, Byron Site Engineering concluded that a deficiency similar to Braidwood's deficiency existed for Byron Fire Zone 11.6-0 FPR Safe Shutdown Analysis. A Byron Problem Identification Form (PIF) was written at that time to document the following discrepancy. Byron FPR, Unit 1, Section 2.4.2.51 (Fire Zone 11.6-0 Safe Shutdown Analysis) states that Division 12 fans will be available after a fire in this zone. FPR Section A5.8.22 states that the Division 12 MEER supply fan will be operational after a fire in zone 11.6-0. Neither of the above statements can be justified because the Division 12 MEER Supply Fan (1VE01C) could be lost due to a fire in zone 11.6-0. Similarly, the Unit 2 Division 22 MEER Supply Fan (2VE01C) could be lost due to a fire in zone 11.6-0.

The FPR Safe Shutdown Analysis for Fire Zone 11.6-0 failed to recognize the loss of electric power to the Division 12 and 22 MEER Supply Fans. Although the power cables for these fans are not routed through Fire Zone 11.6-0, they are powered from Motor Control Centers (MCCs) which are affected by a fire in zone 11.6-0. The MCCs supplying power to the Division 12 and 22 MEER Supply Fans are powered from two 480 volt breakers that also power MCCs located in zone 11.6-0. The MCCs located in fire zone 11.6-0 can be damaged by a fire in this zone. A fire induced fault on these MCCs will cause the 480 volt breakers to open which will also de-energize the MEER Supply Fans. See Figure 1 in Attachment A for a diagram of the above configuration.

Problem: Appendix R Fire in Zone 11.6-0 (Elev. 426', AB) may cause failure of:

- 1). Power cable for 1VX04C (U-1 Div 11 MEER Supply Fan)
- 2). Power cable for 2VX04C (U-2 Div 21 MEER Supply Fan)
- 3). Fault MCC 132X5 which causes Bus 132 Compt 5B breaker to open when sensing fault current.

Therefore MCC 132X4 de-energized resulting in:

- (a) Loss of 1VE01C (U-1 Div 12 MEER Supply Fan)
- 4). Fault MCC 232X5 which causes Bus 232 Compt 5B Breaker to open when sensing fault current.

Therefore MCC 232X4 de-energized resulting in:

- (a) Loss of 2VE01C (U-2 Div 22 MEER Supply Fan)

Which means for a fire in Zone 11.6-0;

Both redundant MEER Supply Fans are lost on both units.

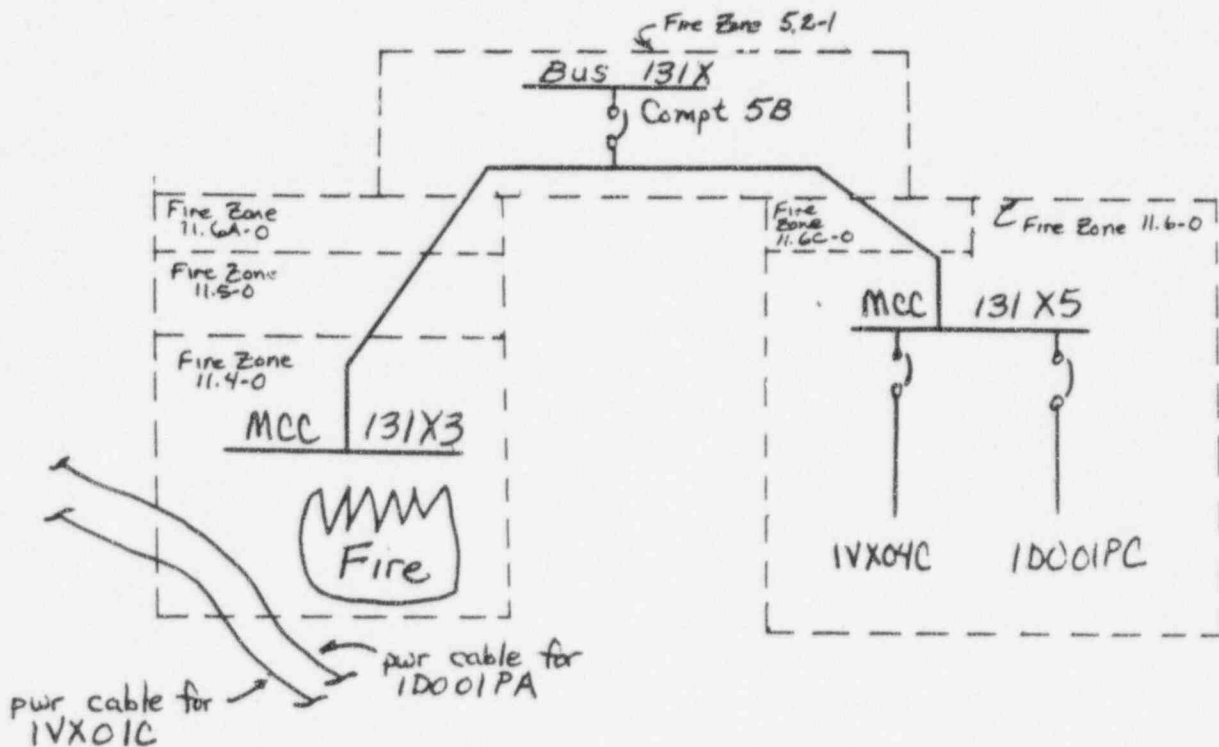
Figure 2: Configuration of Fire Zone 11.4-0

A review of all other Byron configurations of multiple MCCs powered from a common 480 volt breaker was conducted. At 1510 on 10/13/95, all configurations were judged to be acceptable for 10CFR 50, Appendix R considerations, except for a deficiency in the FPR Safe Shutdown Analysis for Fire Zone 11.4-0. The original Safe Shutdown Analysis failed to recognize the possible loss of both Diesel Oil Transfer Pumps for the 1A Emergency Diesel Generator and the loss of the Division 11 ESF Switchgear Room Supply Fan in this zone.

Unit 1 FPR Sections 2.4.2.43 and A5.8.17 state that Division 11 equipment is relied upon for a fire in Fire Zone 11.4-0. The power cable for Diesel Oil Transfer Pump (1DO01PA, Division 11) is routed in this zone and can be damaged by a fire. Redundant pump (1DO01PC, Division 11), its power cable, and MCC power source are located outside of zone 11.4-0. The MCC power source receives power from a common 480 volt bus breaker which also powers an MCC located in Fire Zone 11.4-0. The MCC located in zone 11.4-0 can be damaged by a fire in this zone. Therefore, a fire-induced failure on this MCC will cause the common supply breaker to open and de-energize the MCC supplying power to pump 1DO01PC. With both Diesel Oil Transfer pumps not available, the 1A Emergency Diesel Generator is not available. Additionally, the Division 11 ESF Switchgear Room Supply Fan (1VX04C) is powered by the MCC for pump 1DO01PC. Similarly, fan 1VX04C may not be available for a fire in zone 11.4-0. See Figure 2 in Attachment A for a diagram of the above configuration.

Problem: Appendix R Fire in Zone 11.4-0 (Elev. 383', AB) may cause failure of:

- 1). Pwr cable for 1VX01C (Div 12 ESF Swgr Supply Fan)
- 2). Pwr cable for 1DO01PA (A Diesel Oil pp for 1A D/G)
- 3). Fault MCC 131X3 which causes Bus 131 Compt 5B breaker to open when sensing fault current.

Therefore MCC 131X5 de-energized resulting in:

- (a) Loss of 1VX04C (Div 11 ESF Swgr Supply Fan)
- (b) Loss of 1DO01PC (A Diesel Oil pump for 1A D/G)

Which means for a fire in Zone 11.4-0, which the FPR Safe Shutdown Analysis states that Division 11 will be protected from fire:

- 1). Both DO pumps for the 1A D/G are lost
- 2). Div 11 ESF Swgr Room Supply Fan 1VX04C is lost
