Commonwealth Edison Company
Braidwood Generating Station
Route #1, Box 84
Braceville, IL 60407-9619
Tel 815-458-2801

This report is number 95-013-00, Docket No. 50-456.

LICENSEE EVENT REPORT (LER)

TITLE (4)
Fire Protection Appendix R Design Discrepancies Due to Inadequate Evaluations During Preparation of Original Analysis

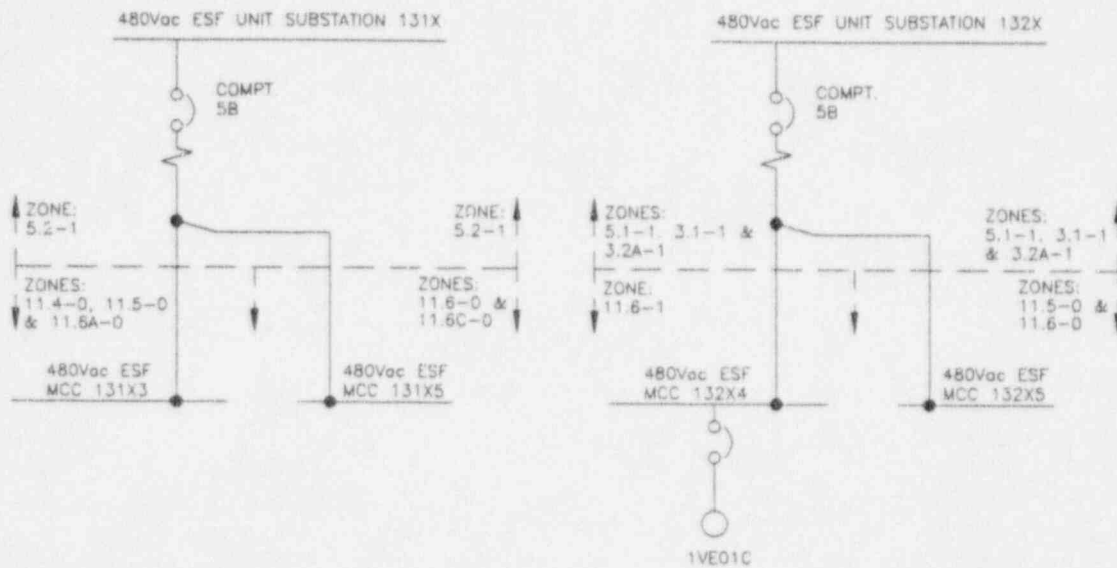
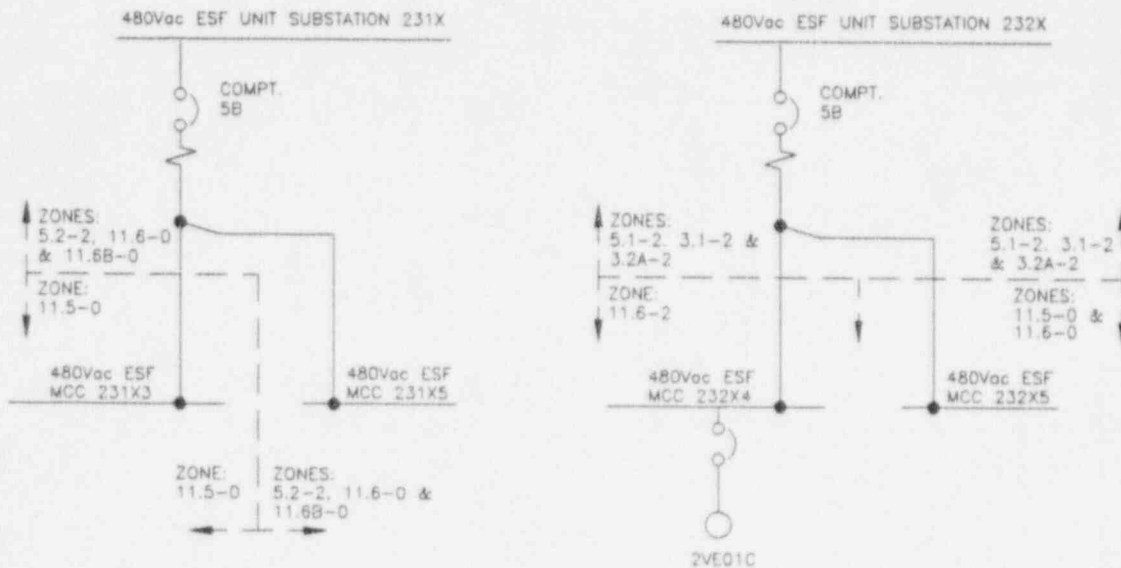
FIGURE 1 - MCCs WITH COMMON SOURCE BREAKERS

The FPR analysis failed to recognize that (2) 480 Vac ESF Motor Control Centers (MCCs) on each train of both Units are powered from a common source breaker at their respective Unit Substations, see Figure 1. As a result, fire induced failures on one MCC, including its feed cable could trip the common source breaker and render both MCCs unavailable. A review of the affected MCCs concluded that the Train A MCCs did not create any Appendix R separation discrepancies; however, the Train B MCCs did. The FPR analysis assumes that the power source for the Train B MEER Supply Fans (1VE01C & 2VE01C) would be available after a fire in zones 11.5-0 (Unit 2) & 11.6-0 (Units 1 & 2). Since the MCCs supplying electrical power to these fans share common Unit Substation breakers with another MCC which could be damaged due to a fire in zones 11.5-0 (Unit 2) & 11.6-0 (Units 1 & 2) the fans would be unavailable. The Engineering Department concluded that a deficiency existed in the FPR analysis and issued a Problem Identification Form (PIF) on October 9, 1995 to document the discrepancy.

The cause of the first identified discrepancy was a failure of the original Braidwood FPR Safe Shutdown Analysis to recognize the interconnection between MCCs powered from a single 480 volt Unit Substation breaker. Consequently, the FPR Analysis for Fire Zones 11.5-0 and 11.6-0 did not consider the potential loss of some MCCs located outside of the fire zone. The analysis addressed what equipment and cables are located in the fire zone and could be directly affected by a fire. An assumption was implicitly made and the analysis was performed as if the power and control cables for each component formed an independent circuit and that a failure of cables for one component would not have any impact on any other safe shutdown components. This assumption is based on breaker coordination studies that demonstrate that fire induced faults on a cable will not cause an upstream supply breaker to open before the specific load fuse or breaker for the circuit in question opens. This assumption is not valid for the identified configuration of two MCCs fed from a single Unit Substation breaker. The exception to the breaker coordination assumption is an isolated case in the existing Byron and Braidwood Safe Shutdown Analysis.

- Hourly fire watches will remain in effect for all fire zones until all Safe Shutdown discrepancies are permanently rectified.
- The Station has initiated plant modifications to permanently resolve the deficiencies described herein. The affected MCCs will be re-powered from different source breakers at their respective Unit Substations. The affected DG and SX system cables will be re-routed out of the fire zones. The AF pump circuitry will be re-wired to eliminate the impact of fire induced failures on the affected AF system cables. Installation of the Unit 1 modifications were all completed during the recent re-fueling outage with the exception of one cable in the SX system. Installation of the Unit 2 modifications will begin during the upcoming re-fueling outage. The installation activities for these modifications will be completed by December 1996. This will be tracked to completion by commitment 456-180-95-01301 and -01302 for Units 1 and 2, respectively.
